Document-feeder roller (M830 only)

Remove the document-feeder roller (M830 only)

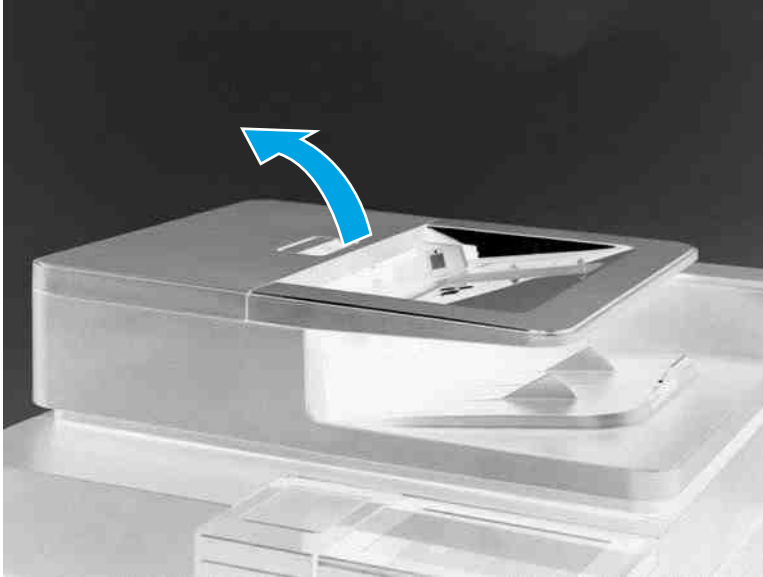
Figure 1-84 Remove the document-feeder roller (M830; 1 of 3)

1. Open the document-feeder door.

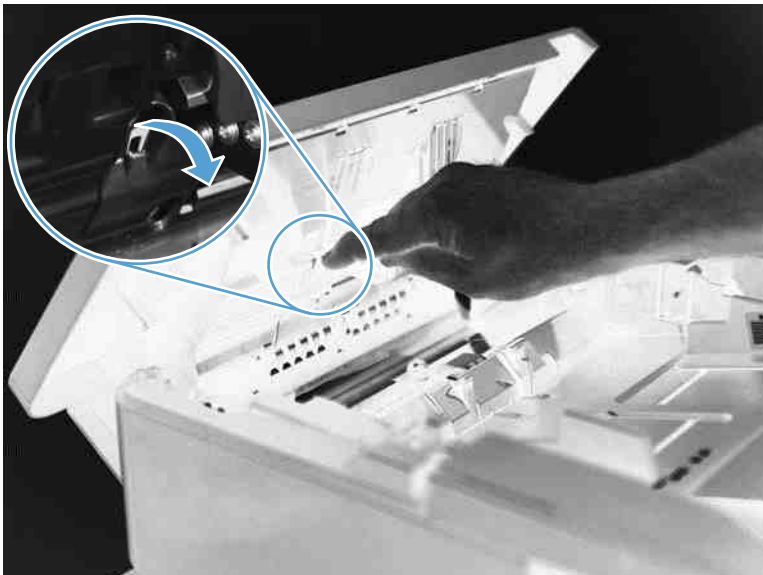
Figure 1-85 Remove the document-feeder roller (M830; 2 of 3)

2. Release one tab, and then open the access door.

Reinstallation tip When the roller is reinstalled, the access door must be fully closed. When you close the door, you should hear two audible clicks. If, after replacing the roller document feeder, a document feeder jam message appears on the control panel display, make sure that the access door is fully closed.

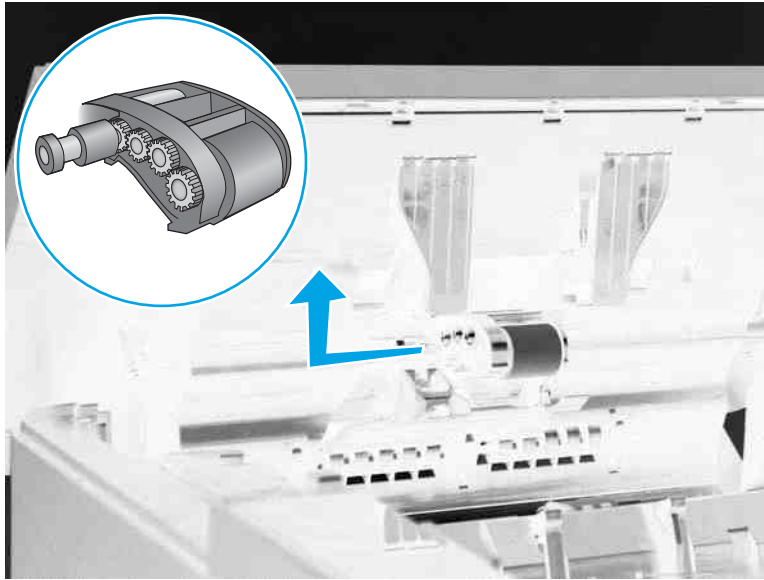
Figure 1-86 Remove the document-feeder roller (M830; 3 of 3)

3. Slide the roller left, and then lift it up and out of the product.

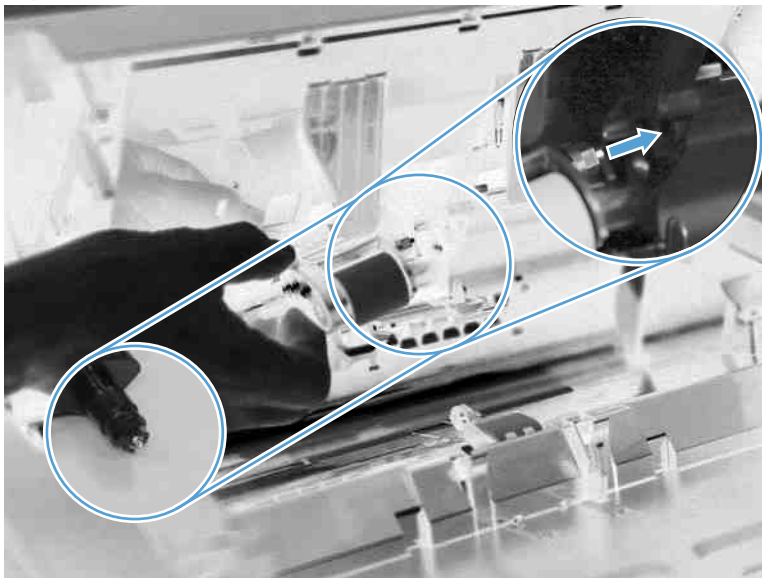
Figure 1-87 Remove the document-feeder roller (M830)

The roller assembly is keyed. When reinstalling the roller assembly, position the hex-shaped fitting on the shaft toward the rear of the product.

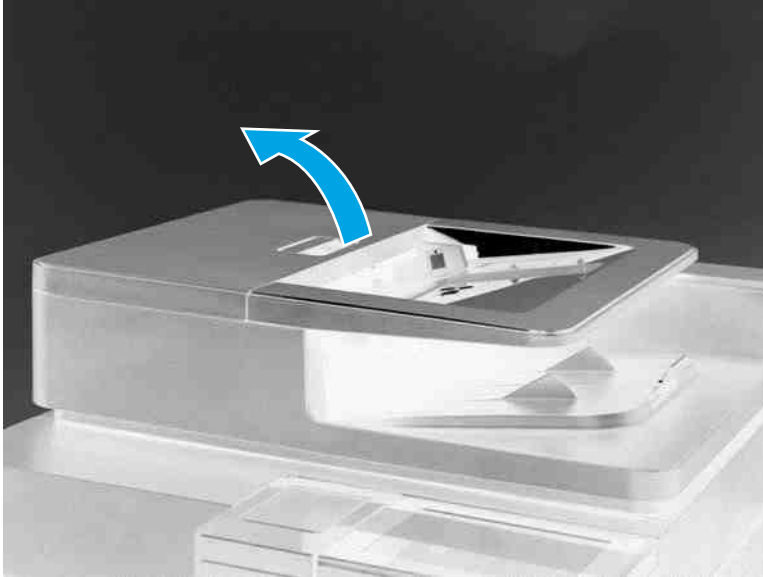
Figure 1-88 Remove the document-feeder separation pad (M830; 1 of 4)

1. Open the document-feeder door.

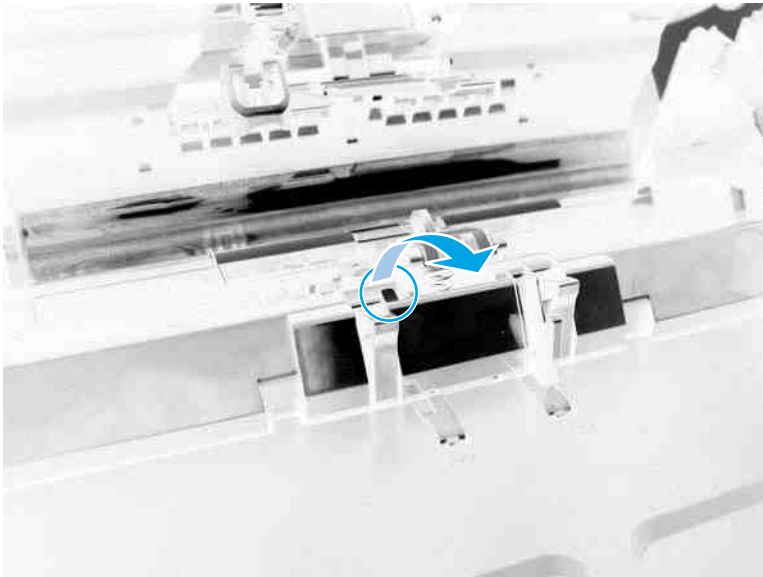
Figure 1-89 Remove the document-feeder separation pad (M830; 2 of 4)

2. Release one tab.

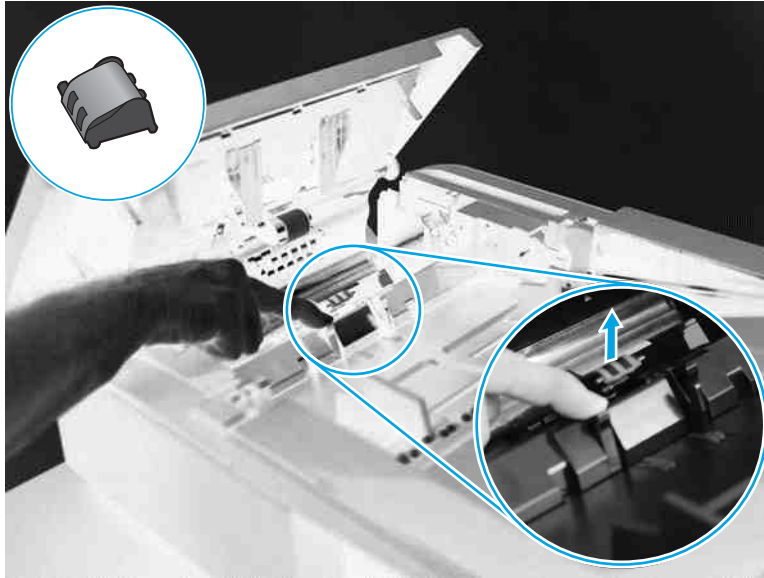
Figure 1-90 Remove the document-feeder separation pad (M830; 3 of 4)

3. Hold the access door open to allow the separation pad to partially release and pop up.

**NOTE:** The separation pad is spring-loaded and partially releases when the access door is opened.

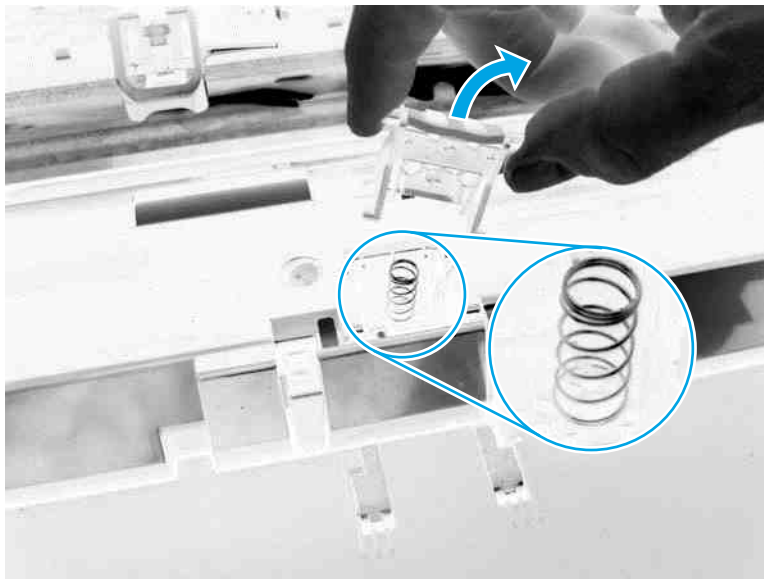
Figure 1-91 Remove the document-feeder separation pad (M830; 4 of 4)

4. Lift the separation pad up and away from the product.

**CAUTION:** If the spring becomes dislodged, securely reinstall it as shown below.

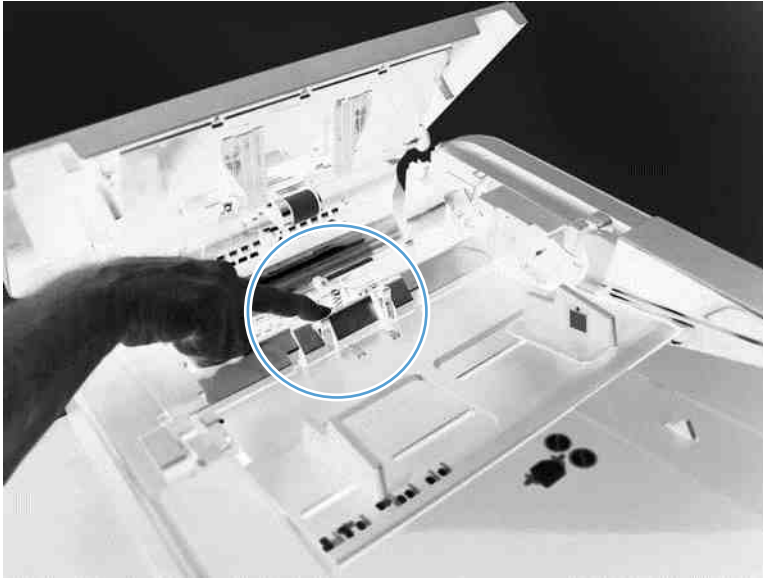
Figure 1-92 Reinstall the document-feeder separation pad (M830; 1 of 5)

1. Release and hold the separation pad access door open.

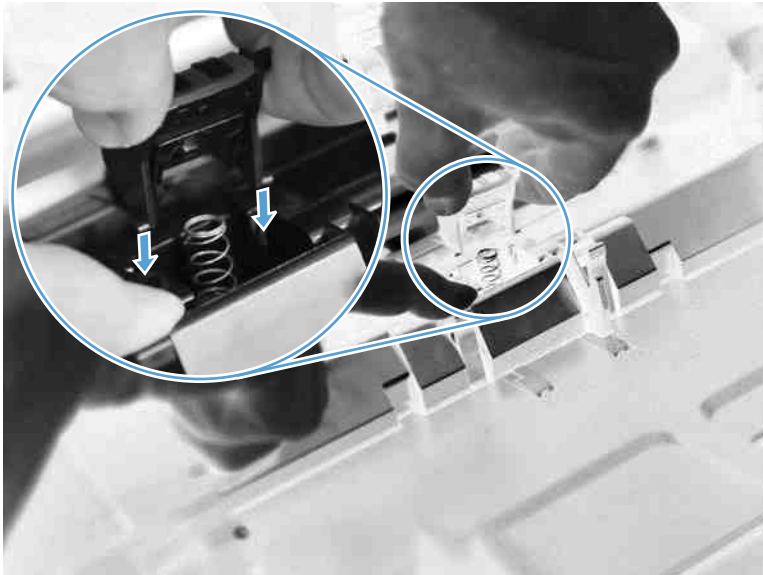
Figure 1-93 Reinstall the document-feeder separation pad (M830; 2 of 5)

2. Align the pins on the separation pad with the mounting slots.

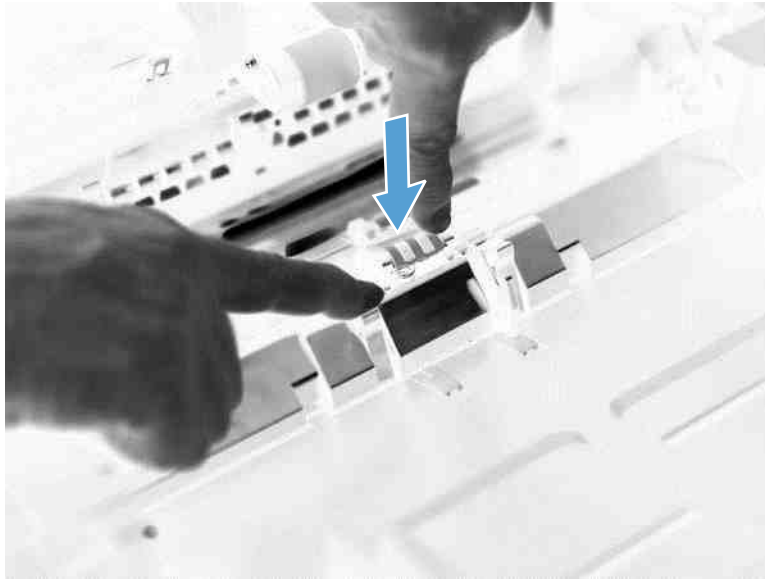
Figure 1-94 Reinstall the document-feeder separation pad (M830; 3 of 5)

3. Carefully press down on the separation pad to compress the spring.

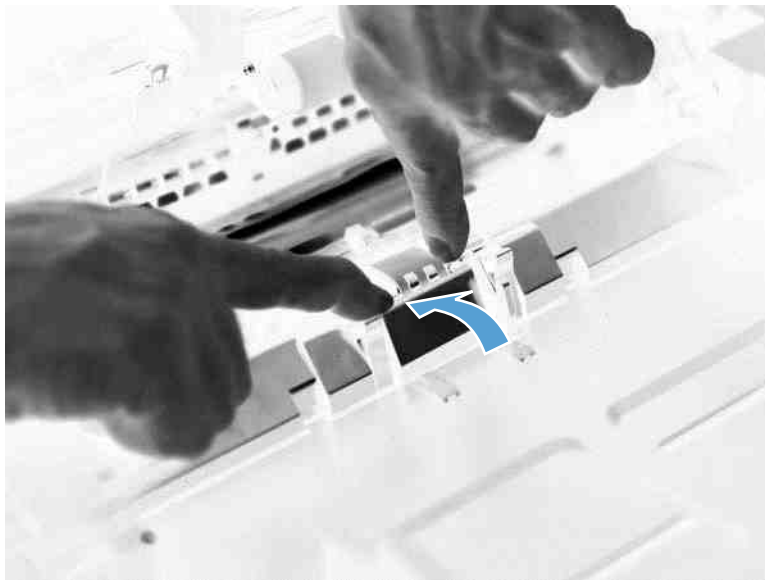
Figure 1-95 Reinstall the document-feeder separation pad (M830; 4 of 5)

4. Continue to press down on the separation pad, and then release the access door.

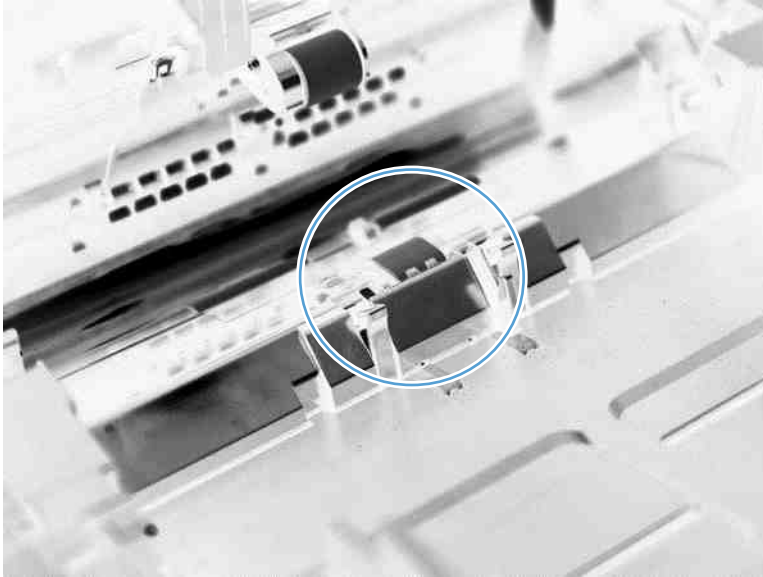
Figure 1-96 Reinstall the document-feeder separation pad (M830; 5 of 5)

5. Verify that the separation pad is correctly installed and that the access door is fully closed as shown below.

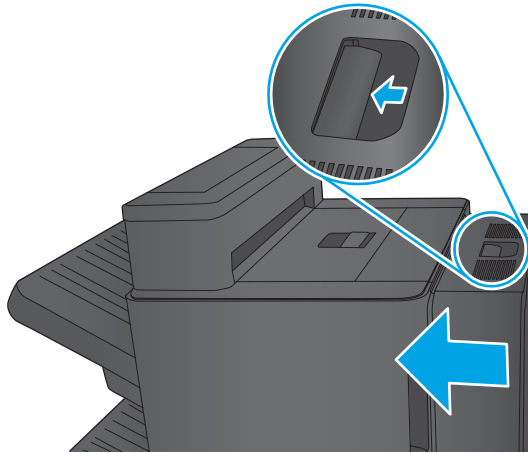
Figure 1-10 Remove the fuser (1 of 3)

1. If a finishing accessory is attached, release one handle, and then slide the finishing accessory away from the product.

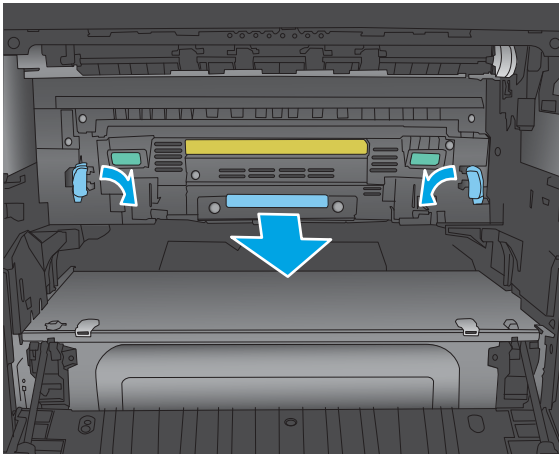
Figure 1-11 Remove the fuser (2 of 3)

2. Open the left door, release two latches, and then slide the fuser toward the left door.

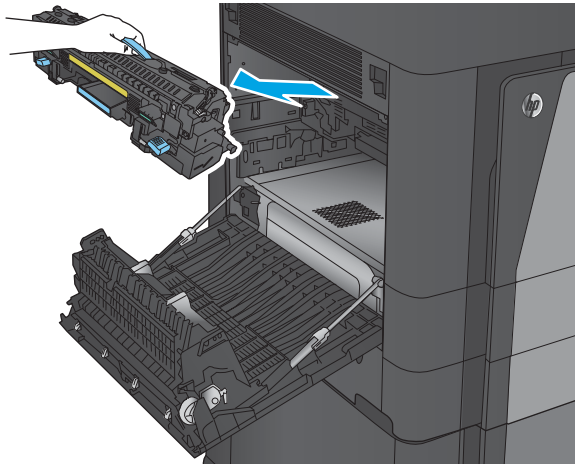
Figure 1-12 Remove the fuser (3 of 3)

3. Grasp the fuser by the handle, and then lift it out of the product.

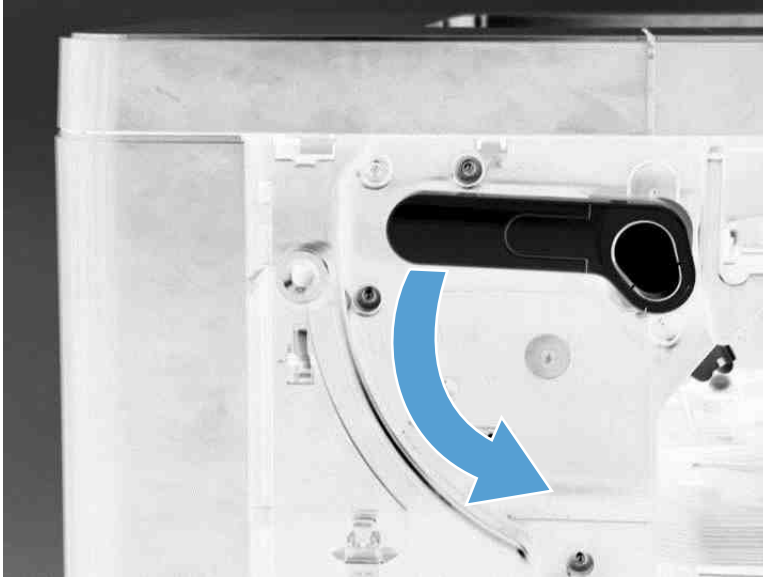
Figure 1-6 Remove the transfer-roller assembly (1 of 2)

1. Open the front cover.
2. Rotate the cartridge release lever down until it clicks into place.

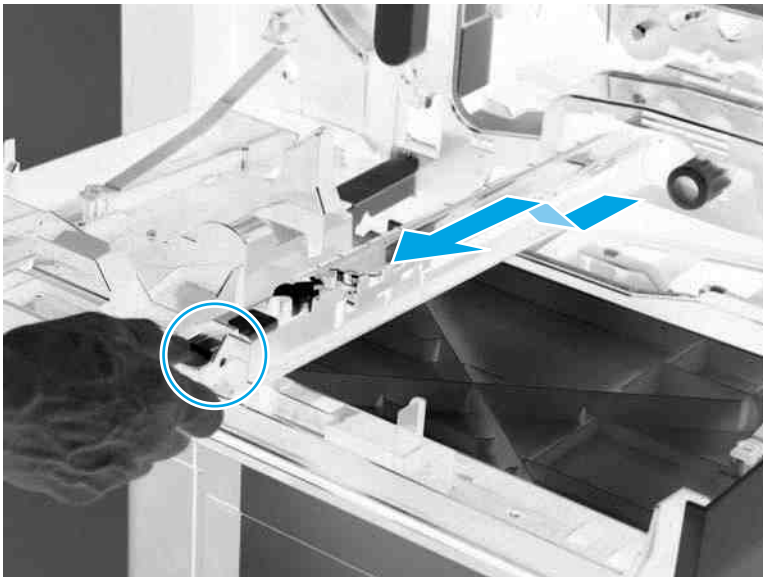
Figure 1-7 Remove the transfer-roller assembly (2 of 2)

3. Press the blue tab, and then slowly pull the transfer roller assembly toward the front of the product until it stops. Lift the assembly up to release the catch on the underside, and then remove the assembly.

Reinstallation tip Make sure that the transfer roller is completely inserted and latched when it is reinstalled.
