HP M712/M725MFP Close left door message

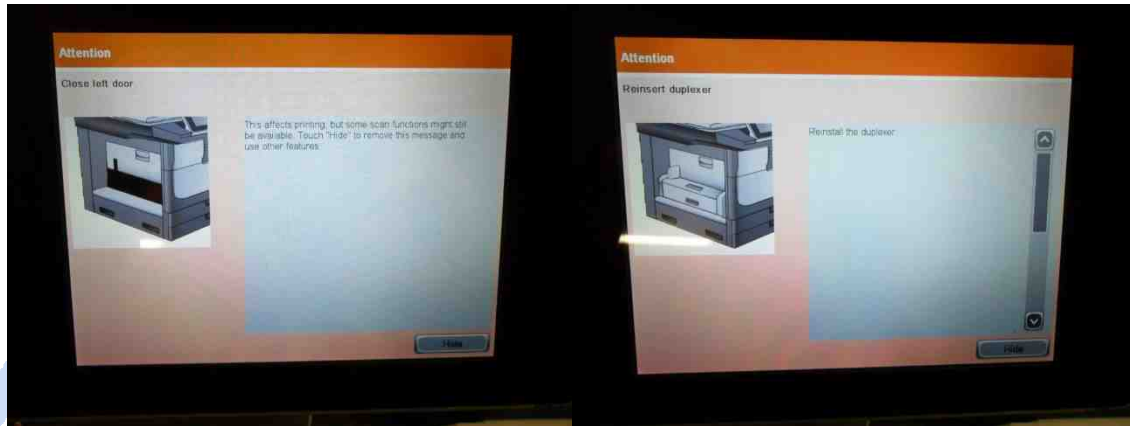
There have been a few cases where the printer will display one of the above messages without the ability to print. The cause of this has been the rear fuser lock tab being just out of the locked position, which will intern cause the linkage to the switch "SW1 fuser/left door" incomplete.

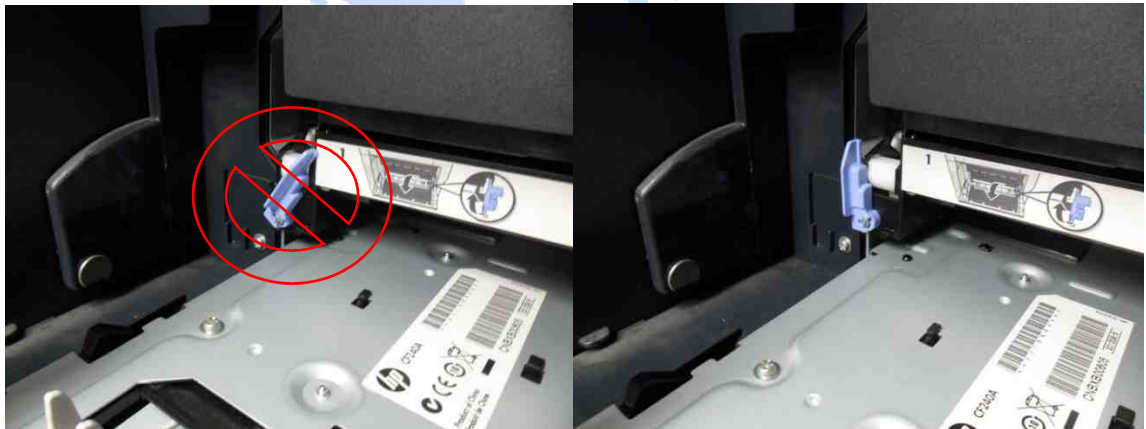
Below are incorrect and correct positions for the rear fuser lock tab:
