HP CP5525/CP5225 Series - Missing Cyan and/or Magenta Colors

Missing colors have been reported on the Color LaserJet CP5225 and CP5525 series.

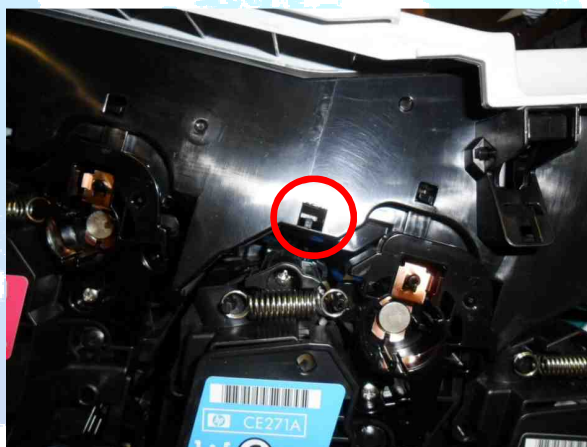
Printers diagnosed with the missing color are caused by the Upper Cartridge Guide Assembly being pulled out slightly from the front of the printer. Typically this is most visible at the center protrusion of the guide - between the Magenta and Cyan cartridges and usually will affect the operation of the front door, not closing completely flush to the frame. Photo with incorrect positioning: Notice lock tab visible on front side of frame

This issue may be addressed by snapping the guide back into position. In order to do this, it is necessary to use a small flat-blade screwdriver and firmly press to help lock the tab behind the sheet metal as shown below. Photo with correct positioning:
