Uspešno pogašen požar v kompenzacijski omarici trafo postaje TP5 - JULON, dne 17.05.2007

REFERENCA O USPEŠNEM DELOVANJU GASILNE AMPULE BONPET

Opis dogodka: Požar v kompenzacijski omarici ki je v trafo postaji TP5- JULON 1

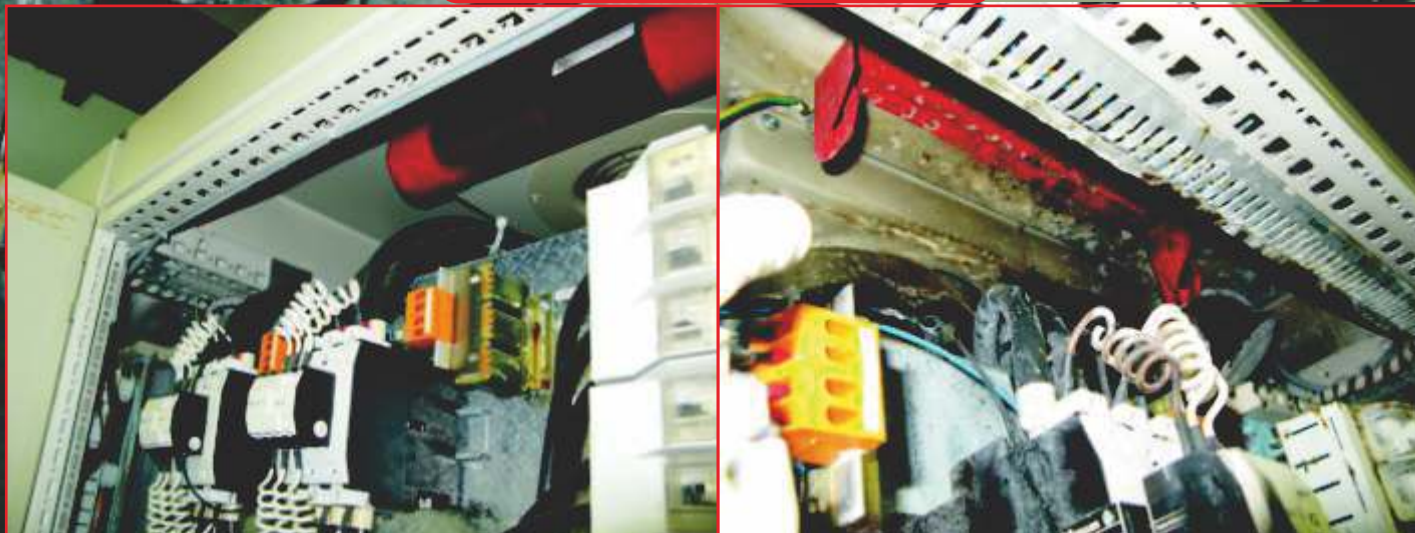
Stanje pred in po požaru

Iz priložene fotografije je razvidno, kako so bile ampule Bonpet nameščene pred aktivacijo.

Enclosed photos shows how ampoules Bonpet were installed before the activation.
