Original design parameters

Printing issue

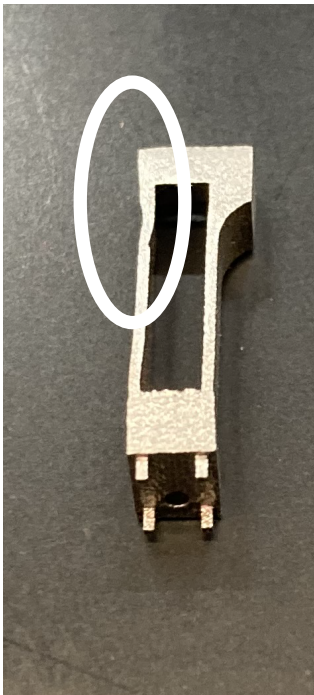
Faulty drive

Add the following note to the drive body: 'Use orientation as in quote 9301-742.'

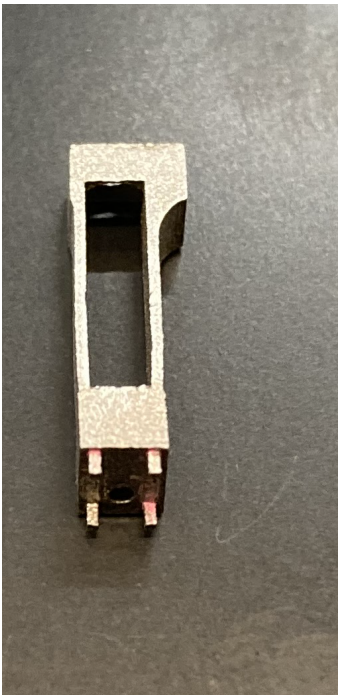
Good drive
