27995.00 \$

Published date: 2023/11/16

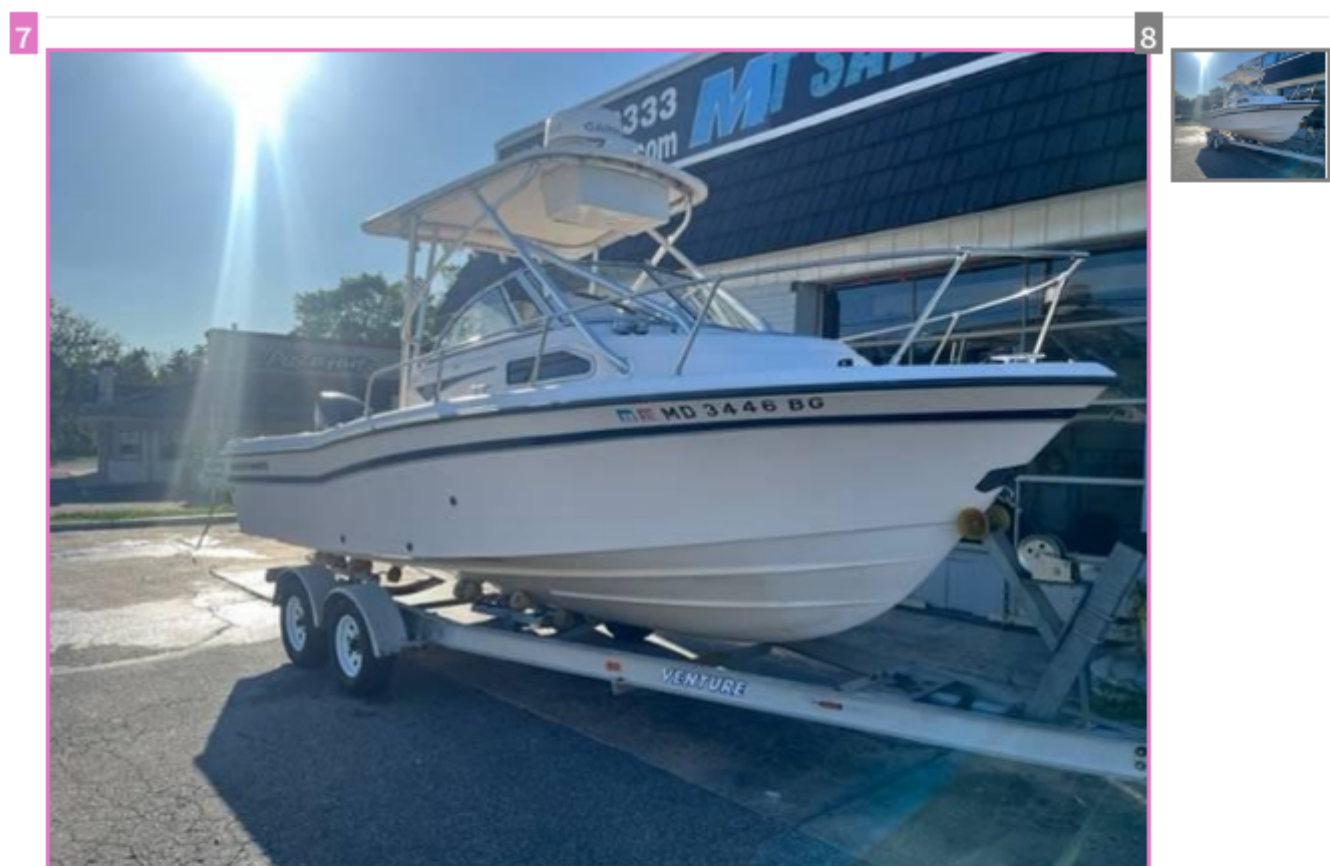
Location: Middle River, Maryland, United States
