# **JMP CASE STUDY: VARIATION IN SEMICONDUCTOR ETCHING PROCESS**

**Prepared by: CHEW CHIA YIK**

**July 2025**

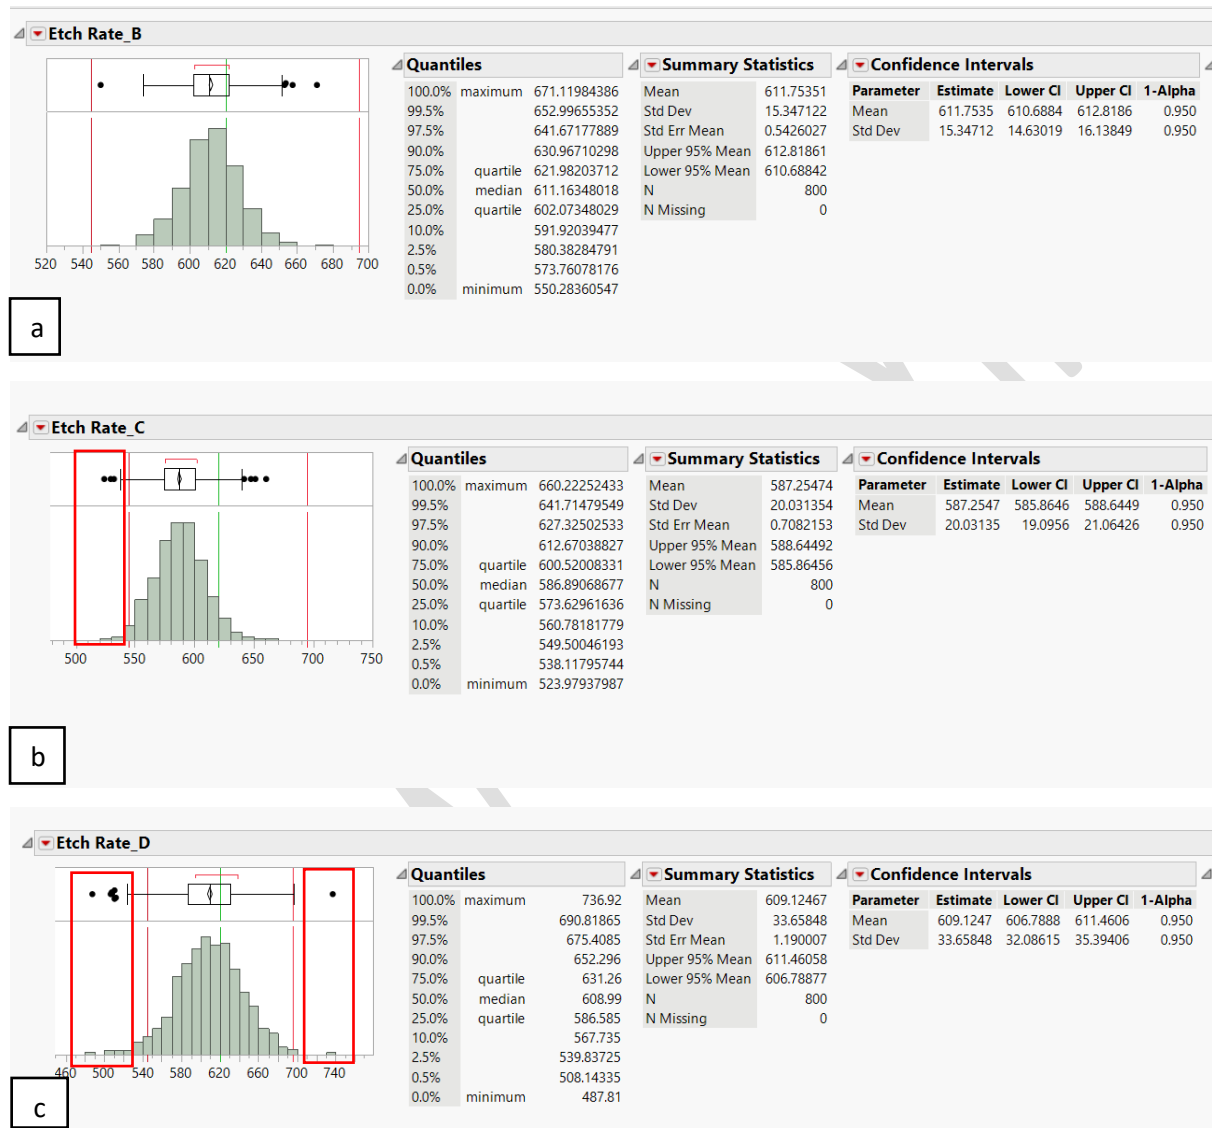
Diagram 1 Histogram, Boxplot, Summary Statistics (\*Red Box indicates out of spec)

From Diagram 1a, it is evident that **the data of Etch Rate B are within the LSL and USL**, indicating a stable and well-controlled variation. However, **Etch Rate C and D exhibit overall process variation that extends beyond the specification limits** as shown in Diagram 1b and 1c, respectively, which indicates undesirable variation as variation should be well within the defined specification ideally.

This section will explore on numerical and graphical summary of Etch Rate data for Line B,C and D. Diagram 1 includes a histogram, boxplot, and summary statistics for the 800 Etch Rate values with reference lines indicating the target and specification limits.

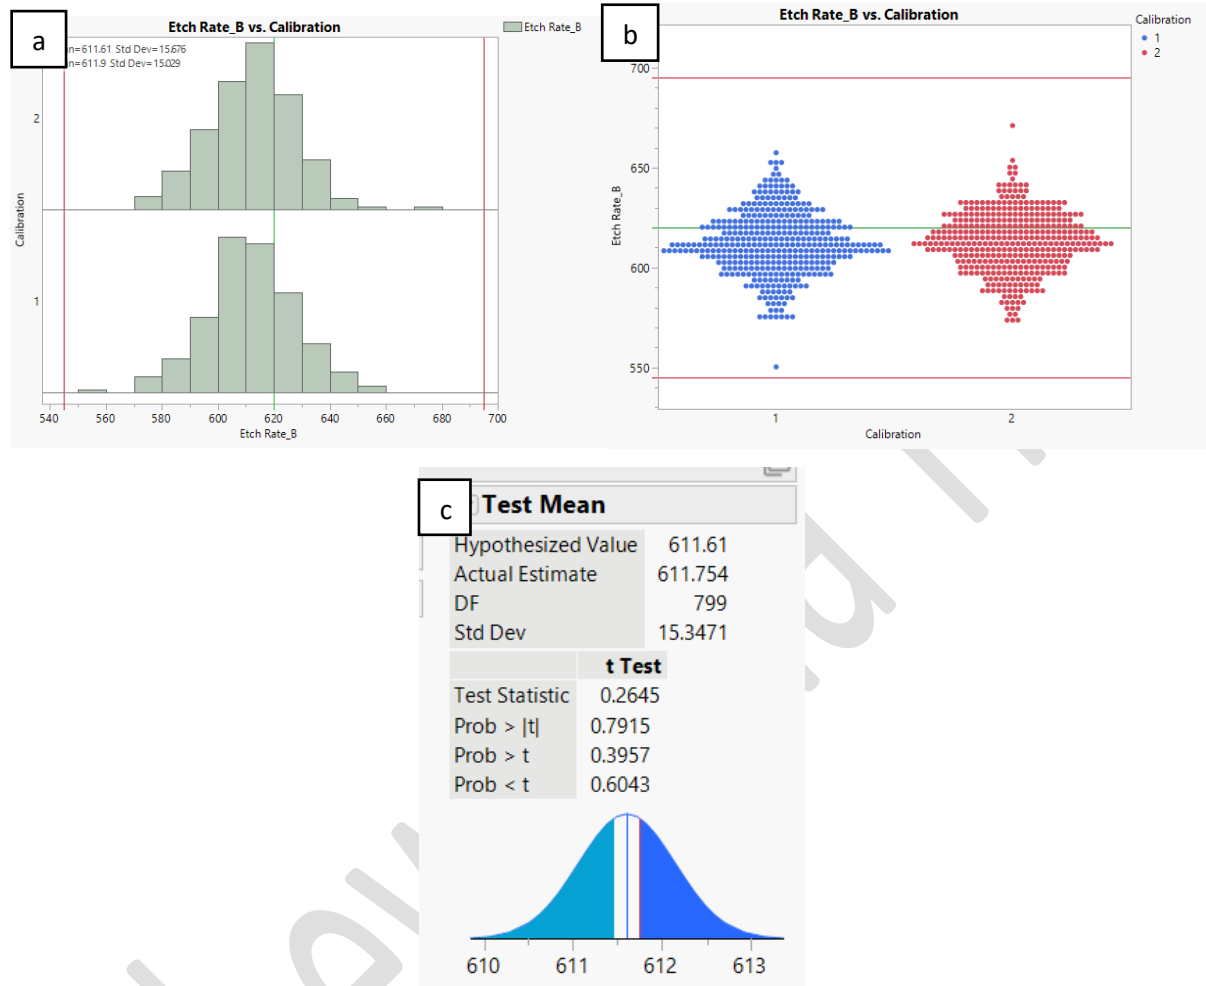
Diagram 2: (2a): Comparative Histogram of Etch Rate B at both calibration rate, (2b): Comparative Dot Plot of Etch Rate B at both calibration rate. (2c): 2 Tailed Test for Mean of Etch Rate B at Calibration 1 with Respect to Calibration 2.

The graphical analysis in Diagram 2 shows that the variation in etch rate during both calibration stages is not excessive, with no evident difference in either the variation or the average. A two-sample t-test comparing the process means between these two stages yielded a probability of 0.7915 ( $> 0.05$ ) which indicates no significant difference between both means.

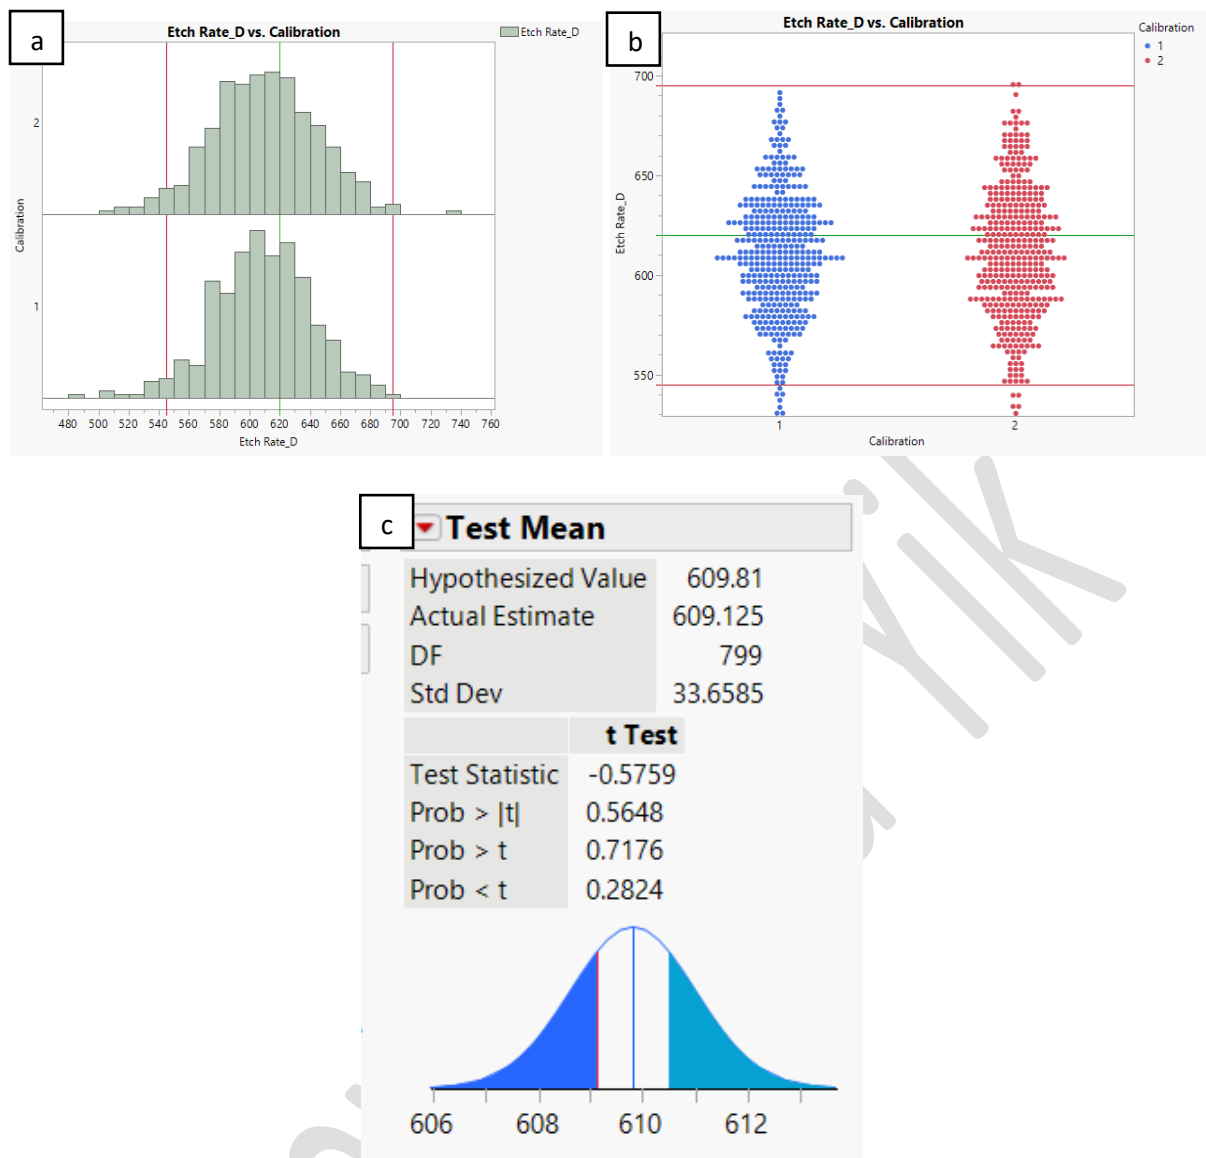
Diagram A2: (a): Comparative Histogram of Etch Rate D at both calibration rate, (b): Comparative Dot Plot of Etch Rate D at both calibration rate. (c): 2 Tailed Test for Mean of Etch Rate D at Calibration 1 with Respect to Calibration 2.

The comparative histogram, dot plot and 2 tailed test for Etch Rate C and D are provided in **Appendix A (Figure A1 & A2)**.

In contrast, **Etch Rate D** exhibits a broader spread and larger standard deviation, suggesting higher variability in the process. The two-sample t-test confirmed a non-significant difference between the means of both calibration 1 and 2 for Etch Rate D with a probability of 0.5648 ( $> 0.05$ ).
