Attacking the PIC16F1936 code protection

Federico Cerutti, fce201
federico@ceres-c.it

PIC microcontrollers are widely used in embedded systems. They support a basic code protection mechanism that can be used to prevent unauthorized access to the program memory. This report describes my (unsuccessful) attempt to bypass this protection on a PIC16F1936 microcontroller via voltage glitching.

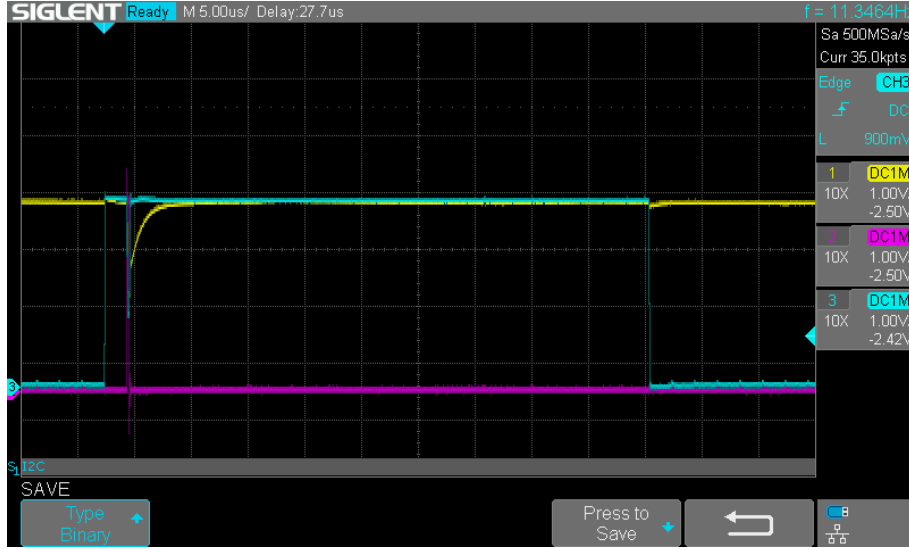
Figure 2: Glitching the flash readout

Channel 1: SCL Channel 2: Glitch trigger out Channel 3: PIC PORTA pin 0

As shown in [fig. 2](#), for the glitch to succeed the delay had to be relatively small, thus the glitch had to be triggered very early in the glitch window. Looking at [listing 2](#), we notice that the output pin is pulled up just before `EECON` register's bit `RD` is set to 1. I speculate that this glitch might be interfering with the register write, effectively not triggering the flash read from the memory subsystem, while the flash peripheral itself operates unaffected.

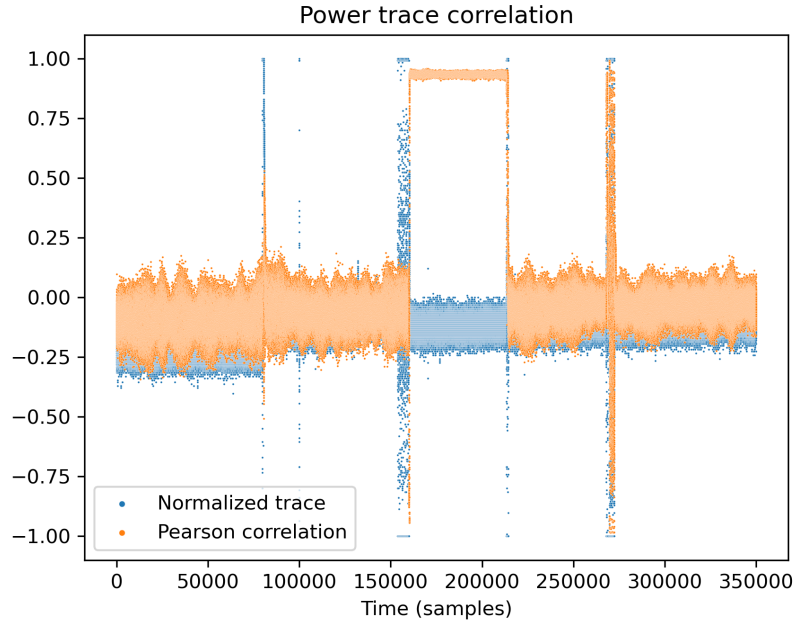
Figure 3: Pearson correlation coefficient between the power traces with and without code protection

The two matrices are correlated by column with [eq. \(1\)](#), and the results are plotted in [fig. 3](#) along with a single powertrace to easily identify the boot stages. When the correlation value is close to 1, power consumption in that instant is directly related to the state of the code protection bit. Comparing this picture with [fig. 1](#), we notice that there is high correlation in 3 key moments:

- The first peak, when the chip is powered on. At this resolution, this is probably due to measurement error, but further analysis could be done focusing on this moment.
- After the ICSP key has been sent to the target, and before first ICSP command is issued. I have no explanation for this, but it signals the fact that by this point the chip already knows if code protection is enabled or not.
- The last peak is the data readout from program memory. This is expected, as no data will be sent to the programmer if code protection is enabled, thus power consumption will be lower.

The second peak is the most interesting, as it tells us that the check for code protection status is probably done once at boot, and not on a per-read basis. This is promising as, if a glitch is successfully obtained, it will be possible to read the entire memory. Otherwise, it would have been necessary to repeat the glitch for each read.

What is missing in this picture is a clear correlation during early boot, something similar to an if-then branch being executed right after the code protection bit is read, which I had hoped to find to pinpoint the exact moment when the code protection bit is read. This was somewhat expected since, as stated in [section 1](#), these devices do not employ a bootloader.

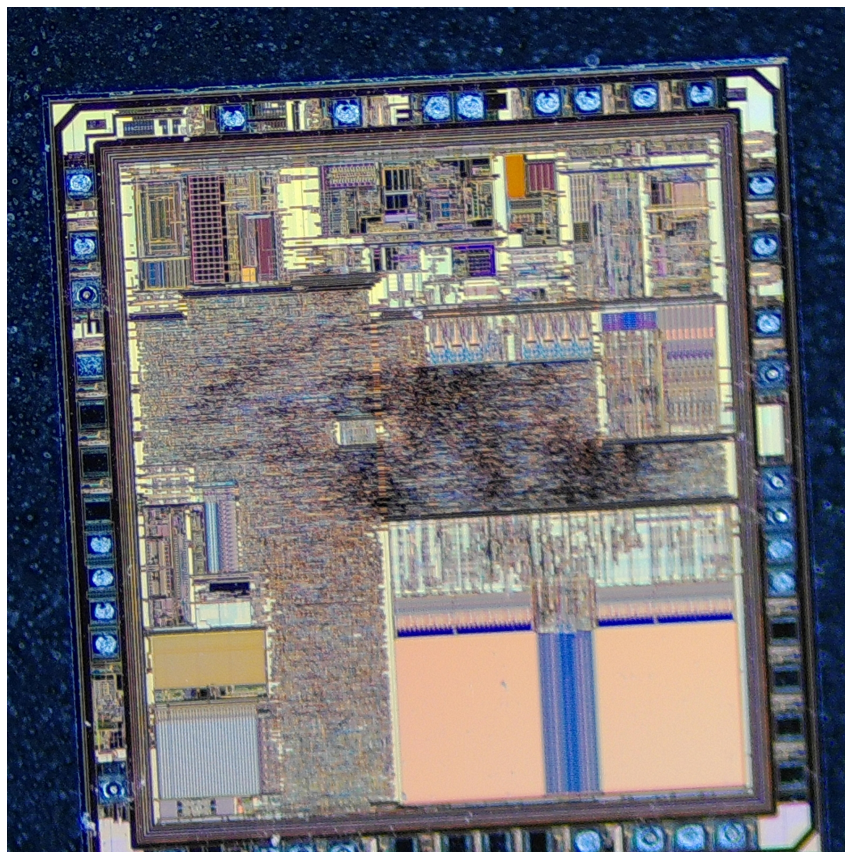
Figure 4: PIC16F1936 silicon die

Finally, in [fig. 4](#) there is a capture of the PIC16F1936 die, taken with my cheap electronics repair HDMI microscope. The chip was decapped⁴ at the hackerspace in Den Haag⁵. I want to obtain actually useful pictures in the future with either a metallurgic or scanning electron microscope.

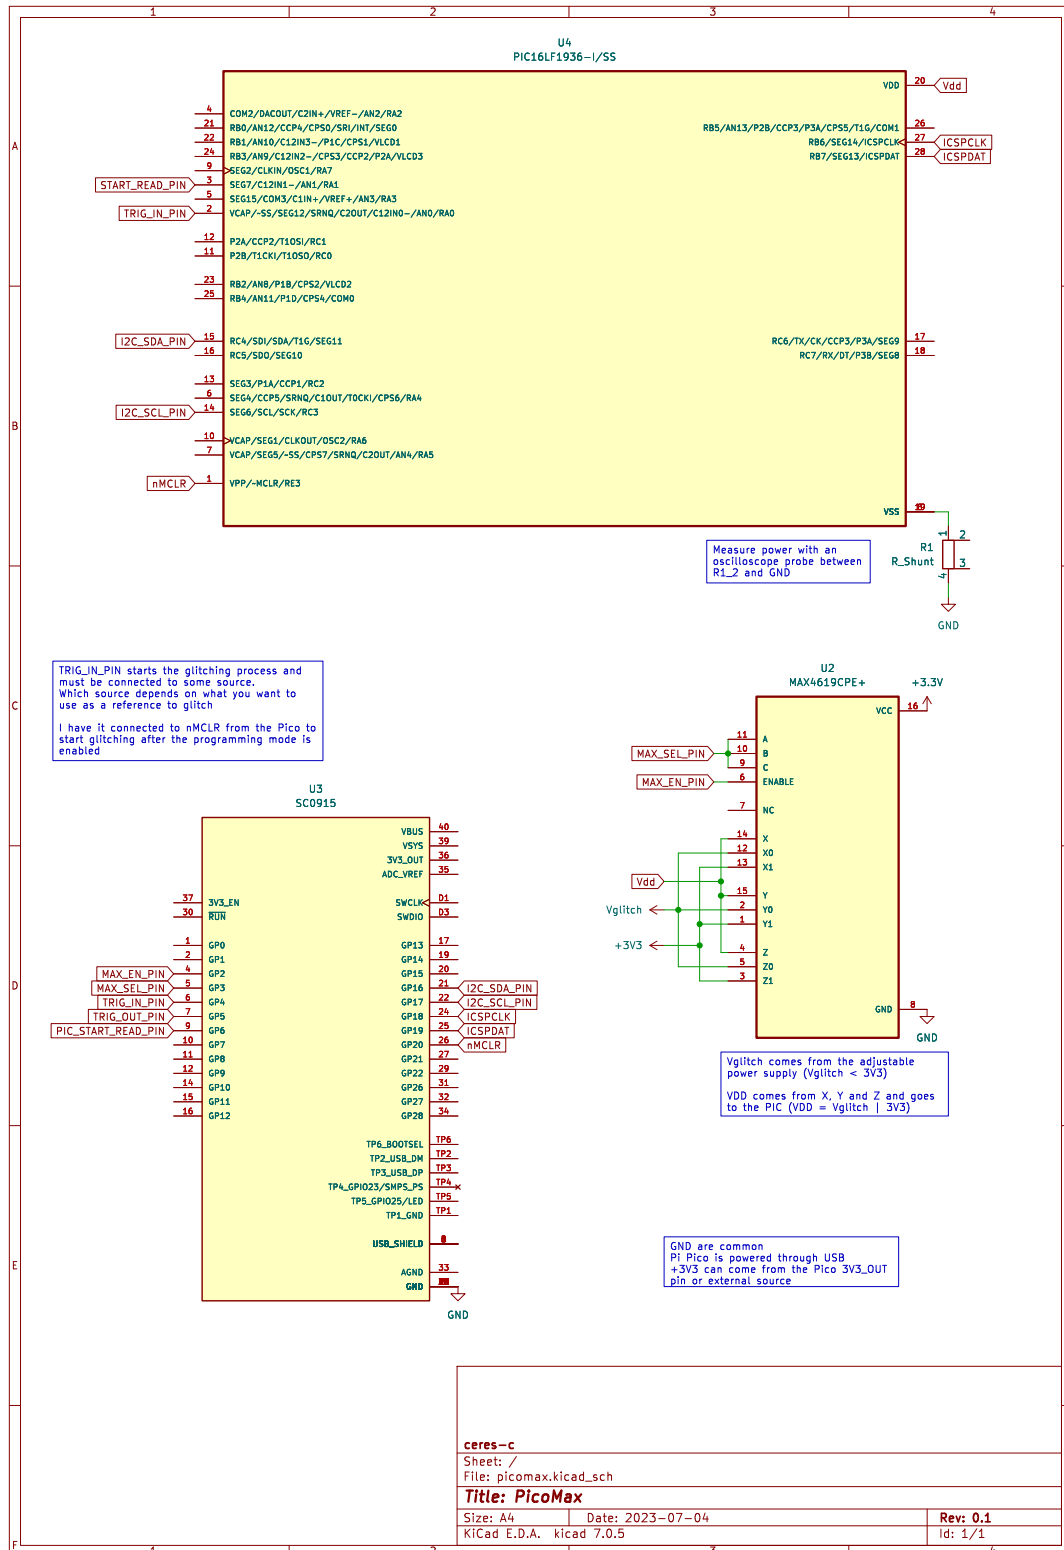
A Hardware

The schematic for the final version of the hardware can be seen in [appendix A](#).

I have decided to build my glitching setup around the MAX4619 [5] high speed switch. This chip can be used to switch the power supply of the target between two different sources, and should be fast enough to be used for voltage glitching. It was successfully used by others to attack more modern, capable microcontrollers [6].

The switch is controlled by a Raspberry Pi Pico, which was picked due to its availability and low cost. Also, the PIO subsystem of the Pico allows to generate very precise pulses, which is a requirement for any kind of glitching. This will be discussed in [section 3](#).
