# Attacking the PIC16F1936 code protection

## Abstract

PIC microcontrollers are widely used in embedded systems. They support a basic code protection mechanism that can be used to prevent unauthorized access to the program memory. This report describes my (unsuccessful) attempt to bypass this protection on a PIC16F1936 microcontroller via voltage glitching.

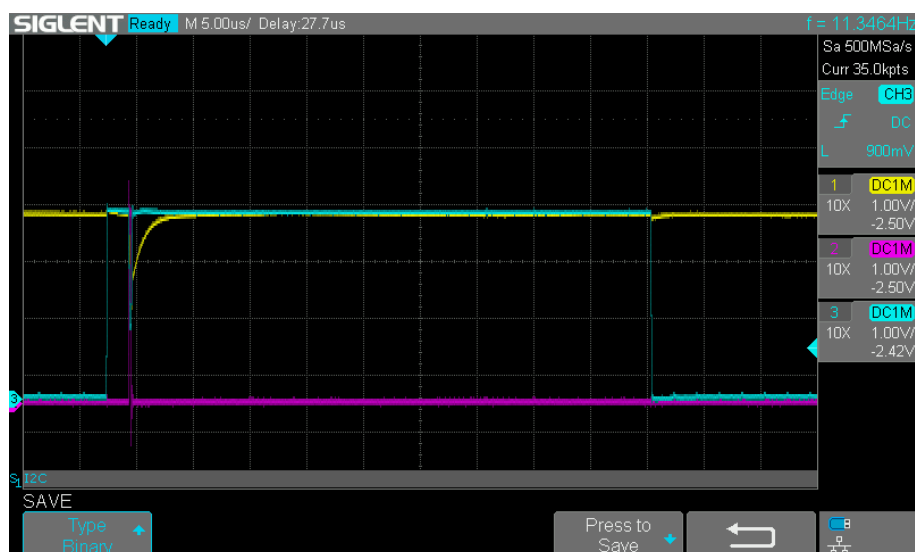
Figure 2: Glitching the flash readout  
Channel 1: SCL    Channel 2: Glitch trigger out    Channel 3: PIC PORTA pin 0

As shown in [Figure 2](#), for the glitch to succeed the delay had to be relatively small, thus the glitch had to be triggered very early in the glitch window. Looking at [Listing 2](#), we notice that the output pin is pulled up just before `EECON` register’s bit `RD` is set to 1. I speculate that this glitch might be interfering with the register write, effectively not triggering the flash read from the memory subsystem, while the flash peripheral itself operates unaffected.

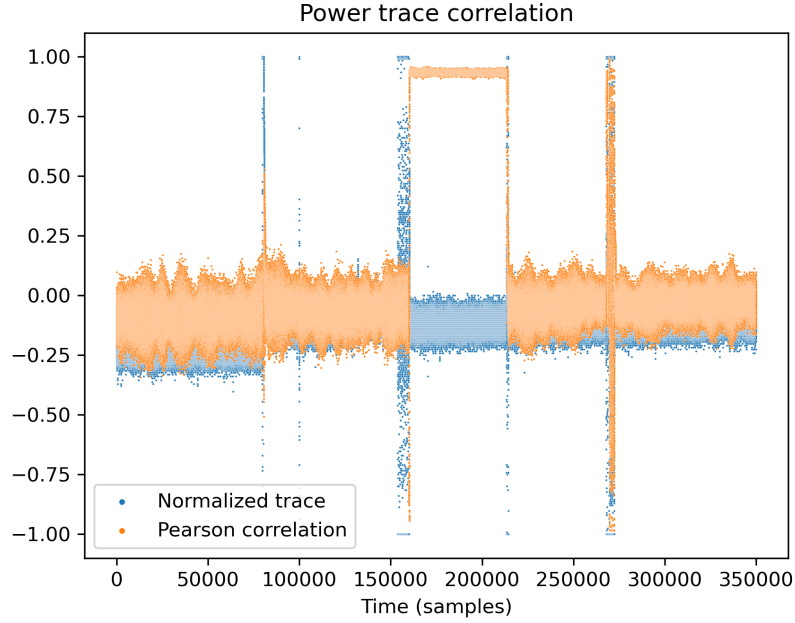
The Pearson correlation coefficient is then calculated over the two matrices by column, and the results are plotted in [Figure 3](#) along with a single powertrace to easily identify the boot stages. When the correlation value is close to 1, power consumption in that instant is directly related to the state of the code protection bit. Comparing this picture with [Figure 1](#), we notice that there is high correlation in 3 key moments:

- The first peak, when the chip is powered on. At this resolution, this is probably due to measurement error, but further analysis could be done focusing on this moment.
- After the ICSP key has been sent to the target, and before first ICSP command is issued. I have no explanation for this, but it signals the fact that by this point the chip already knows if code protection is enabled or not.
- The last peak is the data readout from program memory. This is expected, as no data will be sent to the programmer if code protection is enabled, thus power consumption will be lower.

Figure 3: Pearson correlation coefficient between the power traces with and without code protection

The second peak is the most interesting, as it tells us that the check for code protection status is probably done once at boot, and not on a per-read basis. This is promising as, if a glitch is successfully obtained, it will be possible to read the entire memory. Otherwise, it would have been necessary to repeat the glitch for each read.

What is missing in this picture is a clear correlation during early boot, something similar to an if-then branch being executed right after the code protection bit is read, which I had hoped to find to pinpoint the exact moment when the code protection bit is read. This was somewhat expected since, as stated in [section 1](#), these devices do not employ a bootloader, and apparently there is no difference in peripheral initialization between the two configurations.

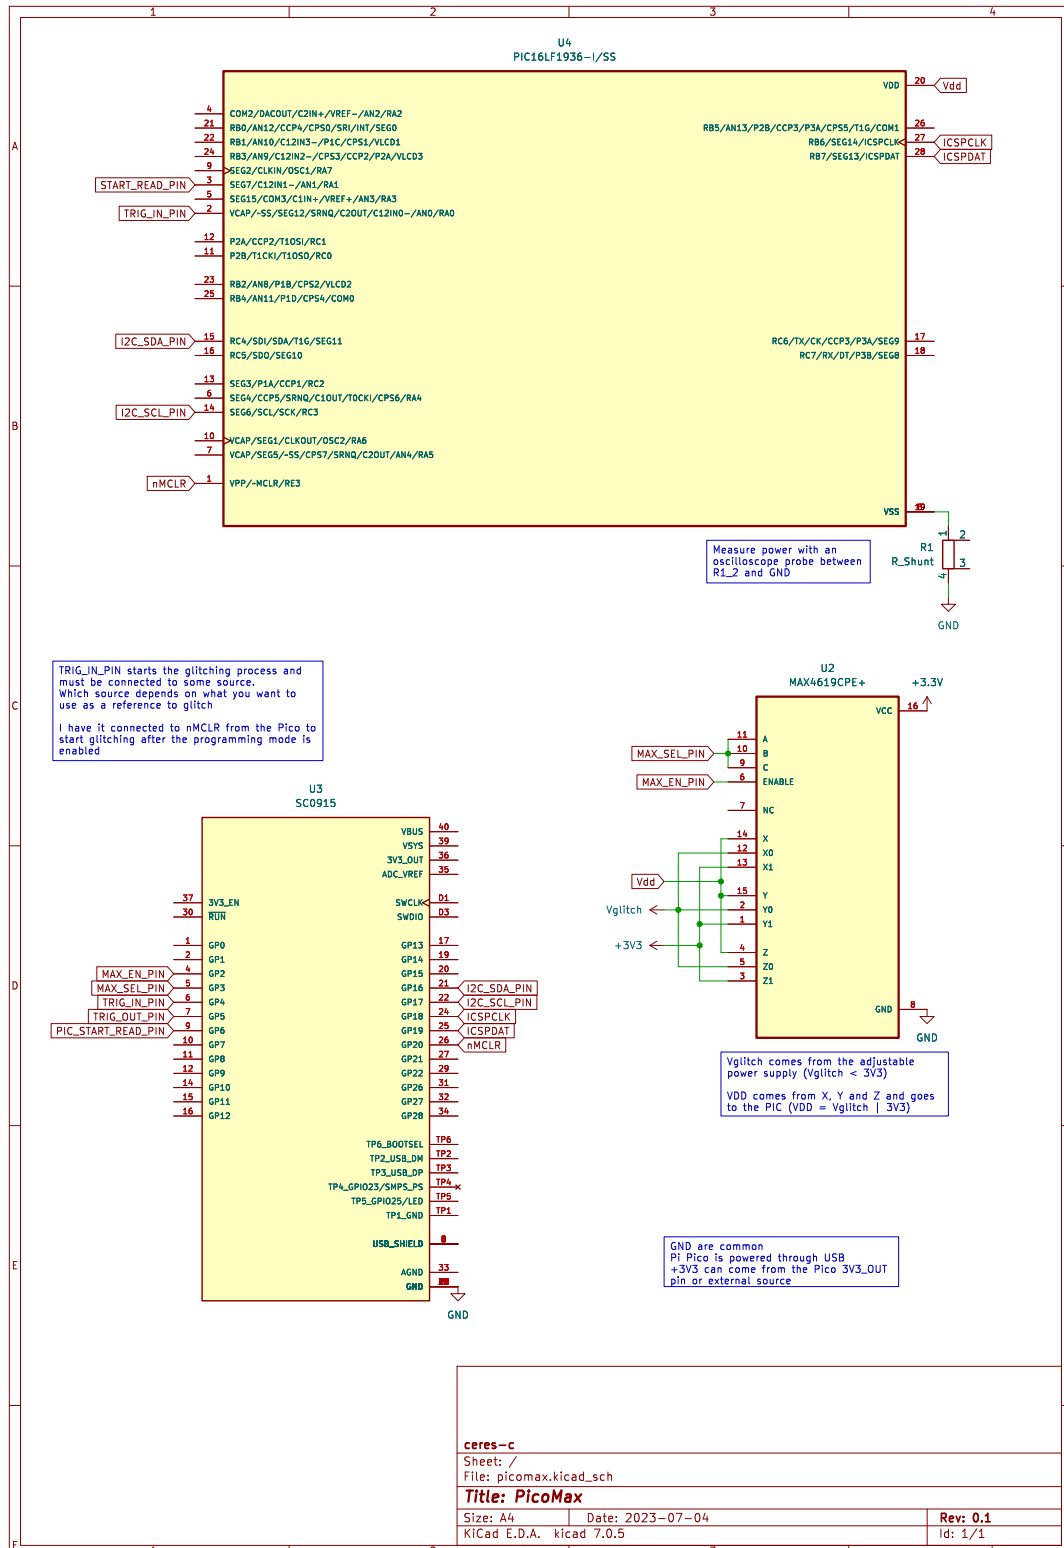
# A Hardware

The schematic for the final version of the hardware can be seen in [Appendix A](#).

I have decided to build my glitching setup around the MAX4619 [5] high speed switch. This chip can be used to switch the power supply of the target between two different sources, and should be fast enough to be used for voltage glitching. It was successfully used by others to attack more modern, capable microcontrollers [6].

The switch is controlled by a Raspberry Pi Pico, which was picked due to its availability and low cost. Also, the PIO subsystem of the Pico allows to generate very precise pulses, which is a requirement for any kind of glitching. This will be discussed in [section 3](#).
