Biodiversity—presence of species-rich areas (B.2.1.1a)

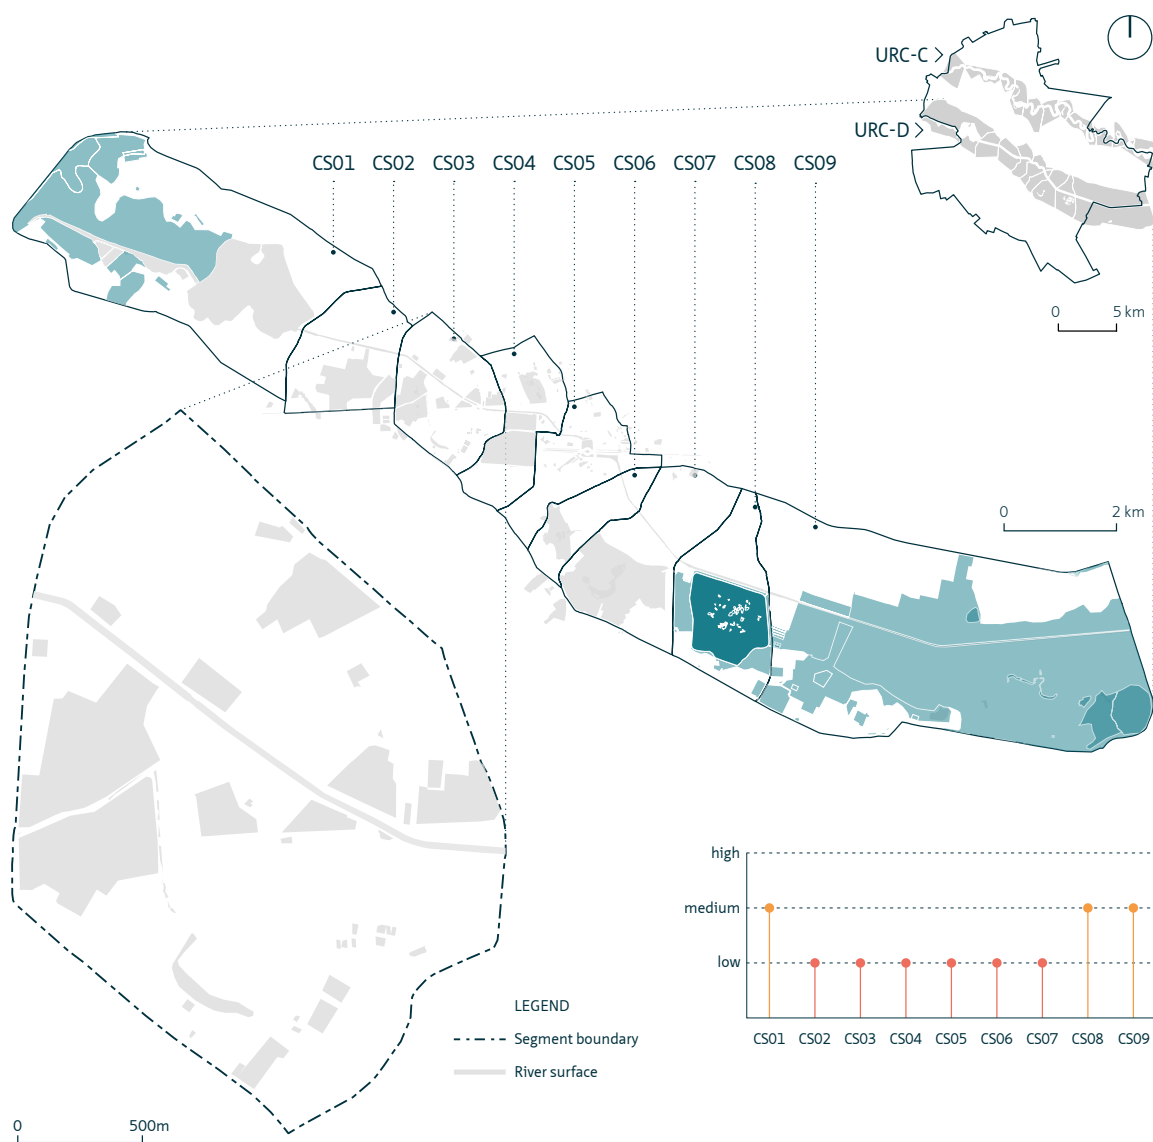
FIGURE APP.E.15 Presence of species-rich areas along URC Dâmbovița, with detail of CS03.

Species-rich areas in the corridor are mapped and classified as follows: [1] **low**, when no such area is present, [2] **medium**, when they are present in the proximity of the river, or [3] **high**, when species-rich areas are in direct contact with the river, i.e. they constitute part of the riparian space.

- Biodiversity—presence of species-rich areas: **low**.
