2023/08/25 ERT3 ver4

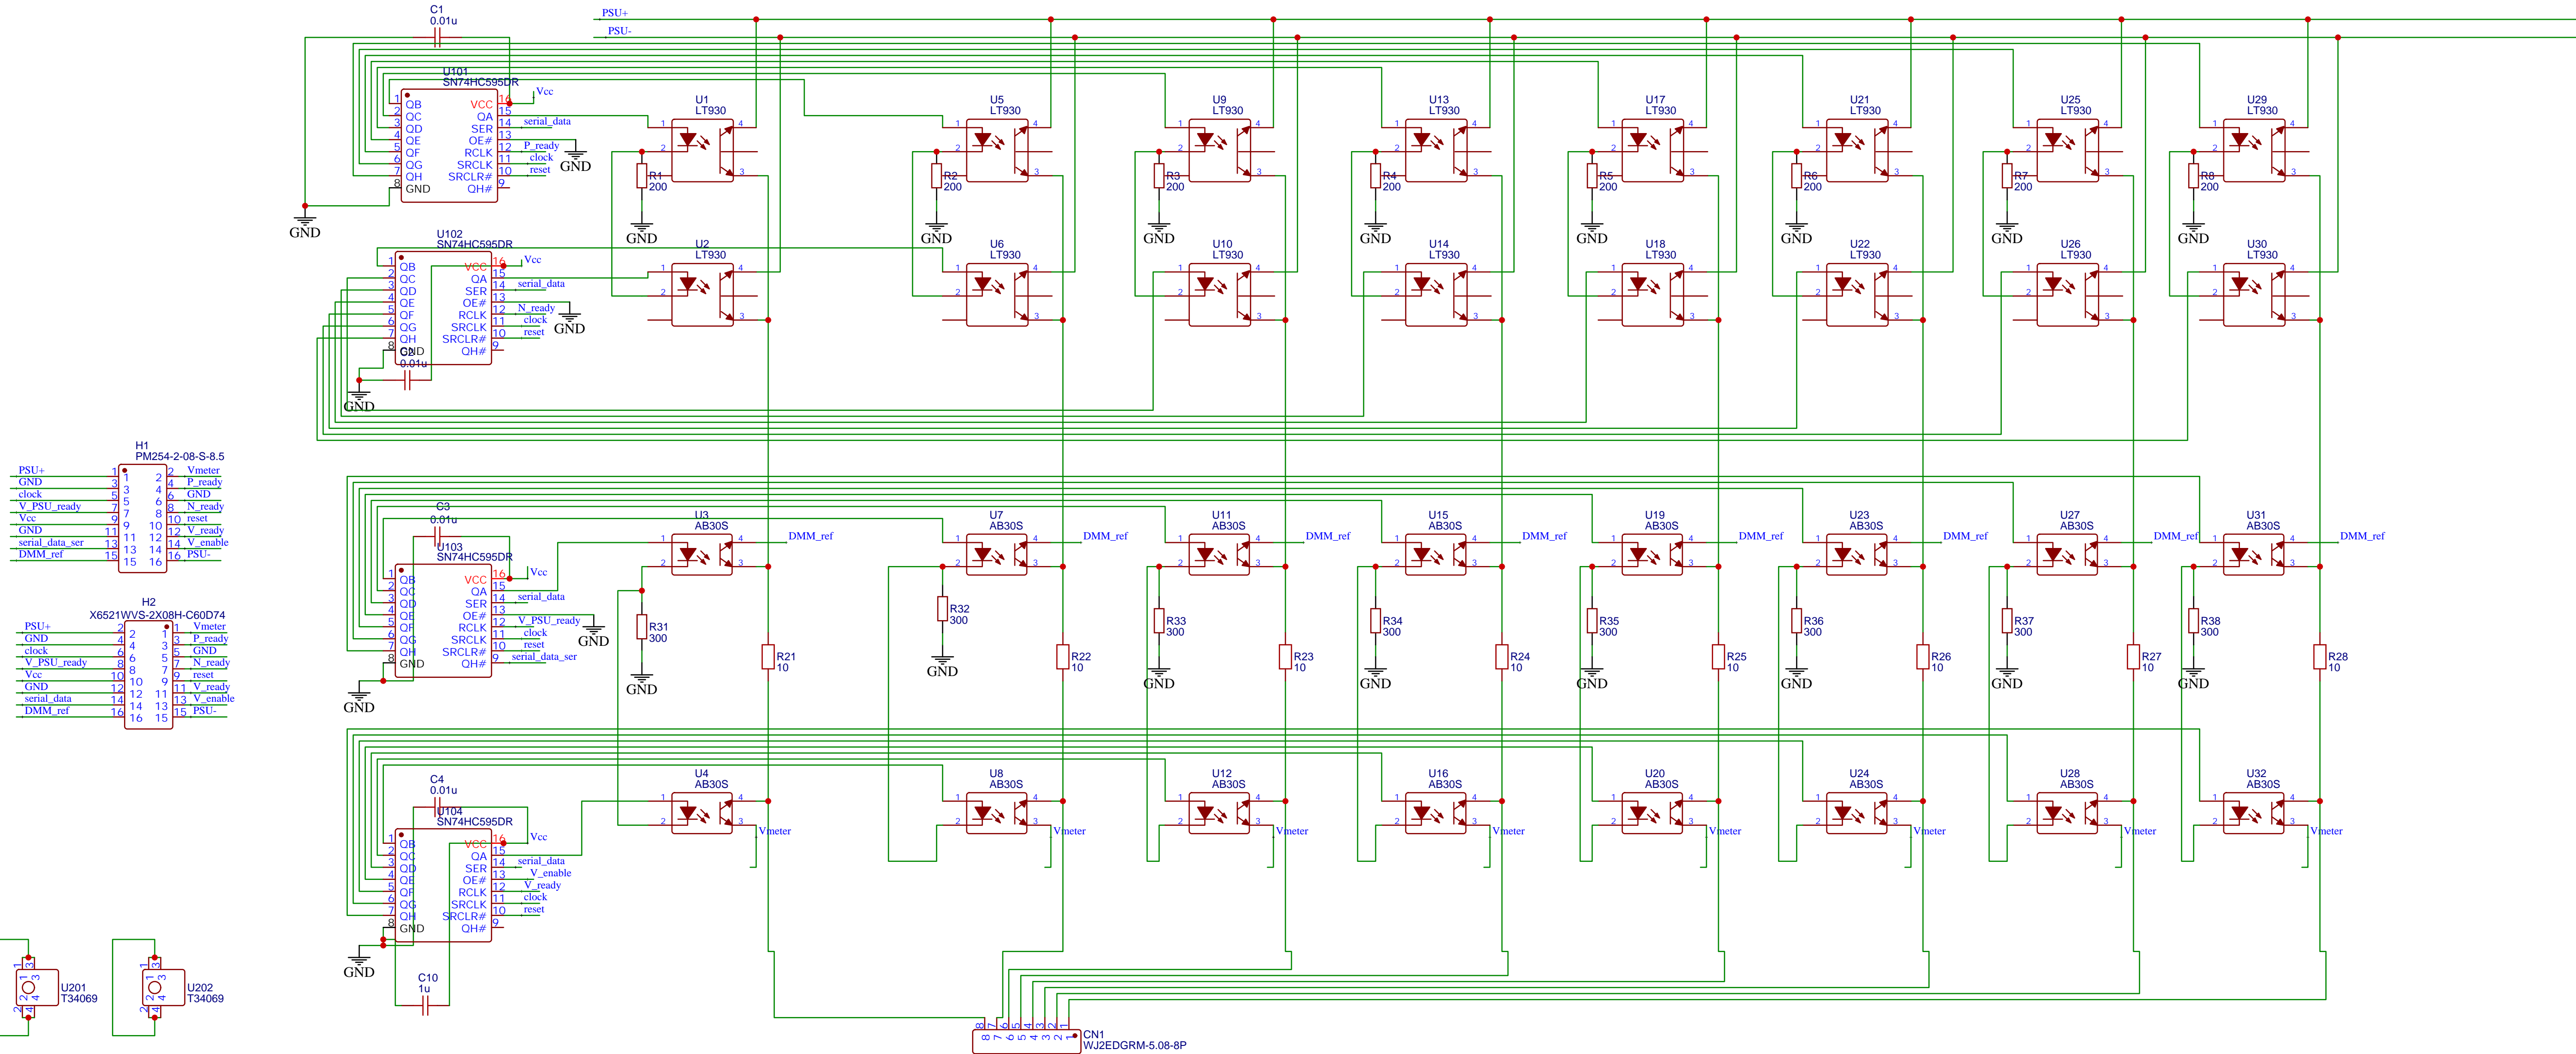
1. fix R1~R8 value error, I only change its name from 300 to 200, which won't change its accutual value.
2. split V\_ready of V\_PSU\_data and V\_date individually, also connect OE# of U103 to ground from V\_enable.
3. add DMM\_ref and V\_PSU\_ready pin .
4. combine all the data pin to one.(arduino code need to change)
