## POWER TO RESTORE WITHOUT LEAVING A TRACE

### CASE STUDY

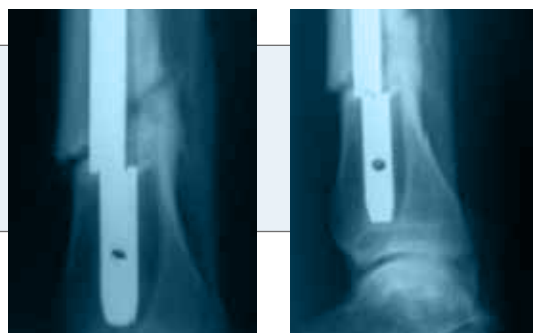
34-year-old male initially treated for right tibia and fibula fracture with a bilateral intramedullary nail, presented 19 months after the initial operation with acute pain around the fracture site. X-ray examination revealed a healed fibula with a non-union of the distal tibia and a fracture through the nail.

Presentation

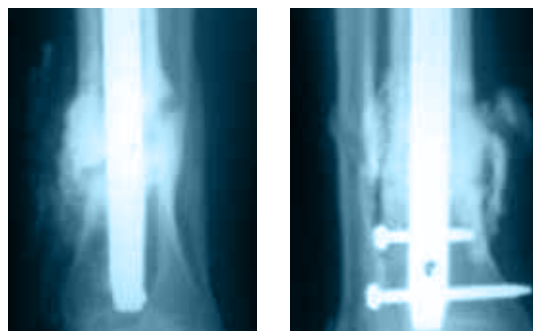
The broken nail was extracted and a new nail inserted and locked distally with 2 locking bolts. The fracture site was decorticated and packed with **genex**. Closure was achieved with vicryl and a drain was placed over the proximal wound. The patient demonstrated good movement of toes and right ankle. Mobilisation to partial and full weight bearing was recommended as soon as comfortable to do so.

Post-operative

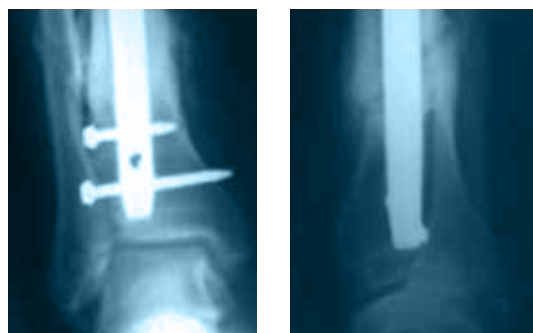
At 3 months' follow-up the wound was clean and the bone appeared to be healing satisfactorily. The patient had mobilised fully and was extremely pleased with the outcome.

3 months' post-operative
