2018 Chrysler Pacifica

Diagnosis & Testing - Sunroof Switch

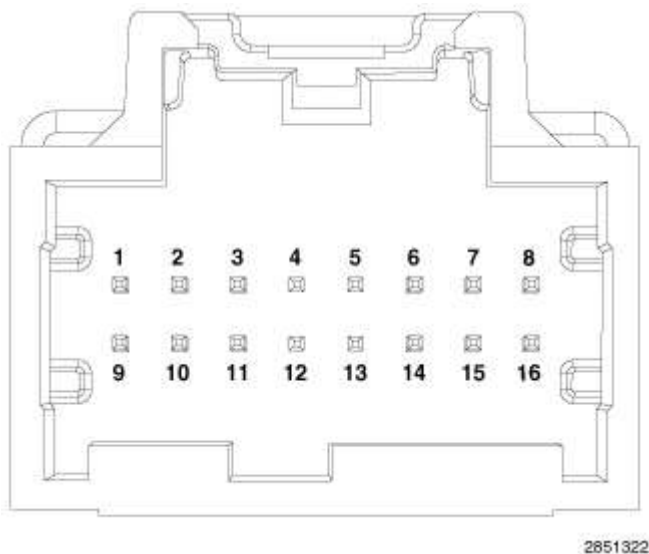
1. Disconnect and isolate the battery negative cable.
2. Remove the overhead console from the headliner. ([Refer to Body/Interior/CONSOLE, Overhead/Removal and Installation](#)).
3. Disconnect the overhead wire harness connector from the overhead console connector receptacle.
4. Using a multimeter, test the continuity between the terminals of the overhead console connector receptacle while actuating the power sunroof switch or power sunshade switch as shown in the Sunroof Switch Tests or Sunshade Switch Tests table.

SUNROOF SWITCH TESTS	
SWITCH POSITION	CONTINUITY BETWEEN PINS
OFF	NO CONTINUITY
OPEN	9 and 12
CLOSE	11 and 12
VENT	10 and 12

SUNSHADE SWITCH TESTS	
SWITCH POSITION	CONTINUITY BETWEEN PINS
OFF	NO CONTINUITY
OPEN	12 and 14
CLOSE	12 and 13

5. If either switch fails any of the tests, replace the overhead console and both switches as a unit as required.
