34-36 Herrick Street

Sault Ste. Marie

Sault Ste. Marie Municipal Heritage Committee Designation Report
(formerly L.A.C.A.C.)

Building Description and History

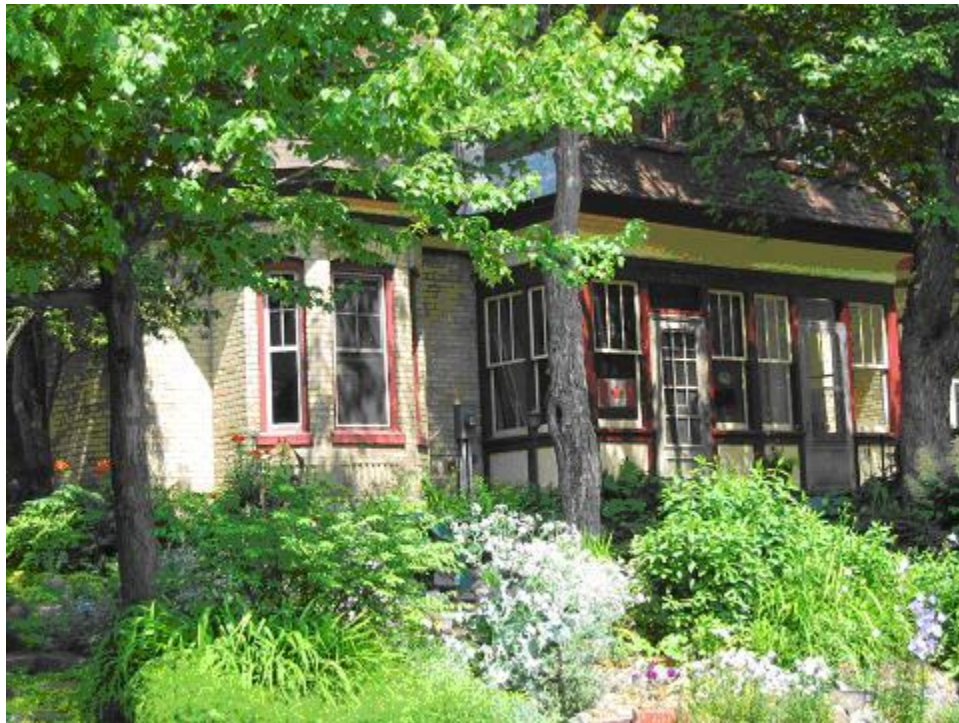
The south elevation of the main house to the street was built as a totally symmetrical composition heightened by a projecting central frontispiece that continues up into the mansard roof constructed of cedar shingles. To the south of the main house was constructed a single storey extension presumed to have been a summer kitchen. The 1901 revision to the fire insurance plan of the City indicates that at that time the extension also projected to the north running parallel to the lane; this no longer exists and may have contained stabling or have acted as a coach house.

The brick has been well detailed particularly at the corners where quoins have been formed, and under the bay windows with inset panels of soldier bricks with their edges set out at 45 degrees. The basement of the house has been constructed of sandstone rubble, and the first three courses of brick above are projected out from the continuing face of the brick above, returning to meet this face with a course of a specially shaped 45-degree angled brick. The brick has all been laid in stretcher bond.

Two large bay windows with double hung wood sash windows are located symmetrically on either side of the central frontispiece which contains the main entrance porch. The lintels over the bay windows are arched and formed of a soldier course and a half of brick.

Second-floor windows are all projected dormers from the mansard roof and each of the four located on the south elevation (two in the projecting central section over the porch and one over each bay window) are roofed individually in miniature replications of the main roof. The windows themselves are double hung wood sash, a pair to each dormer.
