## Cleaning & Disinfection Certificate

<b>Job Ref:</b>	GEMW
<b>Job Details:</b>	Clean & Disinfection
<b>Client Name:</b>	Quinn & Downes
<b>Site Name:</b>	Holiday Inn
<b>Site address:</b>	O'Connell Street, Dublin

<b>Clean / Disinfect</b>	Clean & Disinfection
<b>Water System</b>	C&D of 1 x 27m3 CWST (split 15m3/12m3)
<b>Guidance / Standard</b>	HPSC standard
<b>Chemical</b>	Sanosil
<b>Level PPM (50-75)</b>	50
<b>Date</b>	28 <sup>th</sup> September 2023
<b>Due Next</b>	September 2024

### **Tank: 27m3 CWST (Split – Side A: 15m3)**

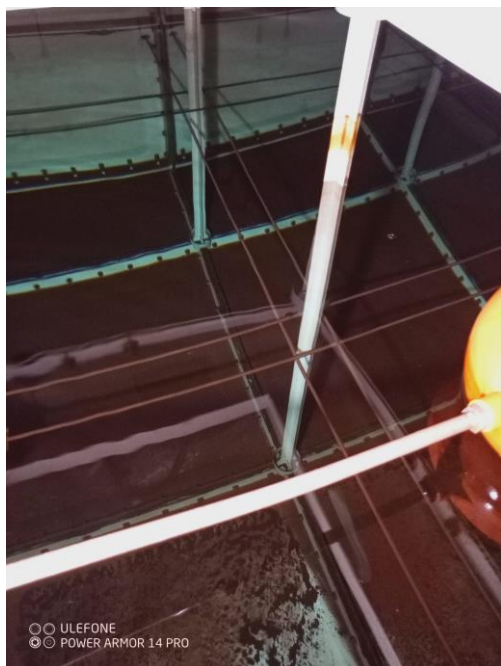
#### **Before**

Tank Lid Condition	Good	Corrosion Presence	None
Tank Vent	Yes	Scale Presence	None
Over Flow	Yes	Biofilm Presence	None
Over flow Inset Screen	Yes	Tank Lid Support	Yes
Cross Flow	Yes	Leaks	None

This tank has been cleaned and disinfected in accordance with the HPSC standard, National Guidelines for the control of Legionellosis, L8 Standards and Irish Safety, Health at Work regulations.

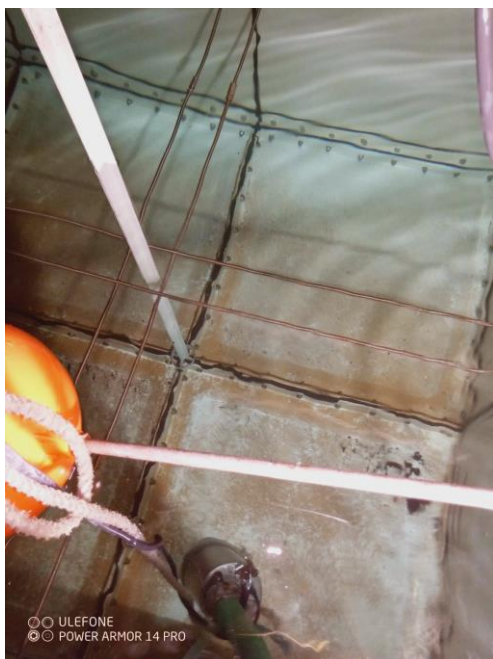
**Before**

### **Tank: 27m3 CWST (Split – Side B: 12m3)**

Tank Lid Condition	Good	Corrosion Presence	None
Tank Vent	Yes	Scale Presence	None
Over Flow	Yes	Biofilm Presence	None
Over flow Inset Screen	Yes	Tank Lid Support	Yes
Cross Flow	Yes	Leaks	None
