Oxygen Test Report

Moisture Test Report

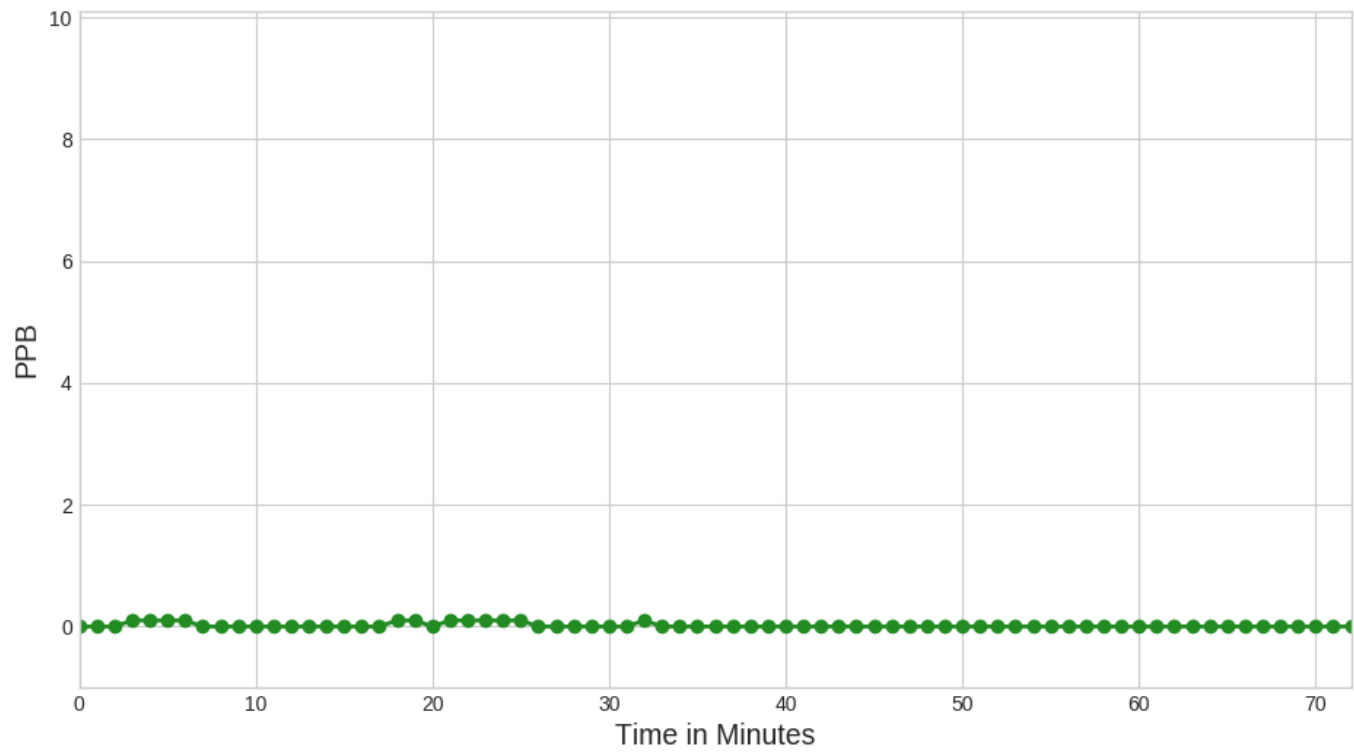
Client:	TEST CLIENT	Analyzer:	Delta F
Facility:	QAM HQ	Serial Number:	PT-18690-V6
Tool / Equipment ID:	TEST123	Calibration Due:	7/2021
System:	PN2	Instrument Flow:	2.0 SCFH
Source ID:	TST-SRC-ID	Start Time/Date:	10:37 02/25/21
Test Point ID:	PN2 TP	Stop Time/Date:	11:48 02/25/21
Test Gas:	Nitrogen	Test Duration:	1 hours 11 minutes
Test Flow:	4.3 SCFH	Average:	0.0 PPB
Technician:	JCH	Final:	0.0 PPB
		Specification:	20 PPB

Comments: First test using only the touchscreen and on-screen keyboard

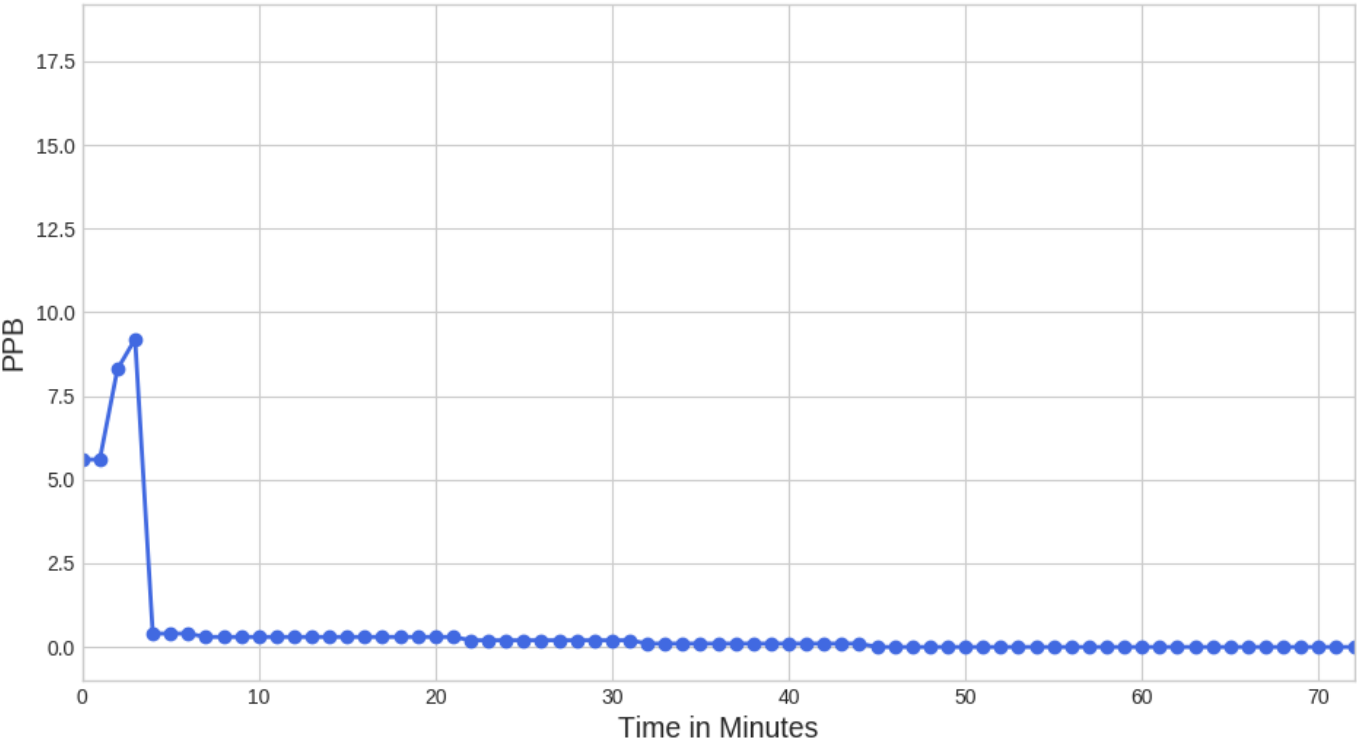
Client:	TEST CLIENT	Analyzer:	Tracer 2
Facility:	QAM HQ	Serial Number:	17367-44-1
Tool / Equipment ID:	TEST123	Calibration Due:	8/2021
System:	PN2	Instrument Flow:	2.3 SCFH
Source ID:	TST-SRC-ID	Start Time/Date:	10:37 02/25/21
Test Point ID:	PN2 TP	Stop Time/Date:	11:48 02/25/21
Test Gas:	Nitrogen	Test Duration:	1 hours 11 minutes
Test Flow:	4.3 SCFH	Average:	0.5 PPB
Technician:	JCH	Final:	0.0 PPB
		Specification:	20 PPB

Comments: First test using only the touchscreen and on-screen keyboard
