Oxygen Test Report

Moisture Test Report

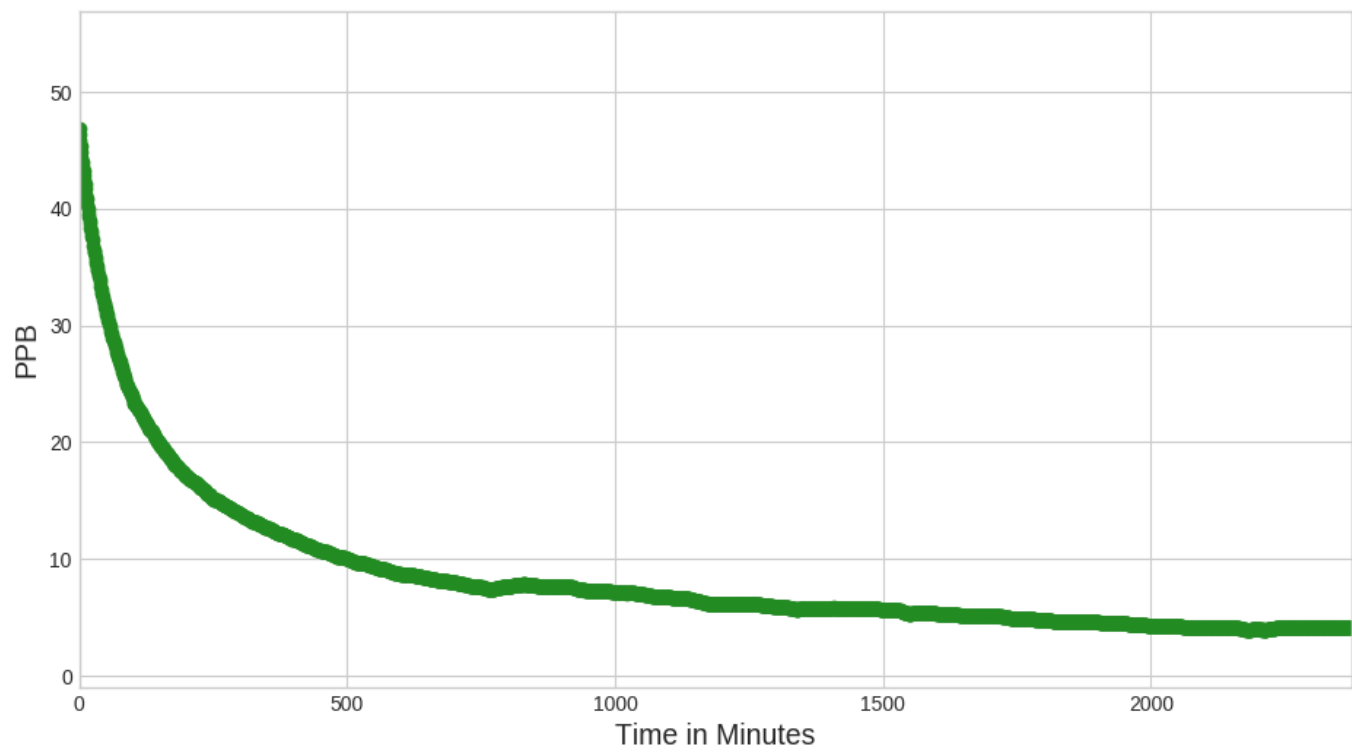
Client:	TEST CLIENT	Analyzer:	Delta F
Facility:	QAM HQ	Serial Number:	PT-18690-V6
Tool / Equipment ID:	TST123	Calibration Due:	7/2021
System:	PN2	Instrument Flow:	2.0 SCFH
Source ID:	TST-SRC-ID	Start Time/Date:	15:40 03/03/21
Test Point ID:	TEST BENCH	Stop Time/Date:	07:12 03/05/21
Test Gas:	Nitrogen	Test Duration:	15 hours 31 minutes
Test Flow:	4.3 SCFH	Average:	8.6 PPB
Technician:	JCH	Final:	4.2 PPB
		Specification:	20 PPB

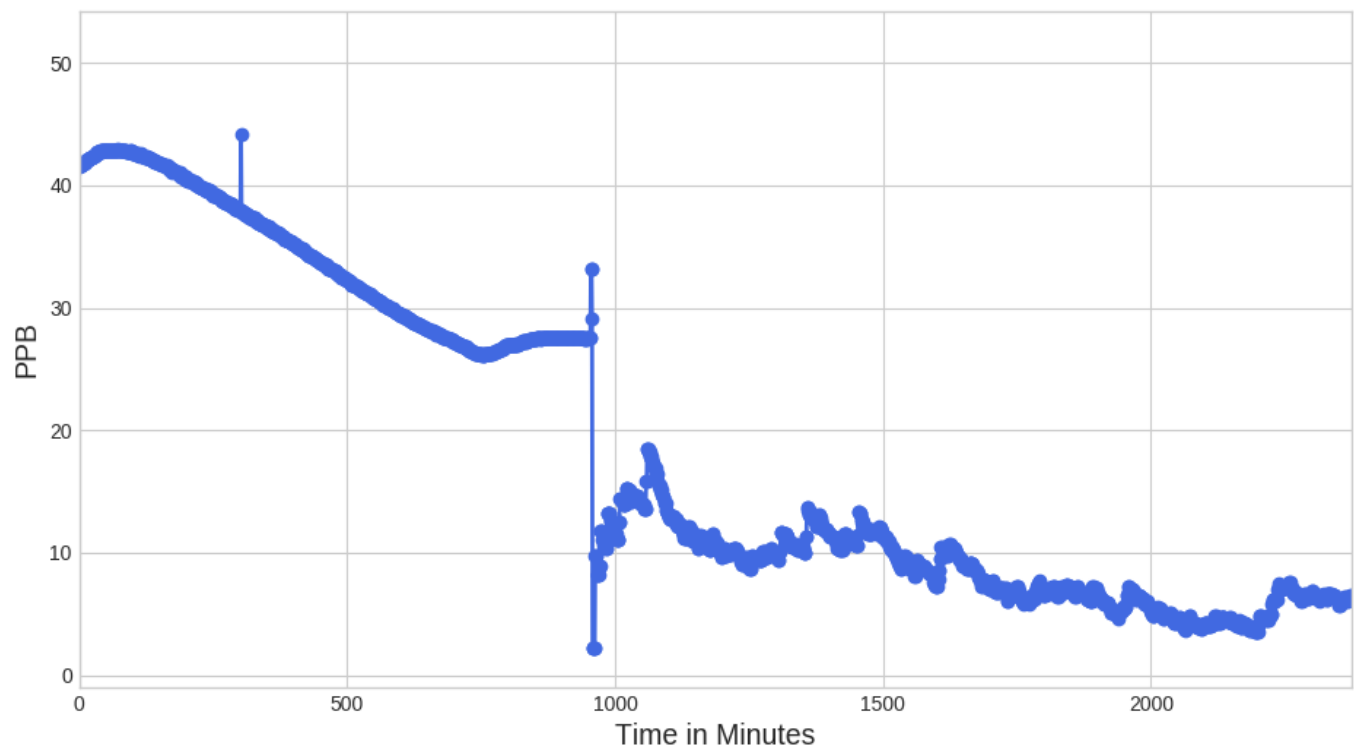
Client:	TEST CLIENT	Analyzer:	Tracer 2
Facility:	QAM HQ	Serial Number:	17367-44-1
Tool / Equipment ID:	TST123	Calibration Due:	8/2021
System:	PN2	Instrument Flow:	2.3 SCFH
Source ID:	TST-SRC-ID	Start Time/Date:	15:40 03/03/21
Test Point ID:	TEST BENCH	Stop Time/Date:	07:12 03/05/21
Test Gas:	Nitrogen	Test Duration:	15 hours 31 minutes
Test Flow:	4.3 SCFH	Average:	18.7 PPB
Technician:	JCH	Final:	6.5 PPB
		Specification:	20 PPB
