Oxygen Test Report

Moisture Test Report

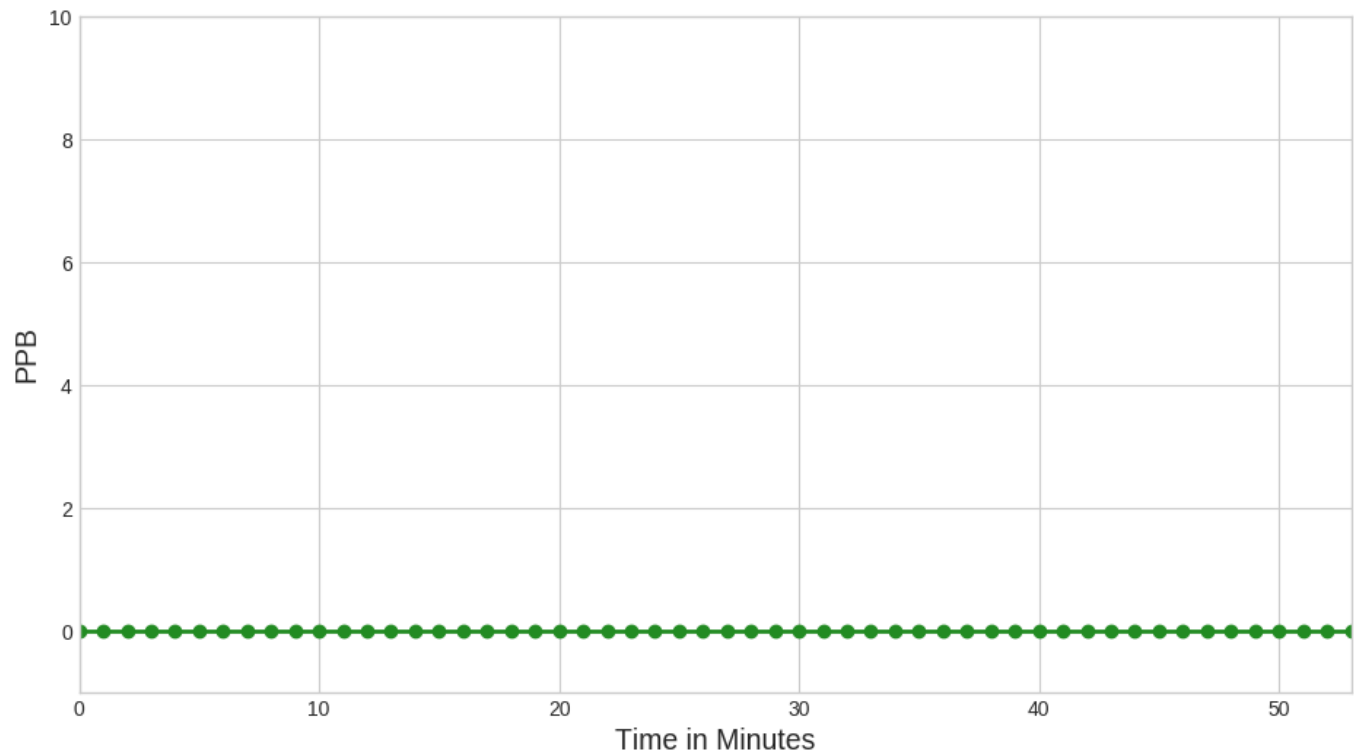
Client:	TEST CLIENT	Analyzer:	Delta F
Facility:	HQ	Serial Number:	PT-18690-V6
Tool / Equipment ID:	TEST123	Calibration Due:	7/2021
System:	PN2	Instrument Flow:	2.0 SCFH
Source ID:	TEST-SOURCE	Start Time/Date:	12:08 02/24/21
Test Point ID:	PN2 LINE	Stop Time/Date:	13:02 02/24/21
Test Gas:	Nitrogen	Test Duration:	53 minutes
Test Flow:	4.3 SCFH	Average:	0.0 PPB
Technician:	JCH	Final:	0.0 PPB
		Specification:	20 PPB

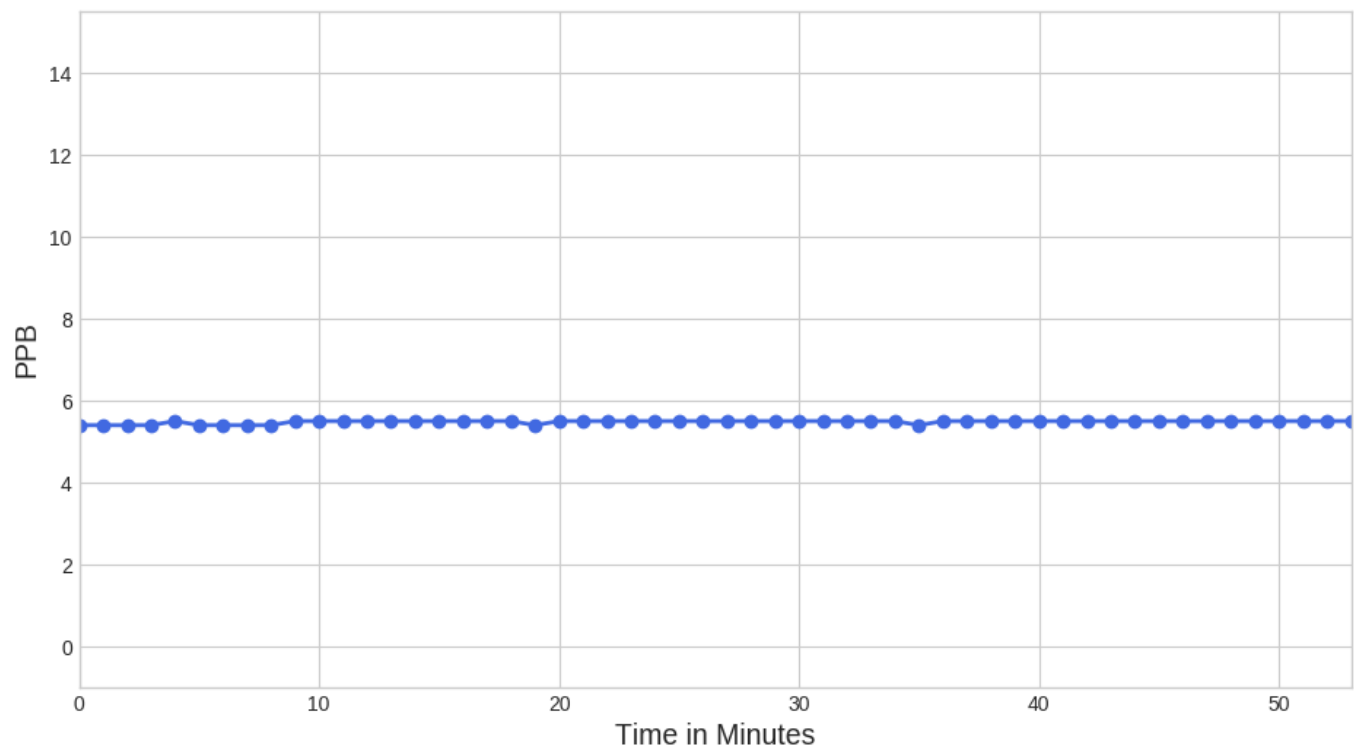
Client:	TEST CLIENT	Analyzer:	Tracer 2
Facility:	HQ	Serial Number:	17367-44-1
Tool / Equipment ID:	TEST123	Calibration Due:	8/2021
System:	PN2	Instrument Flow:	2.3 SCFH
Source ID:	TEST-SOURCE	Start Time/Date:	12:08 02/24/21
Test Point ID:	PN2 LINE	Stop Time/Date:	13:02 02/24/21
Test Gas:	Nitrogen	Test Duration:	53 minutes
Test Flow:	4.3 SCFH	Average:	5.5 PPB
Technician:	JCH	Final:	5.5 PPB
		Specification:	20 PPB
