# Oxygen Test Report

# Moisture Test Report

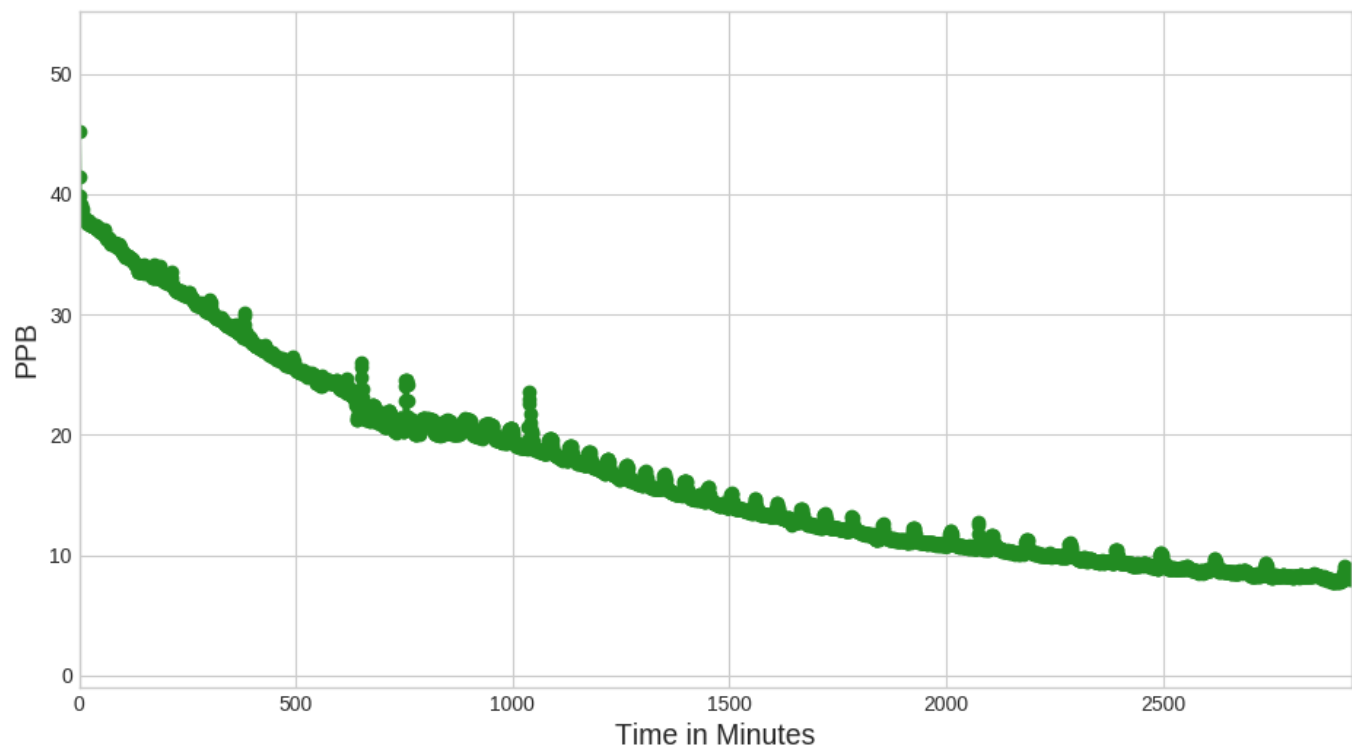
Client:	TEST CLIENT	Analyzer:	Delta F
Facility:	QAM HQ	Serial Number:	PT-11058-V6
Tool / Equipment ID:		Calibration Due:	Not calibrated
System:		Instrument Flow:	2.0 SCFH
Source ID:		Start Time/Date:	06:05 07/09/21
Test Point ID:		Stop Time/Date:	06:59 07/11/21
Test Gas:		Test Duration:	53 minutes
Test Flow:	4.3 SCFH	Average:	17.1 PPB
Technician:		Final:	8.1 PPB
		Specification:	20 PPB

Comments: Removed zero and span settings

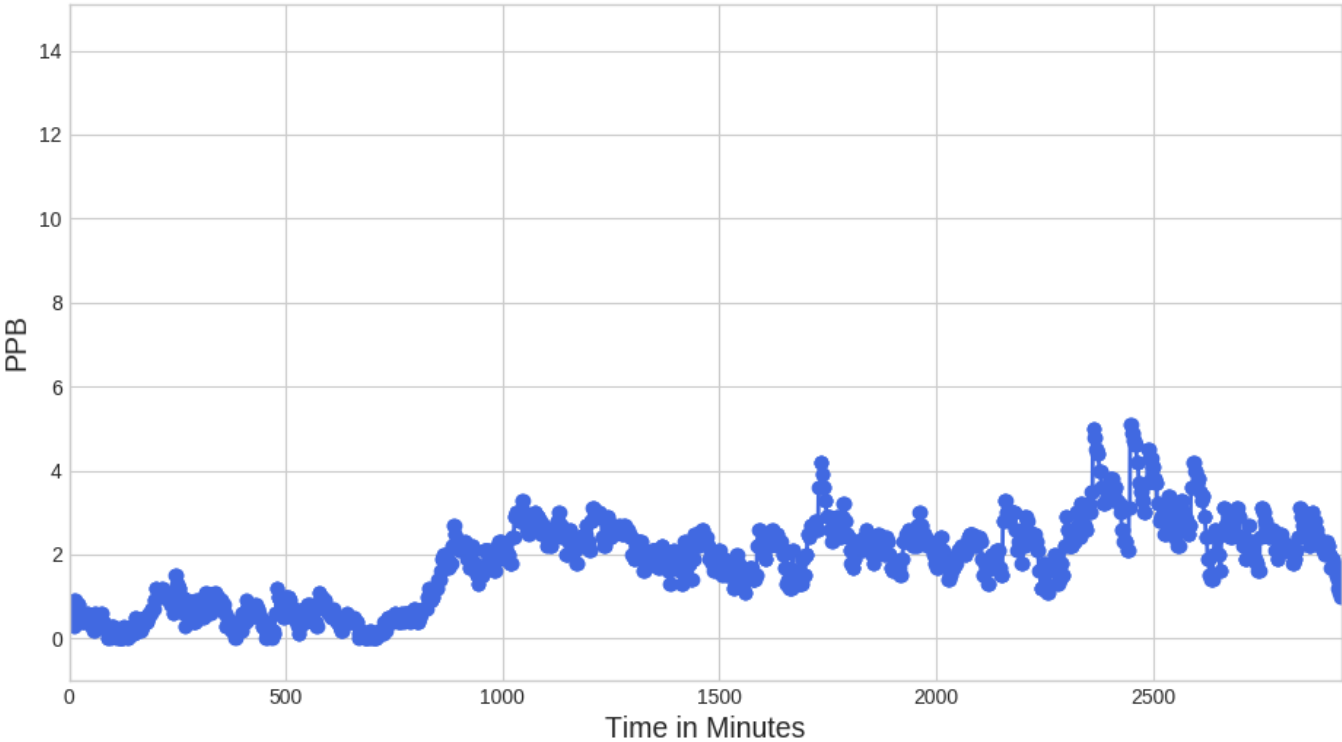
Client:	TEST CLIENT	Analyzer:	Tracer 2
Facility:	QAM HQ	Serial Number:	17481-44-1
Tool / Equipment ID:		Calibration Due:	02/23/2023
System:		Instrument Flow:	2.3 SCFH
Source ID:		Start Time/Date:	06:05 07/09/21
Test Point ID:		Stop Time/Date:	06:59 07/11/21
Test Gas:		Test Duration:	53 minutes
Test Flow:	4.3 SCFH	Average:	1.8 PPB
Technician:		Final:	1.0 PPB
		Specification:	20 PPB

Comments: Removed zero and span settings
