Quality Assurance Management, Inc.
1620 Valwood Pkwy, Ste. 128
Carrollton, TX 75006
972-331-5800
QAM.com

Oxygen Test Report

Moisture Test Report

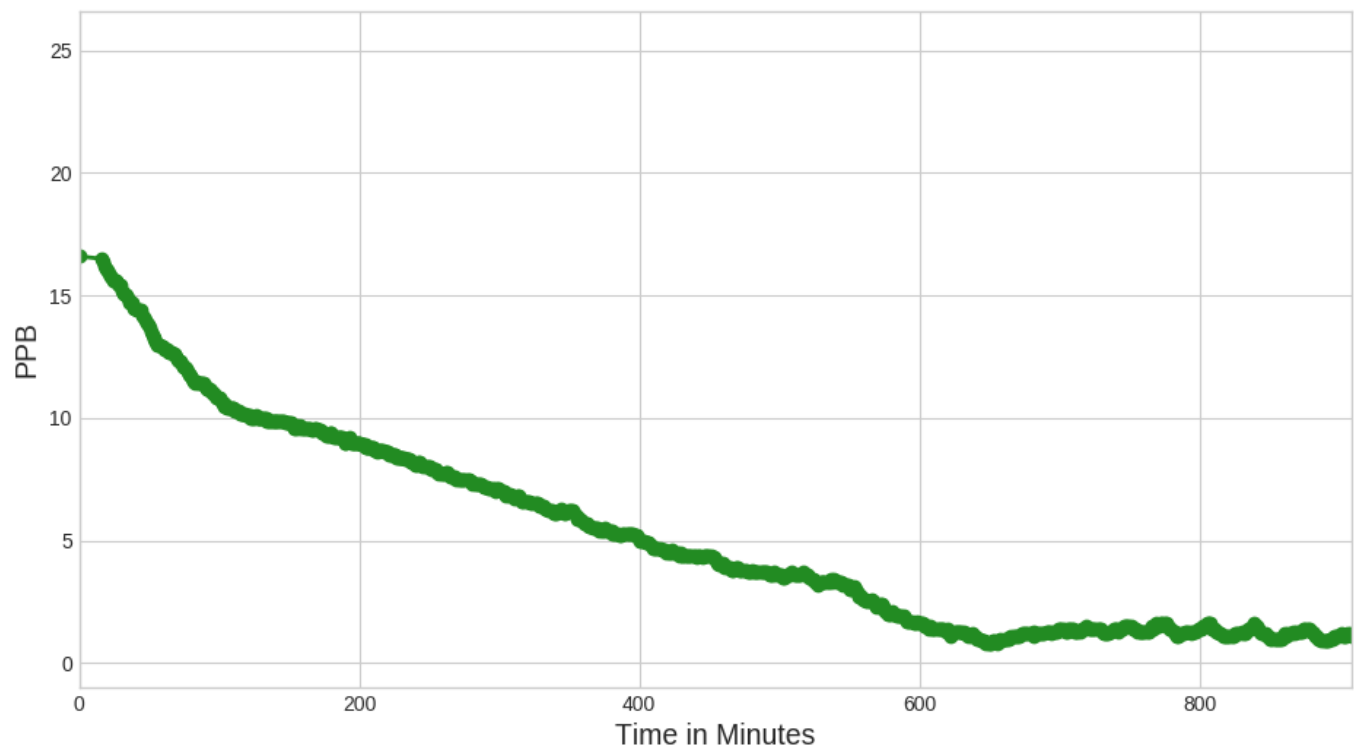
Client:	TEST CLIENT	Analyzer:	Delta F
Facility:	QAM HQ	Serial Number:	PT-11058-V6
Tool / Equipment ID:		Calibration Due:	Not calibrated
System:		Instrument Flow:	2.0 SCFH
Source ID:		Start Time/Date:	16:34 07/14/21
Test Point ID:		Stop Time/Date:	07:42 07/15/21
Test Gas:		Test Duration:	15 hours 7 minutes 43 seconds
Test Flow:	4.3 SCFH	Average:	5.5 PPB
Technician:		Final:	1.1 PPB
		Specification:	20 PPB

Comments: Removed zero and span settings

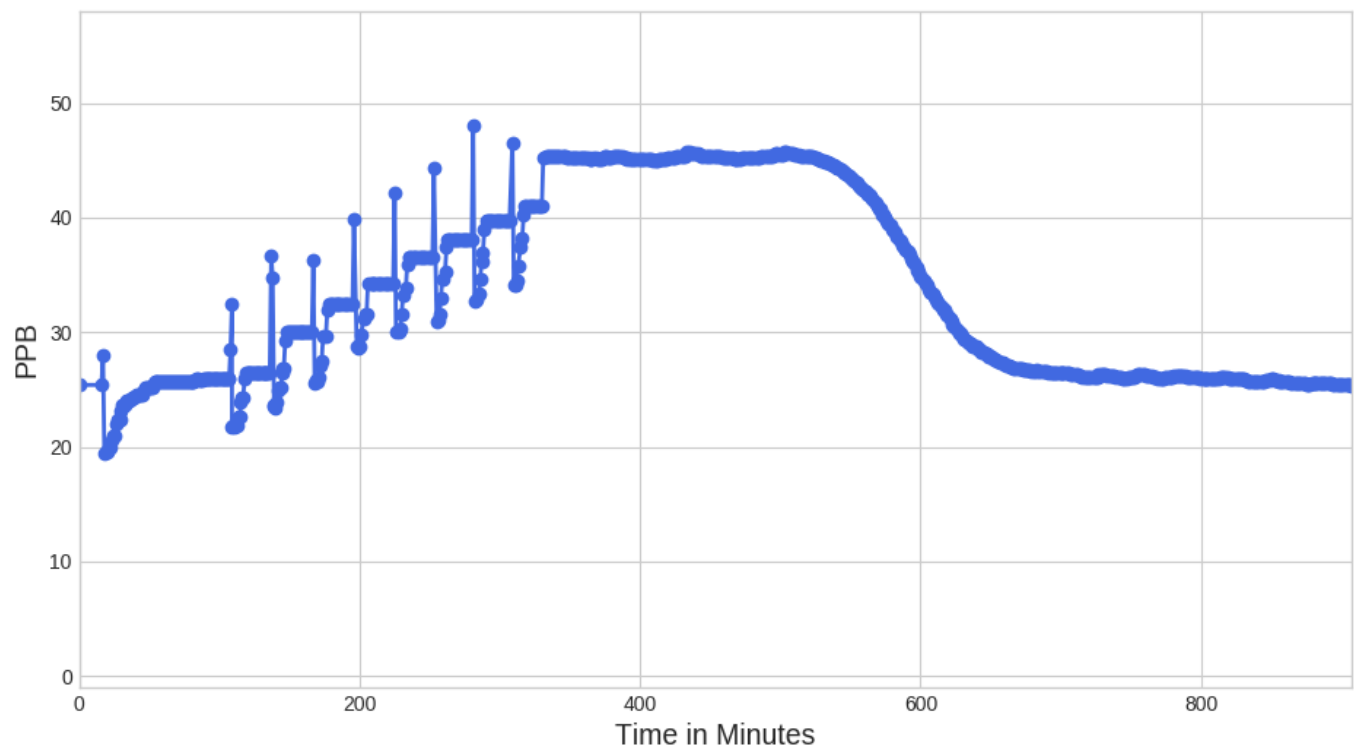
Client:	TEST CLIENT	Analyzer:	Tracer 2
Facility:	QAM HQ	Serial Number:	17481-44-1
Tool / Equipment ID:		Calibration Due:	02/23/2023
System:		Instrument Flow:	2.3 SCFH
Source ID:		Start Time/Date:	16:34 07/14/21
Test Point ID:		Stop Time/Date:	07:42 07/15/21
Test Gas:		Test Duration:	15 hours 7 minutes 43 seconds
Test Flow:	4.3 SCFH	Average:	33.2 PPB
Technician:		Final:	25.3 PPB
		Specification:	20 PPB

Comments: Removed zero and span settings
