Oxygen Test Report

Moisture Test Report

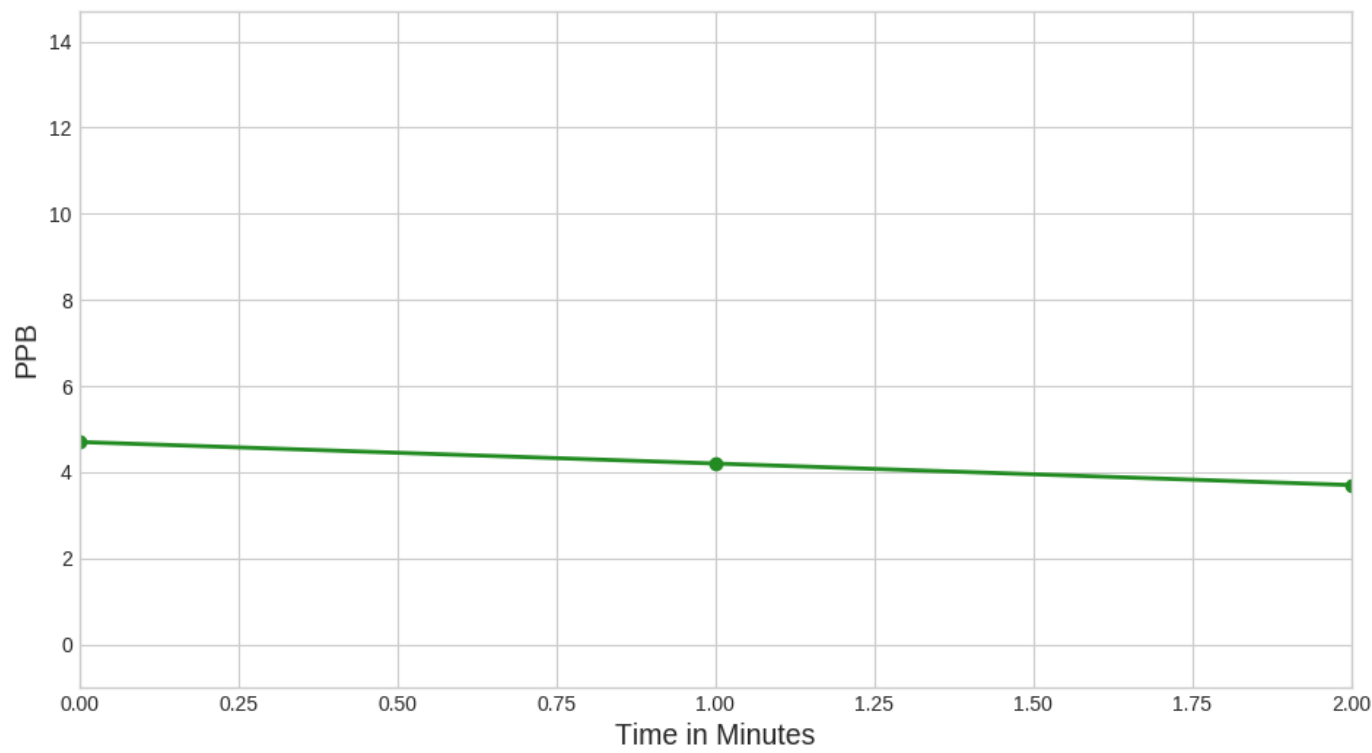
Client:	TEST CLIENT	Analyzer:	Delta F
Facility:	QAM HQ	Serial Number:	PT-11058-V6
Tool / Equipment ID:		Calibration Due:	Not calibrated
System:		Instrument Flow:	2.0 SCFH
Source ID:		Start Time/Date:	12:47 09/13/21
Test Point ID:		Stop Time/Date:	12:49 09/13/21
Test Gas:		Test Duration:	1 minutes
Test Flow:	4.3 SCFH	Average:	4.2 PPB
Technician:		Final:	3.7 PPB
		Specification:	20 PPB

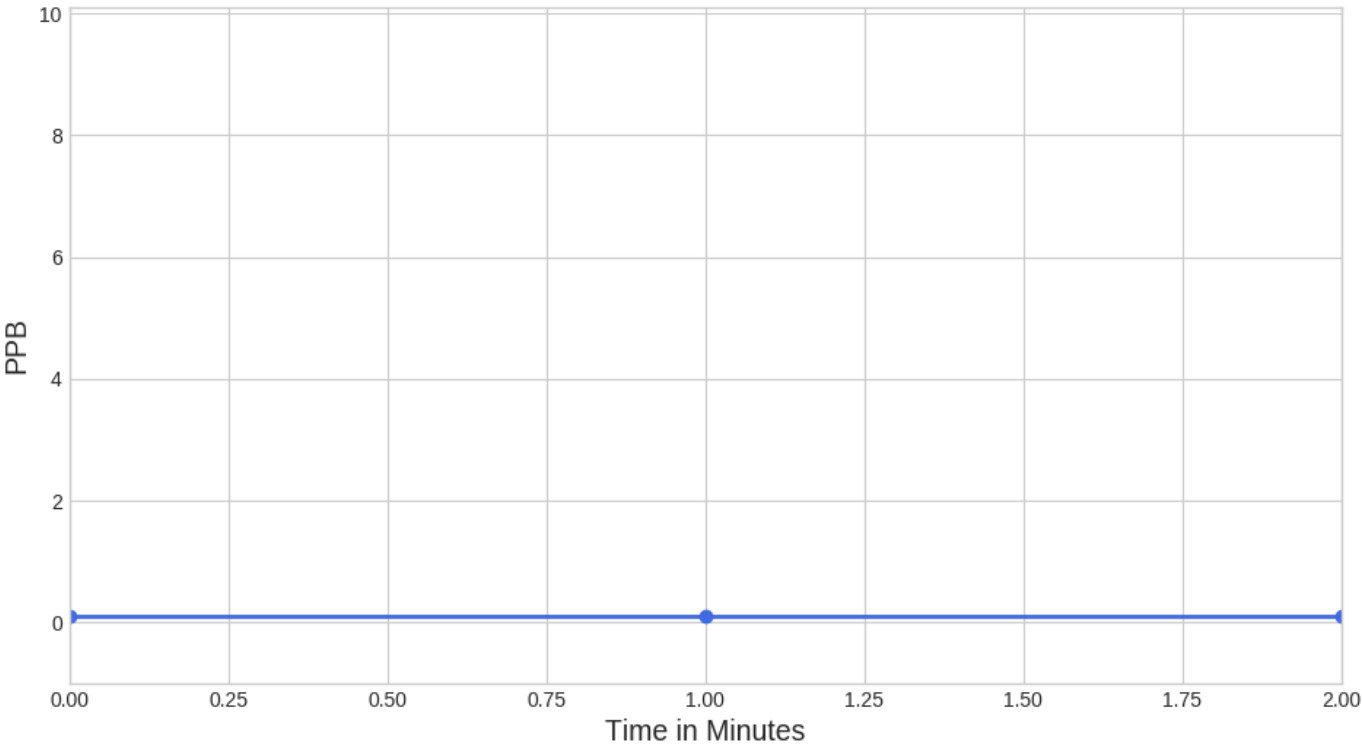
Client:	TEST CLIENT	Analyzer:	Tracer 2
Facility:	QAM HQ	Serial Number:	17481-44-1
Tool / Equipment ID:		Calibration Due:	02/23/2023
System:		Instrument Flow:	2.3 SCFH
Source ID:		Start Time/Date:	12:47 09/13/21
Test Point ID:		Stop Time/Date:	12:49 09/13/21
Test Gas:		Test Duration:	1 minutes
Test Flow:	4.3 SCFH	Average:	0.1 PPB
Technician:		Final:	0.1 PPB
		Specification:	20 PPB
