# Oxygen Test Report

# Moisture Test Report

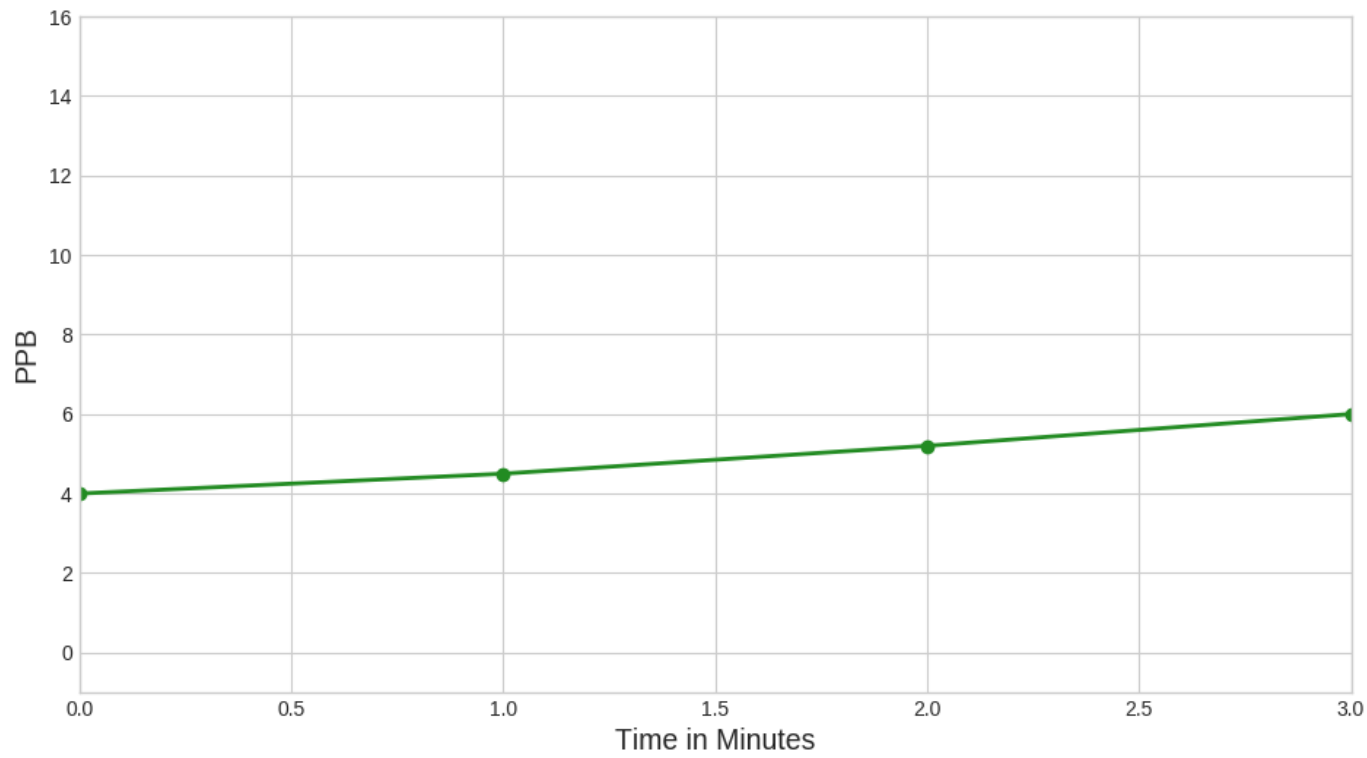
Client:	TEST CLIENT	Analyzer:	Delta F
Facility:	QAM HQ	Serial Number:	PT-26818-V6
Tool / Equipment ID:		Calibration Due:	08/06/2022
System:		Instrument Flow:	2.0 SCFH
Source ID:		Start Time/Date:	13:04 09/13/21
Test Point ID:		Stop Time/Date:	13:07 09/13/21
Test Gas:		Test Duration:	3 minutes
Test Flow:	4.3 SCFH	Average:	4.9 PPB
Technician:		Final:	6.0 PPB
		Specification:	20 PPB

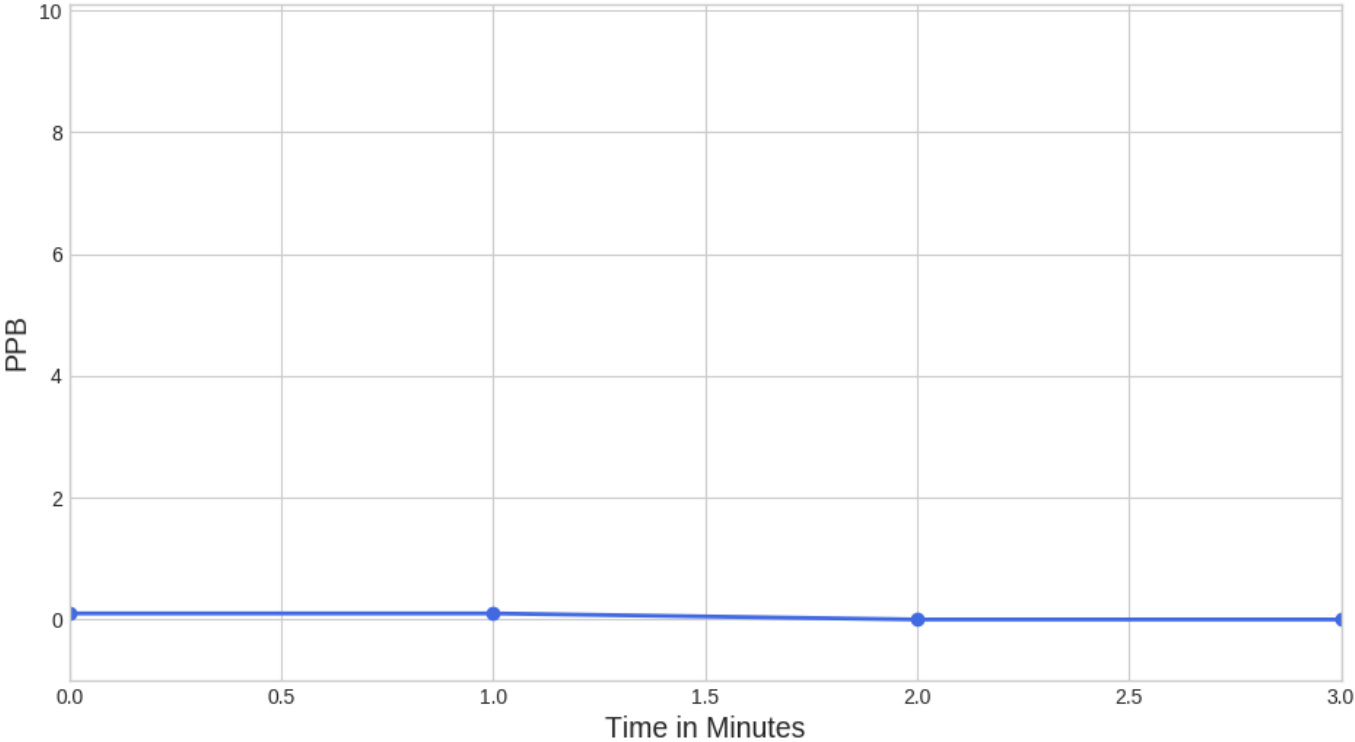
Client:	TEST CLIENT	Analyzer:	Tracer 2
Facility:	QAM HQ	Serial Number:	17481-44-1
Tool / Equipment ID:		Calibration Due:	02/23/2023
System:		Instrument Flow:	2.3 SCFH
Source ID:		Start Time/Date:	13:04 09/13/21
Test Point ID:		Stop Time/Date:	13:07 09/13/21
Test Gas:		Test Duration:	3 minutes
Test Flow:	4.3 SCFH	Average:	0.1 PPB
Technician:		Final:	-0.0 PPB
		Specification:	20 PPB
