Oxygen Test Report

Moisture Test Report

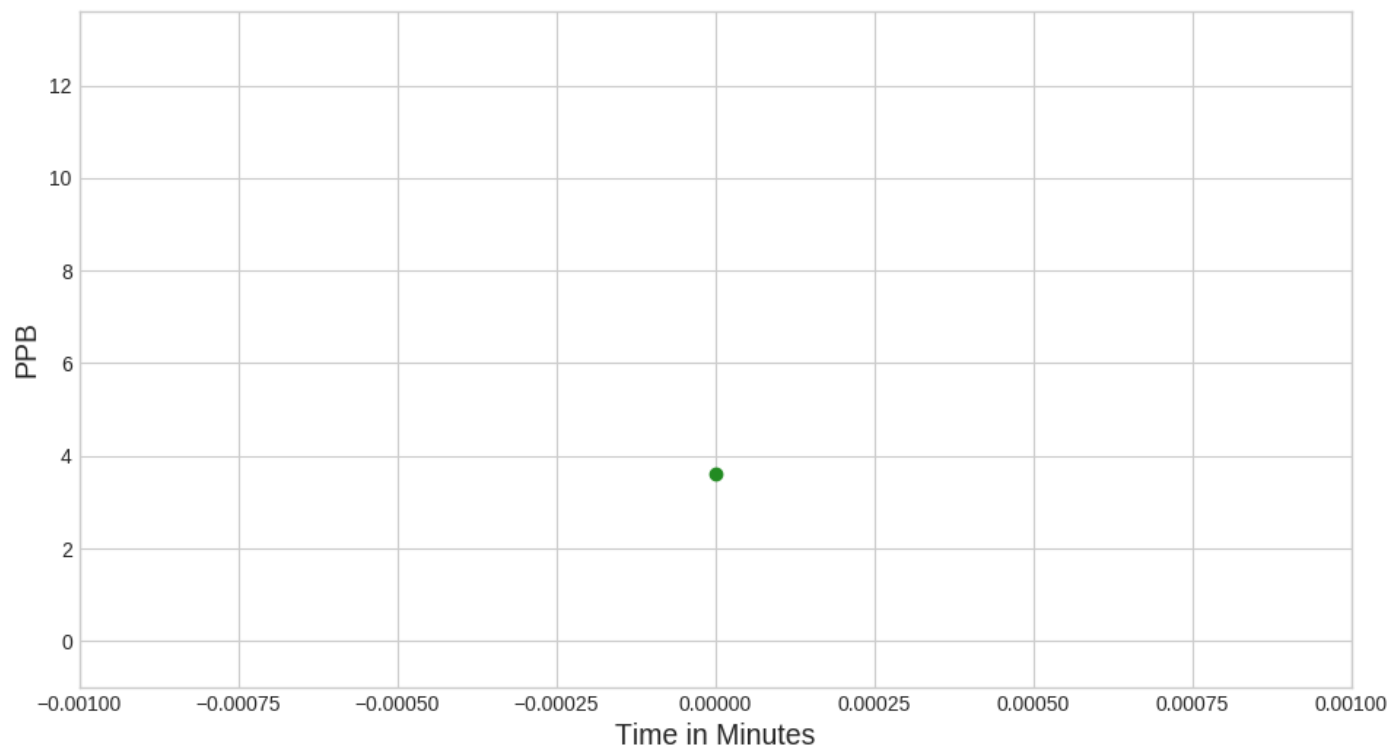
Client:	TEST CLIENT	Analyzer:	Delta F
Facility:	QAM HQ	Serial Number:	PT-26818-V6
Tool / Equipment ID:		Calibration Due:	08/06/2022
System:		Instrument Flow:	2.0 SCFH
Source ID:		Start Time/Date:	13:26 09/13/21
Test Point ID:		Stop Time/Date:	13:27 09/13/21
Test Gas:	Nitrogen	Test Duration:	16 seconds
Test Flow:	4.3 SCFH	Average:	3.6 PPB
Technician:		Final:	3.6 PPB
		Specification:	20 PPB

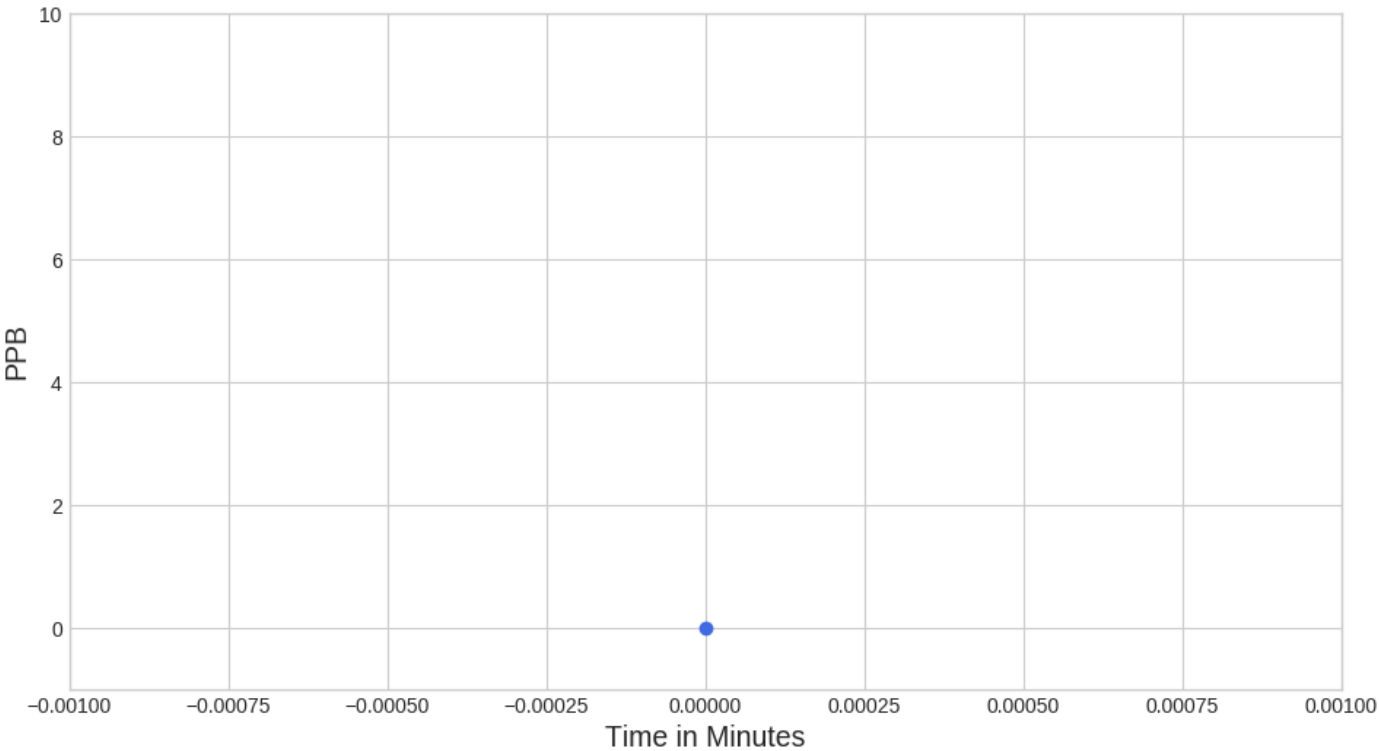
Client:	TEST CLIENT	Analyzer:	Tracer 2
Facility:	QAM HQ	Serial Number:	17481-44-1
Tool / Equipment ID:		Calibration Due:	02/23/2023
System:		Instrument Flow:	2.3 SCFH
Source ID:		Start Time/Date:	13:26 09/13/21
Test Point ID:		Stop Time/Date:	13:27 09/13/21
Test Gas:	Nitrogen	Test Duration:	16 seconds
Test Flow:	4.3 SCFH	Average:	0.0 PPB
Technician:		Final:	-0.0 PPB
		Specification:	20 PPB
