Oxygen Test Report

Moisture Test Report

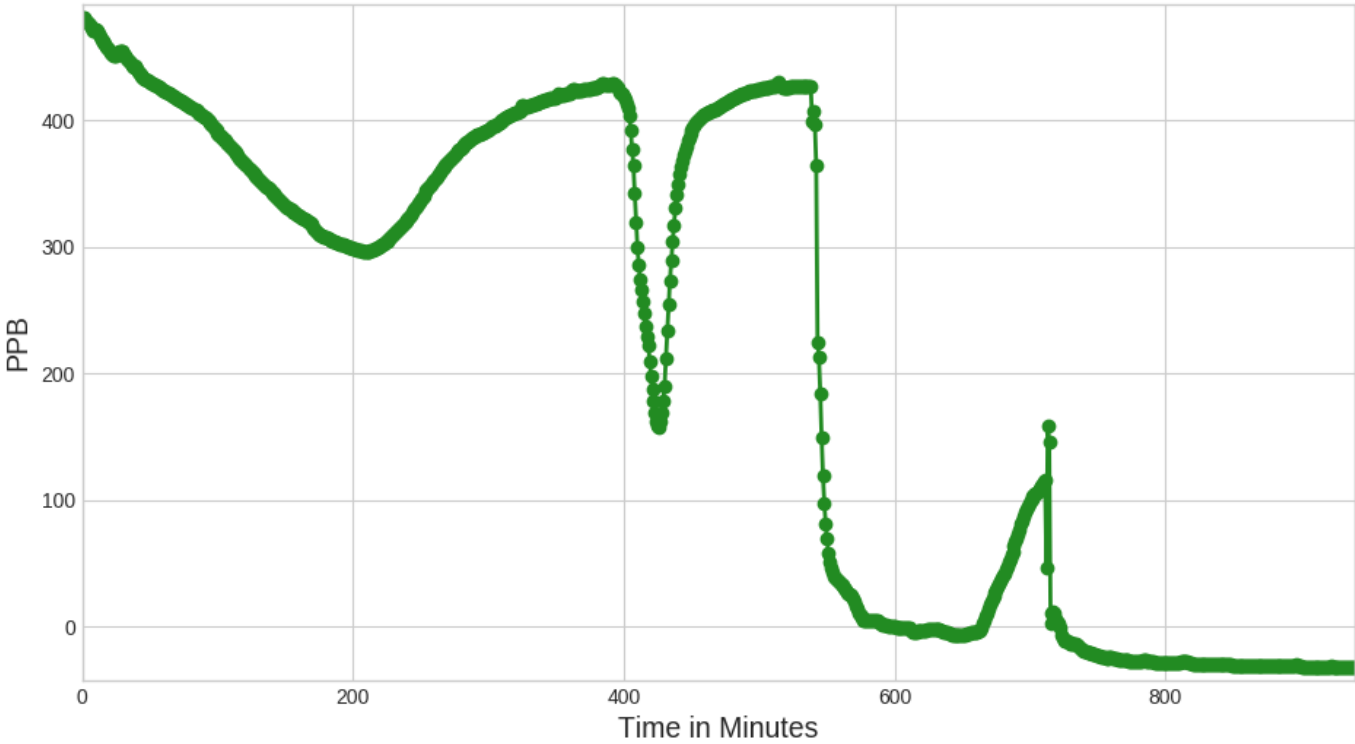
Client:	TEST CLIENT	Analyzer:	Delta F
Facility:	QAM HQ	Serial Number:	PT-11058-V6
Tool / Equipment ID:		Calibration Due:	Not calibrated
System:		Instrument Flow:	2.0 SCFH
Source ID:		Start Time/Date:	14:21 07/08/21
Test Point ID:		Stop Time/Date:	06:00 07/09/21
Test Gas:		Test Duration:	15 hours 39 minutes
Test Flow:	4.3 SCFH	Average:	218.5 PPB
Technician:		Final:	-32.2 PPB
		Specification:	20 PPB

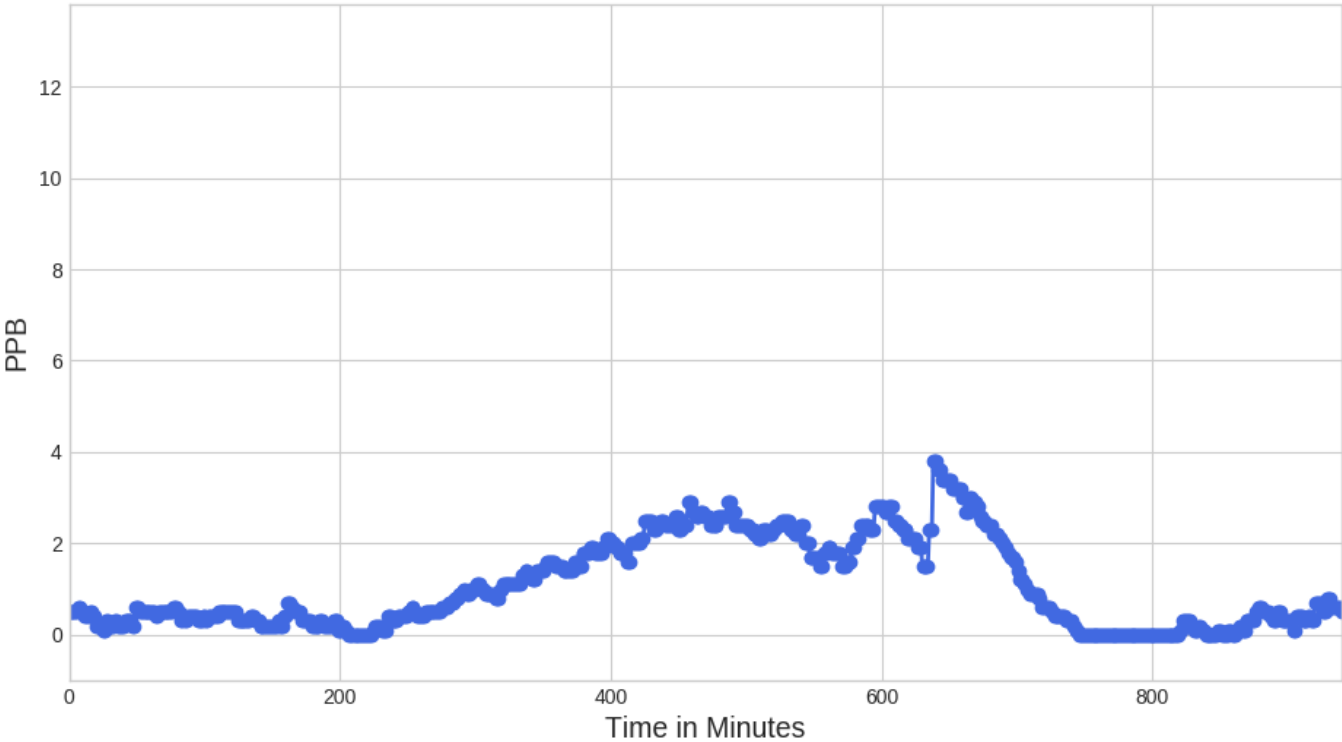
Client:	TEST CLIENT	Analyzer:	Tracer 2
Facility:	QAM HQ	Serial Number:	17481-44-1
Tool / Equipment ID:		Calibration Due:	02/23/2023
System:		Instrument Flow:	2.3 SCFH
Source ID:		Start Time/Date:	14:21 07/08/21
Test Point ID:		Stop Time/Date:	06:00 07/09/21
Test Gas:		Test Duration:	15 hours 39 minutes
Test Flow:	4.3 SCFH	Average:	1.1 PPB
Technician:		Final:	0.5 PPB
		Specification:	20 PPB
