Oxygen Test Report

Moisture Test Report

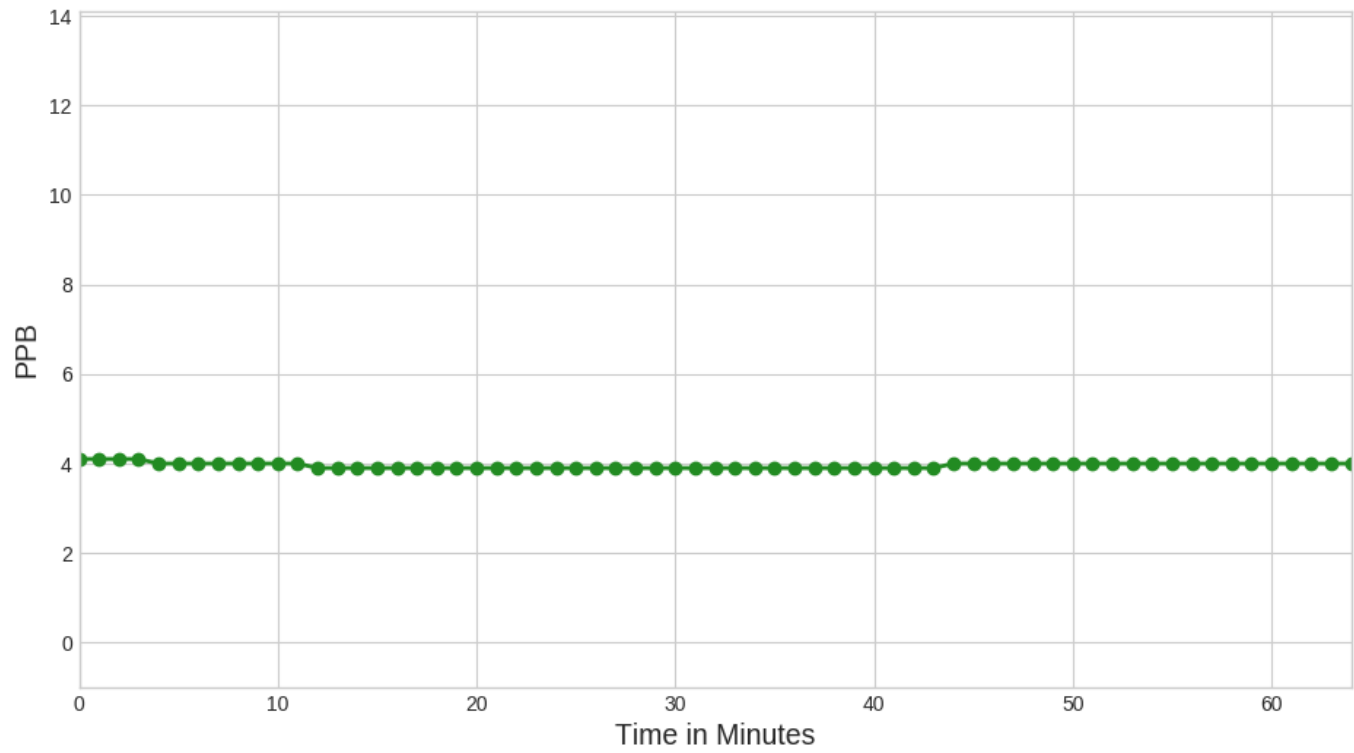
Client:	TEST CLIENT	Analyzer:	Delta F
Facility:	QAM HQ	Serial Number:	PT-18690-V6
Tool / Equipment ID:	TEST BENCH	Calibration Due:	7/2021
System:	PN2	Instrument Flow:	2.0 SCFH
Source ID:	TST-SRC	Start Time/Date:	07:18 03/05/21
Test Point ID:	TEST EQUIPMENT	Stop Time/Date:	08:21 03/05/21
Test Gas:	Nitrogen	Test Duration:	1 hours 3 minutes
Test Flow:	4.3 SCFH	Average:	4.0 PPB
Technician:	JCH	Final:	4.0 PPB
		Specification:	20 PPB

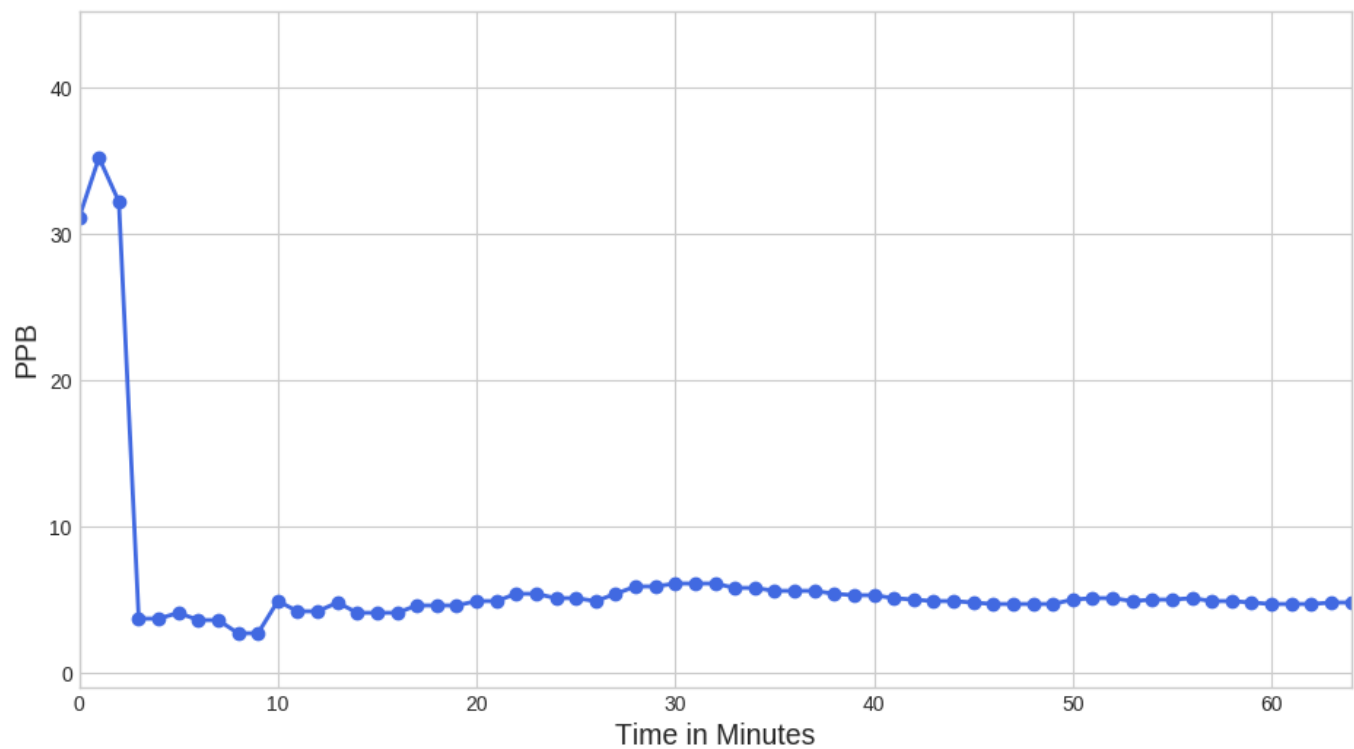
Client:	TEST CLIENT	Analyzer:	Tracer 2
Facility:	QAM HQ	Serial Number:	17367-44-1
Tool / Equipment ID:	TEST BENCH	Calibration Due:	8/2021
System:	PN2	Instrument Flow:	2.3 SCFH
Source ID:	TST-SRC	Start Time/Date:	07:18 03/05/21
Test Point ID:	TEST EQUIPMENT	Stop Time/Date:	08:21 03/05/21
Test Gas:	Nitrogen	Test Duration:	1 hours 3 minutes
Test Flow:	4.3 SCFH	Average:	6.1 PPB
Technician:	JCH	Final:	4.8 PPB
		Specification:	20 PPB
