# Oxygen Test Report

# Moisture Test Report

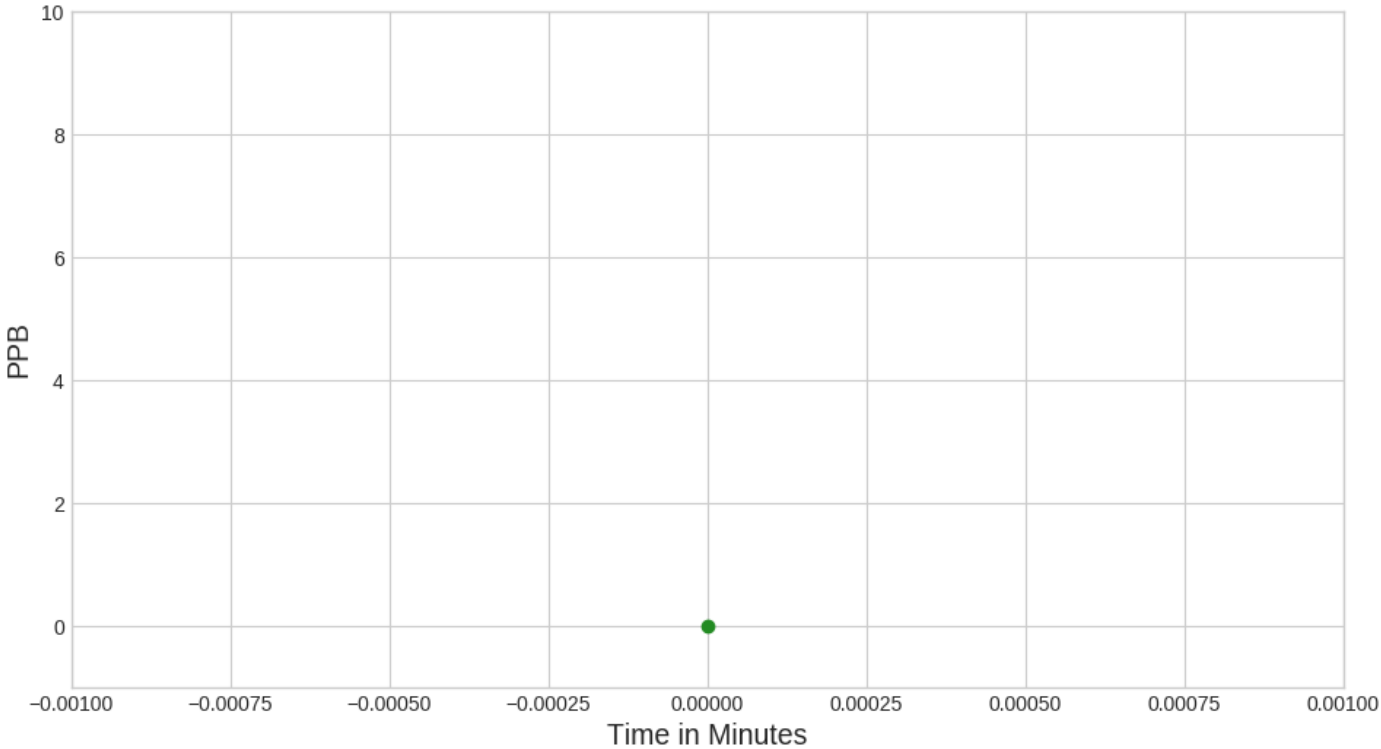
Client:	TEXAS INSTRUMENTS	Analyzer:	Delta F
Facility:	RFAB	Serial Number:	PT-18690-V6
Tool / Equipment ID:		Calibration Due:	7/2021
System:		Instrument Flow:	2.0 SCFH
Source ID:		Start Time/Date:	08:32 02/24/21
Test Point ID:		Stop Time/Date:	08:32 02/24/21
Test Gas:		Test Duration:	23 seconds
Test Flow:	4.3 SCFH	Average:	0.0 PPB
Technician:		Final:	0.0 PPB
		Specification:	20 PPB

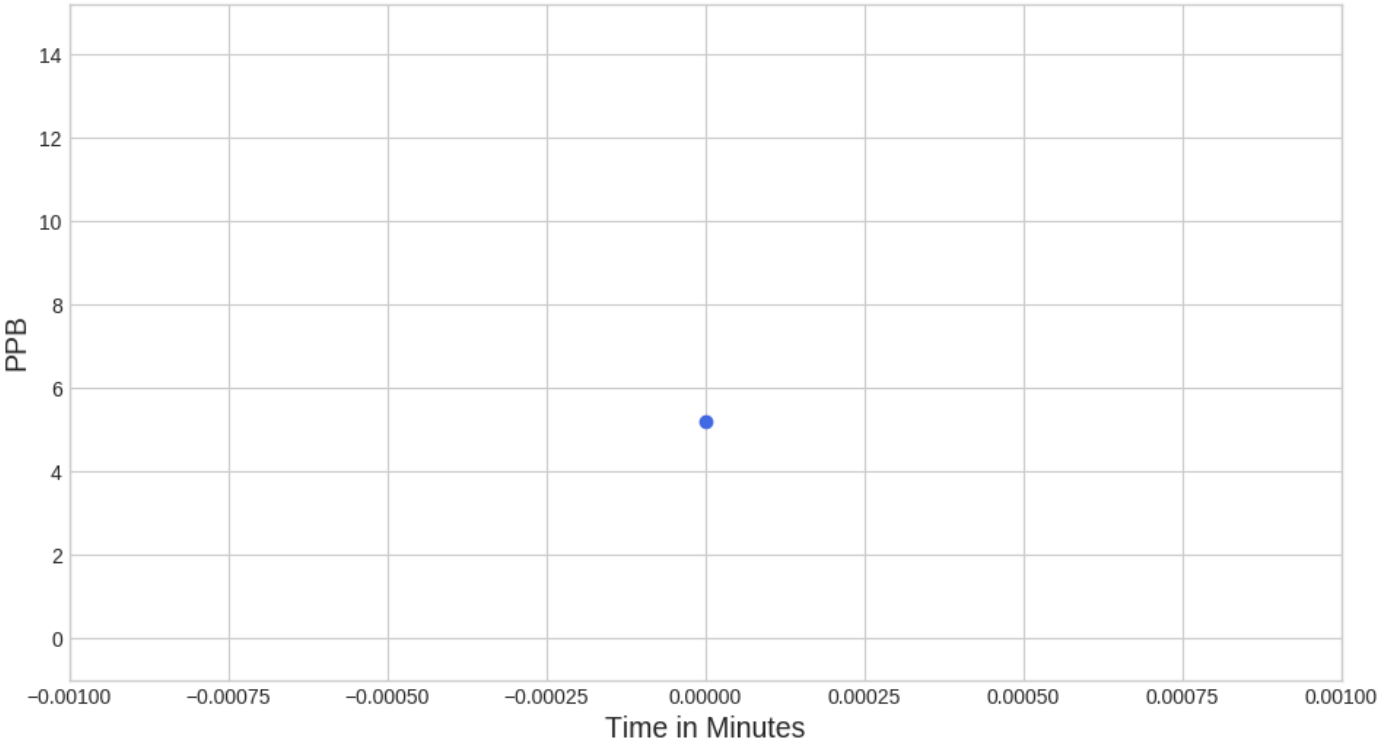
Client:	TEXAS INSTRUMENTS	Analyzer:	Tracer 2
Facility:	RFAB	Serial Number:	17367-44-1
Tool / Equipment ID:		Calibration Due:	8/2021
System:		Instrument Flow:	2.3 SCFH
Source ID:		Start Time/Date:	08:32 02/24/21
Test Point ID:		Stop Time/Date:	08:32 02/24/21
Test Gas:		Test Duration:	23 seconds
Test Flow:	4.3 SCFH	Average:	5.2 PPB
Technician:		Final:	5.2 PPB
		Specification:	20 PPB
