Oxygen Test Report

Client:	TEXAS INSTRUMENTS	Analyzer:	Delta F
Facility:	RFAB	Serial Number:	PT-18690-V6
Tool / Equipment ID:		Calibration Due:	7/2021
System:		Instrument Flow:	2.0 SCFH
Source ID:		Start Time/Date:	09:00 11/02/20
Test Point ID:		Stop Time/Date:	09:02 11/02/20
Test Gas:		Test Duration:	2 minutes 6 seconds
Test Flow:	4.3 SCFH	Average:	6.3 PPB
Technician:		Final:	6.2 PPB
		Specification:	20 PPB

Moisture Test Report

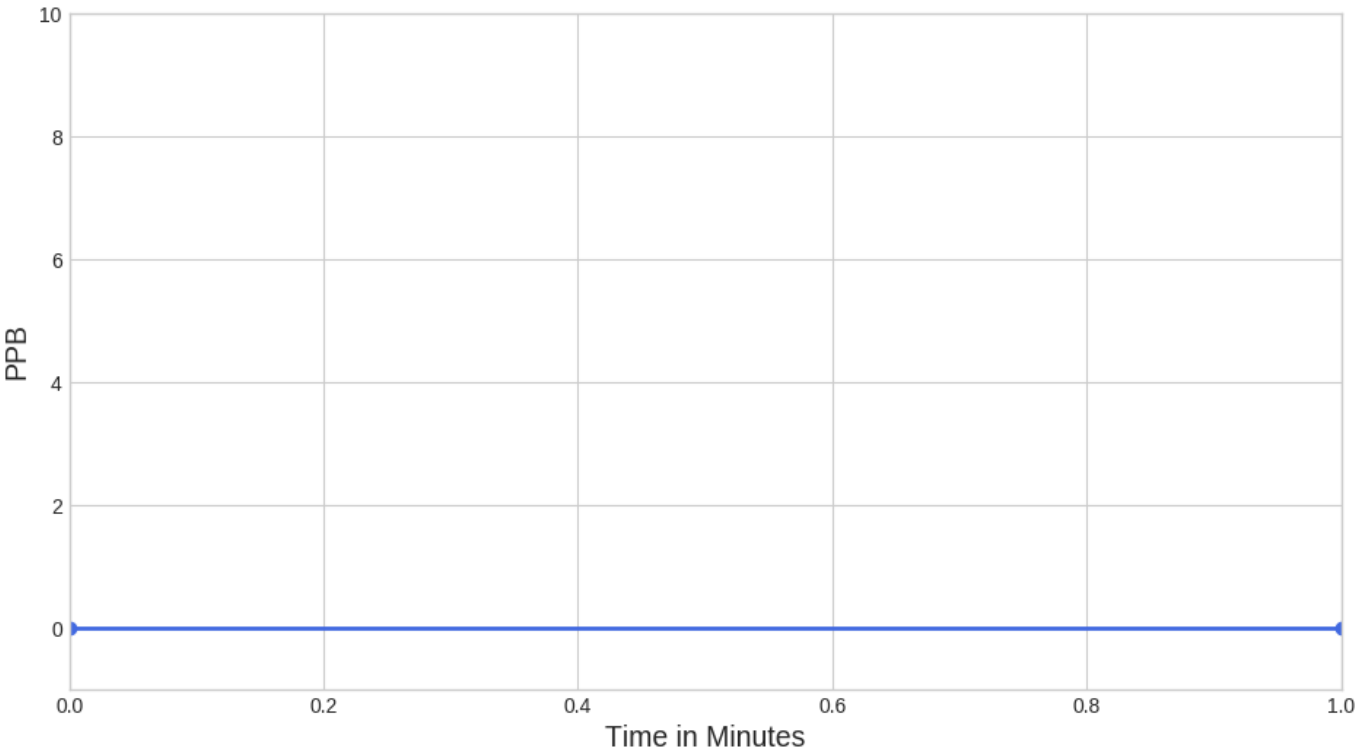
Client:	TEXAS INSTRUMENTS	Analyzer:	Tracer 2
Facility:	RFAB	Serial Number:	17367-44-1
Tool / Equipment ID:		Calibration Due:	8/2021
System:		Instrument Flow:	2.3 SCFH
Source ID:		Start Time/Date:	09:00 11/02/20
Test Point ID:		Stop Time/Date:	09:02 11/02/20
Test Gas:		Test Duration:	2 minutes 6 seconds
Test Flow:	4.3 SCFH	Average:	0.0 PPB
Technician:		Final:	0.0 PPB
		Specification:	20 PPB
