# York County, Virginia Shoreline Inventory Report Methods and Guidelines

**November, 2009**

Special report in Applied Marine Science and Ocean Engineering No. 415 of the Virginia Institute of Marine Science

# York County - Shoreline Inventory Report

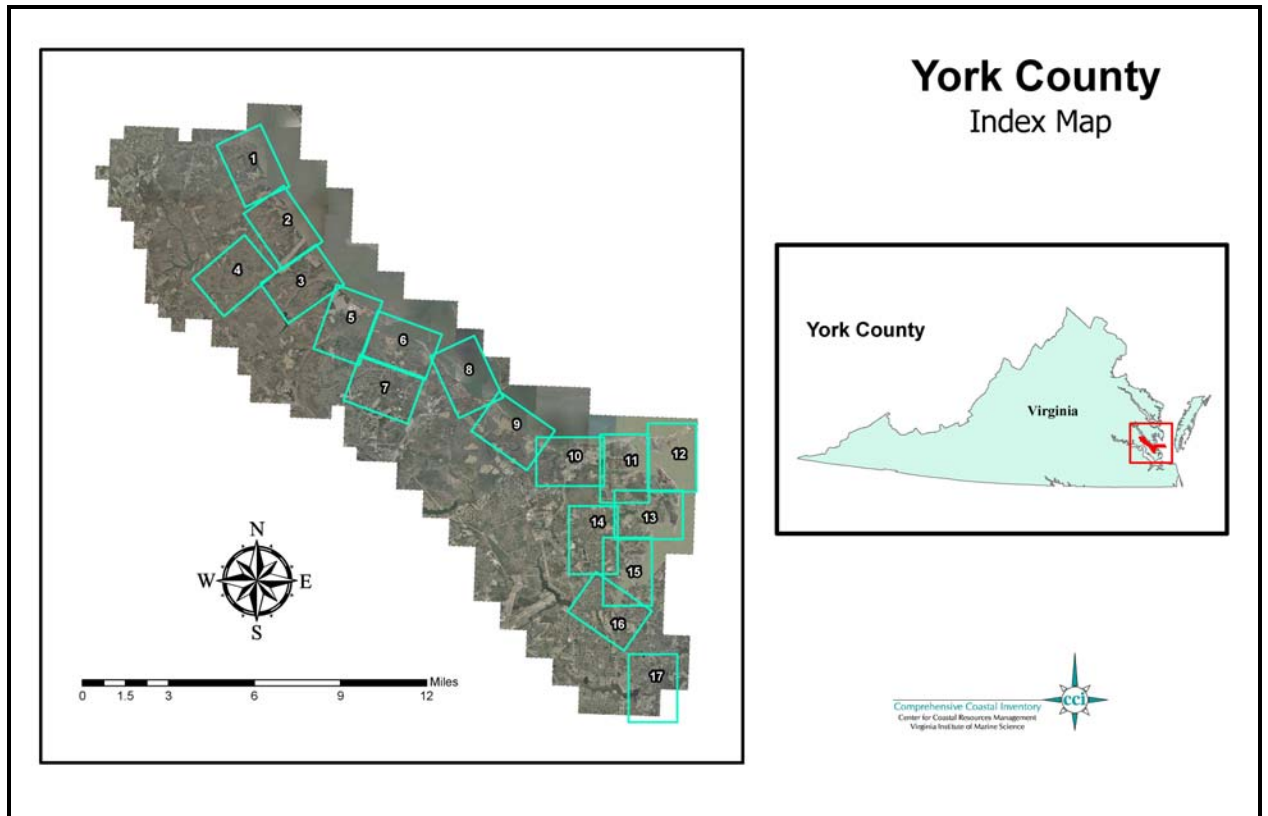
Figure 2. Map index for York County

For publication purposes the City is divided into a series of maps. Maps are scaled at 1:12,000 for publication at 11x17. Scale will vary if printed at a different size. There are 17 maps for York County; determined the county's geographic size and shape. For each map there are four plates (plate 1a, 1b, 1c, 1d, etc.), for a total of 68 map compositions. On the website (Figure 1), an index is provided to help users locate the area of interest and view the orientation of the maps to each other (Figure 2).

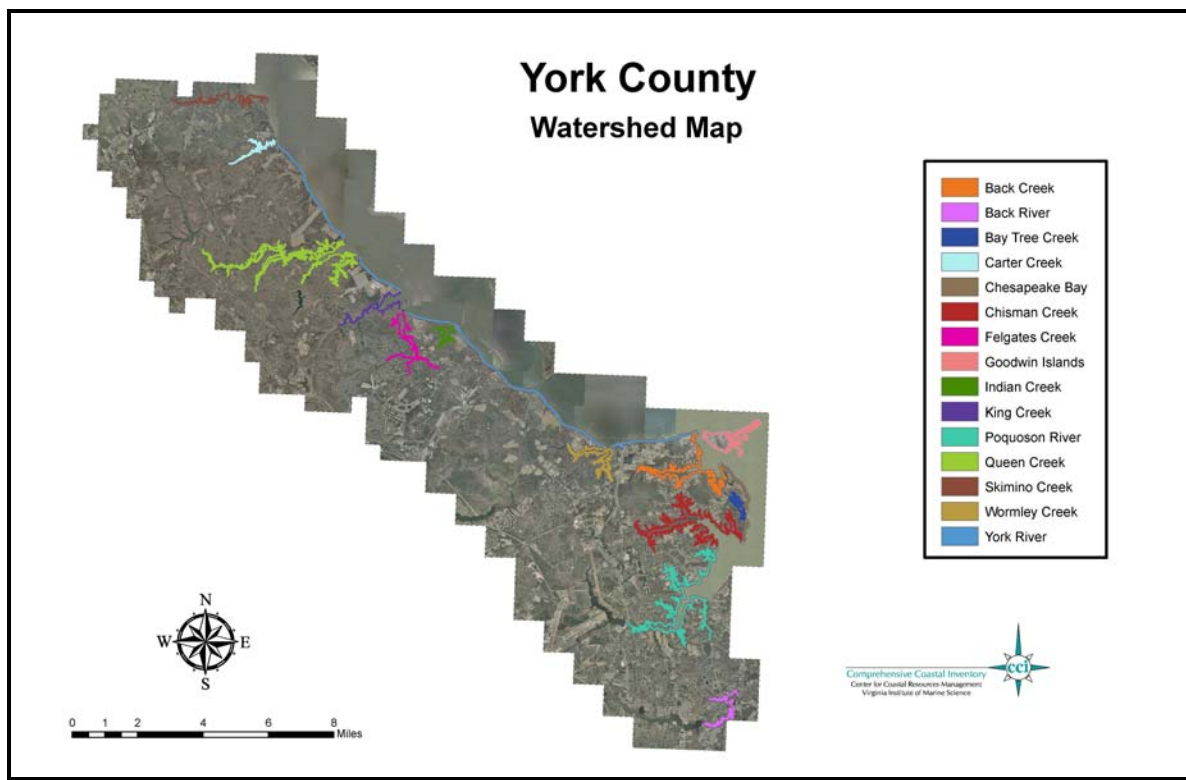
Figure 3. Delineation of county watersheds used for data reporting

Tables 4, 5, and 6 quantify features and conditions mapped along the rivers using frequency analysis techniques in ArcInfo. The values quantify features by river system (Figure 3). For linear features, values are reported in actual miles surveyed. Point features are enumerated. The total miles of shoreline surveyed for each tributary is reported. For the county, a total of 160.59 miles (258.44 km) were surveyed in the field. Approximately 71.13 miles (114.47 km) of shoreline were surveyed using remote sensing techniques. Figure 4 illustrates where field surveys were conducted and where remote sensing techniques were applied. The majority of these miles were places where navigation was restricted. Table 6 reports the survey dates, miles surveyed, and miles surveyed remotely.

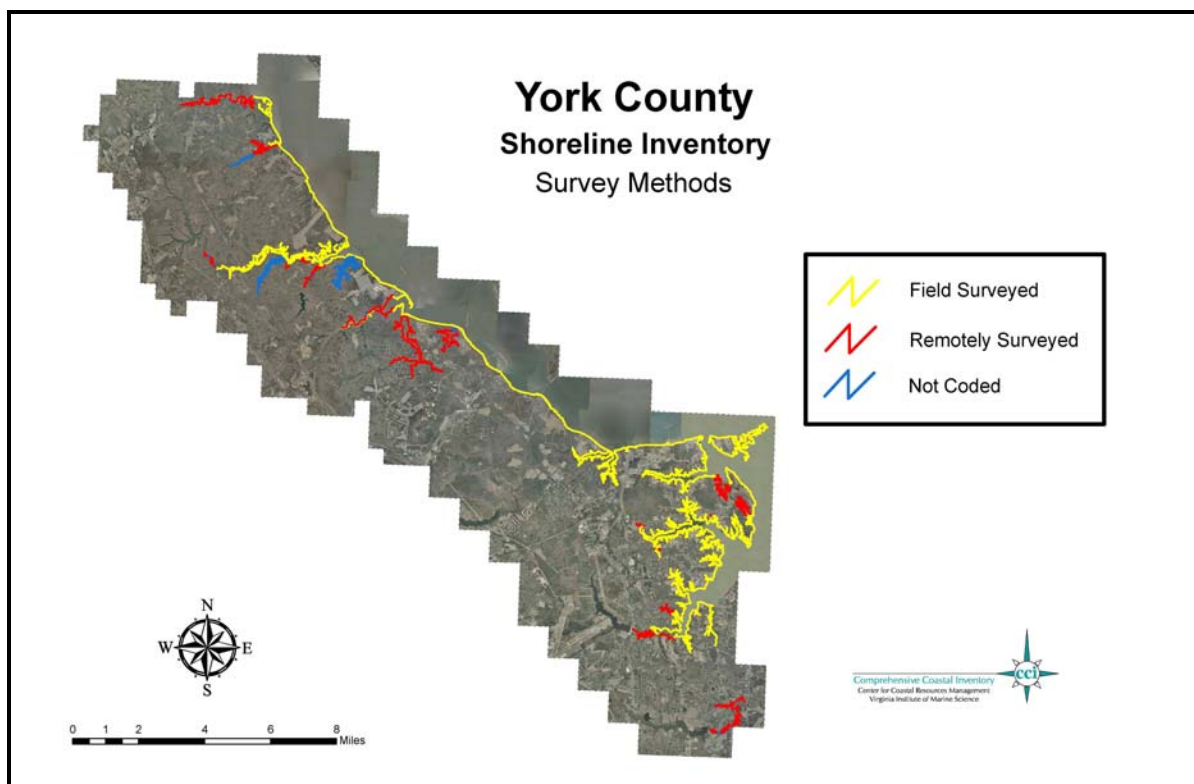
Figure 4. Location of field surveys and remotely sensed data collection.

Shoreline condition is described for York County along primary and secondary shoreline. Characteristics are described for all navigable tidal waterways contiguous to these shorelines. A total of 231.72 miles (372.91 km) of the total 246.55 miles of shoreline are described. Field surveys covered 160.59 miles (258.44 km) of shoreline. Remote sensing was used to code 71.13 miles (114.47 km) of shoreline in the county (Figure 4).

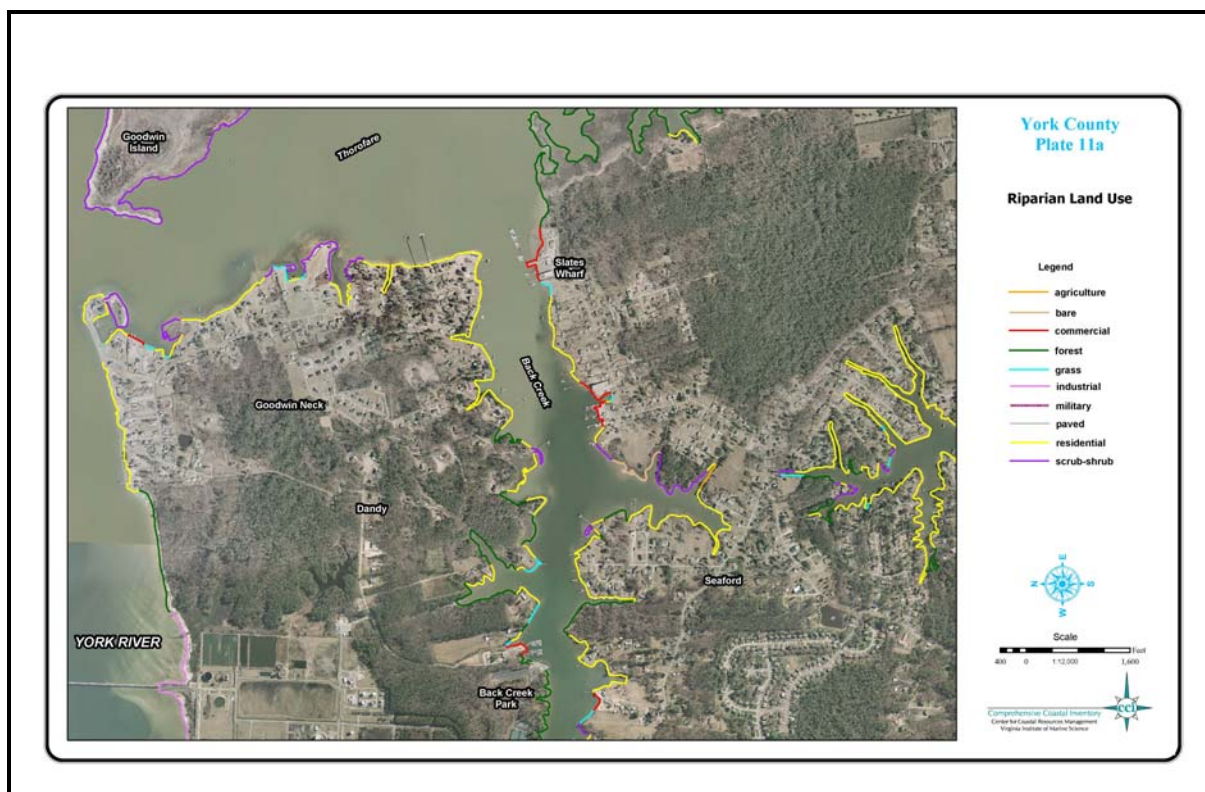
Figure 6. Sample riparian land use map for York County

Plate A describes the riparian land use as color-coded bars along the shore. The background imagery is natural color VBMP imagery at a publication scale of 1:12,000. Users should note that the imagery is sometime rotated in order to meet the scale requirements. This means that “north” is not always to the top of the page.

Once you determine which plate you want, the scroll down menu on the left has links to the four part series for each plate (Figure 5). At the top of the scroll bar Riparian Land Use (plate a) is first. You can scroll down to see links to maps illustrating Bank Conditions (plate b), Shoreline Features (plate c), and Natural Buffers (plate d). The content and details of the four part plate series was described in detail in Chapter 2. The actual map will come up when you click on the plate number. For example, Figure 6 is the riparian land use map for plate 11. Figure 7 is the map illustrating bank conditions for plate 11. Figure 8 shows all the shoreline features for that same area, and Figure 9 the natural buffers associated with that section.

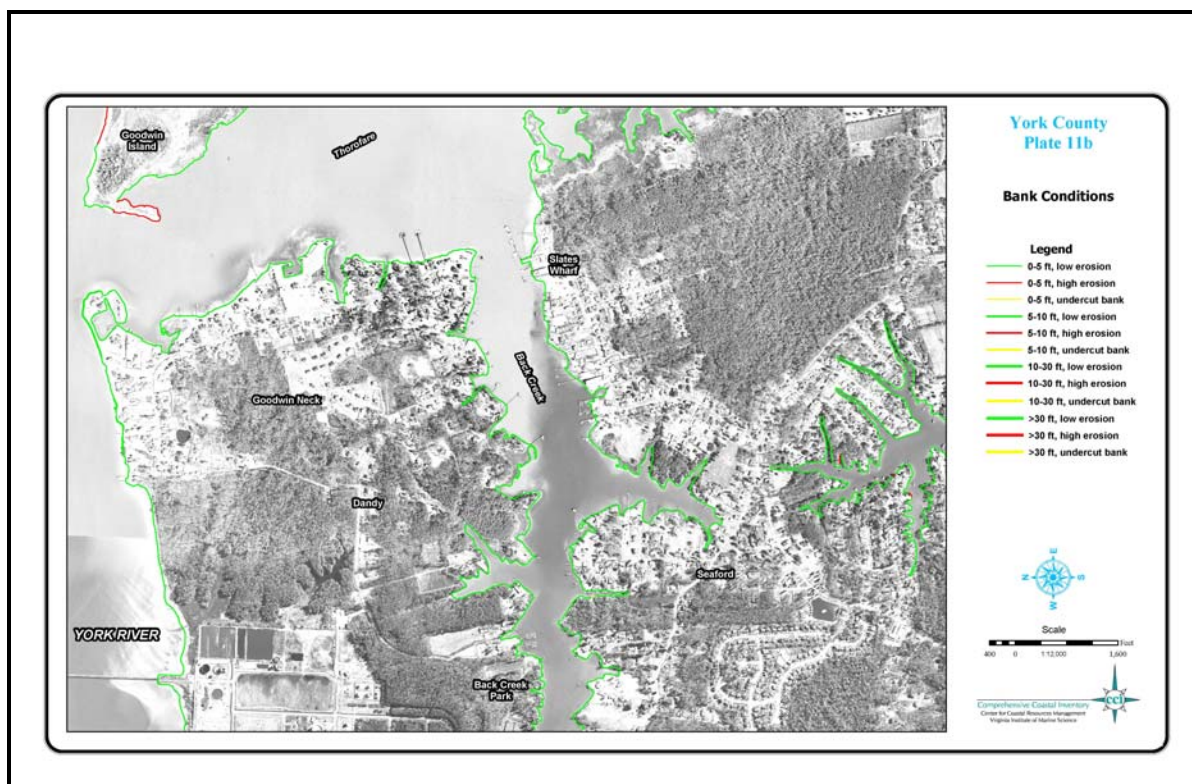
Figure 7. Map illustrating bank conditions for plate 11 in York County

Plate B depicts the condition of the bank; specifically bank stability, bank cover, and

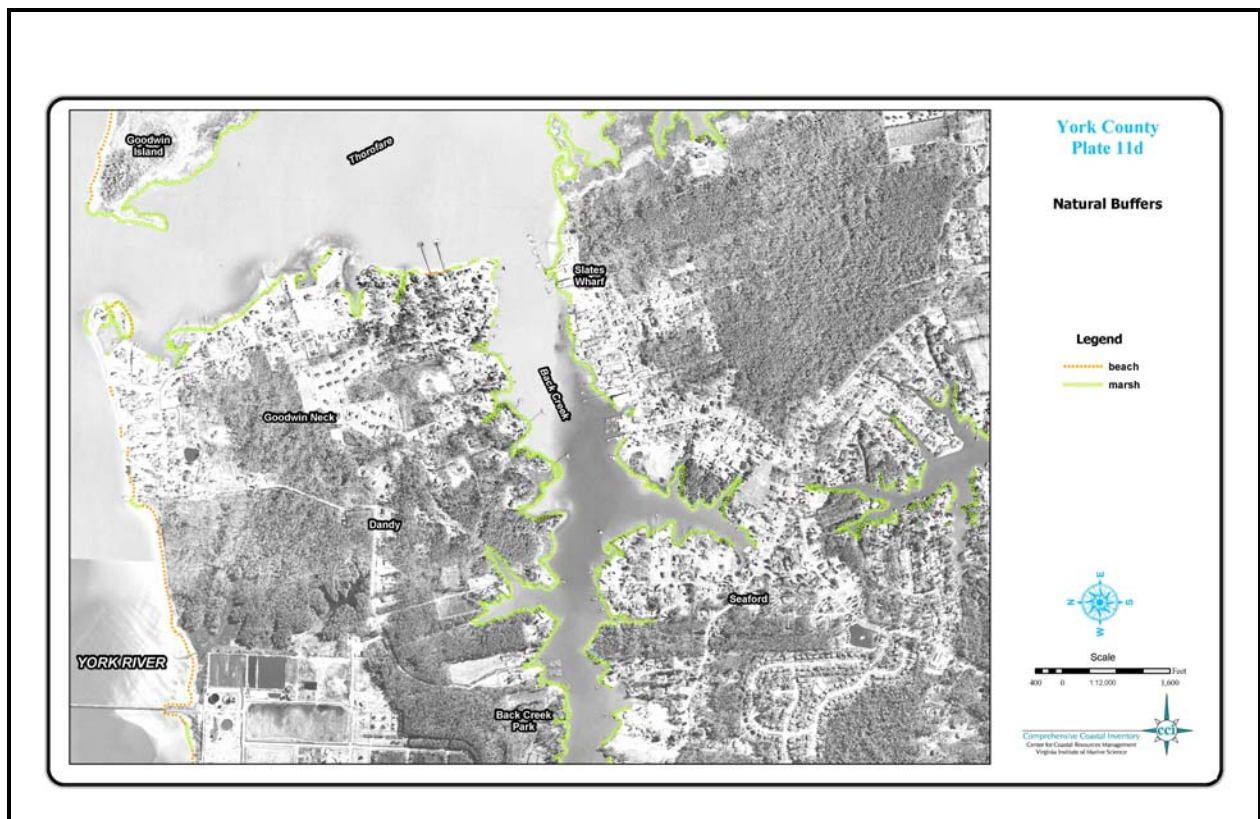
Figure 9. Map illustrating natural buffers for plate 11 in York County

On Plate D, a pattern of small colored circles along the shoreline describes any natural buffers present. These are limited to marshes and beaches. Orange solid circles represent the presence of beaches and green open circles represent marshes.
