## The Eight Disciplines (8D) Report

Two manholes fitted in the material preparation area and sent to a fabrication bay. Each manhole is fixed in place on site by four fixing bolts. The manhole did not have the 4 holes laser cut in them to allow for the fixing bolts.

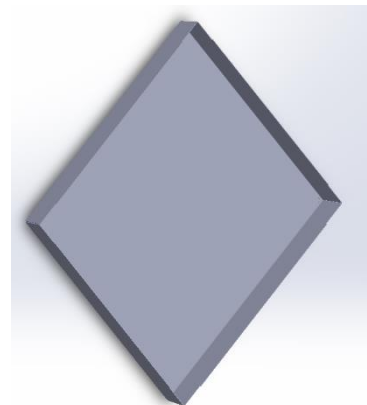
The engineer did not know that holes were required in Engineer did not receive appropriate training in relation to manipulating step files in SolidWorks to prepare them for laser programming.

- 1) An engineering change order needs to be placed on the drawing to ensure it is not released to production at a later date.
- 2) A standardised training program:
  - To teach engineers how to prepare drawing files for laser programming.
  - To teach engineers about the technical details of the product they are working on.
