CIRCUIT INSPECTION

DTC	B1211 / 11	Driver door ECU communication stop
------------	-------------------	---

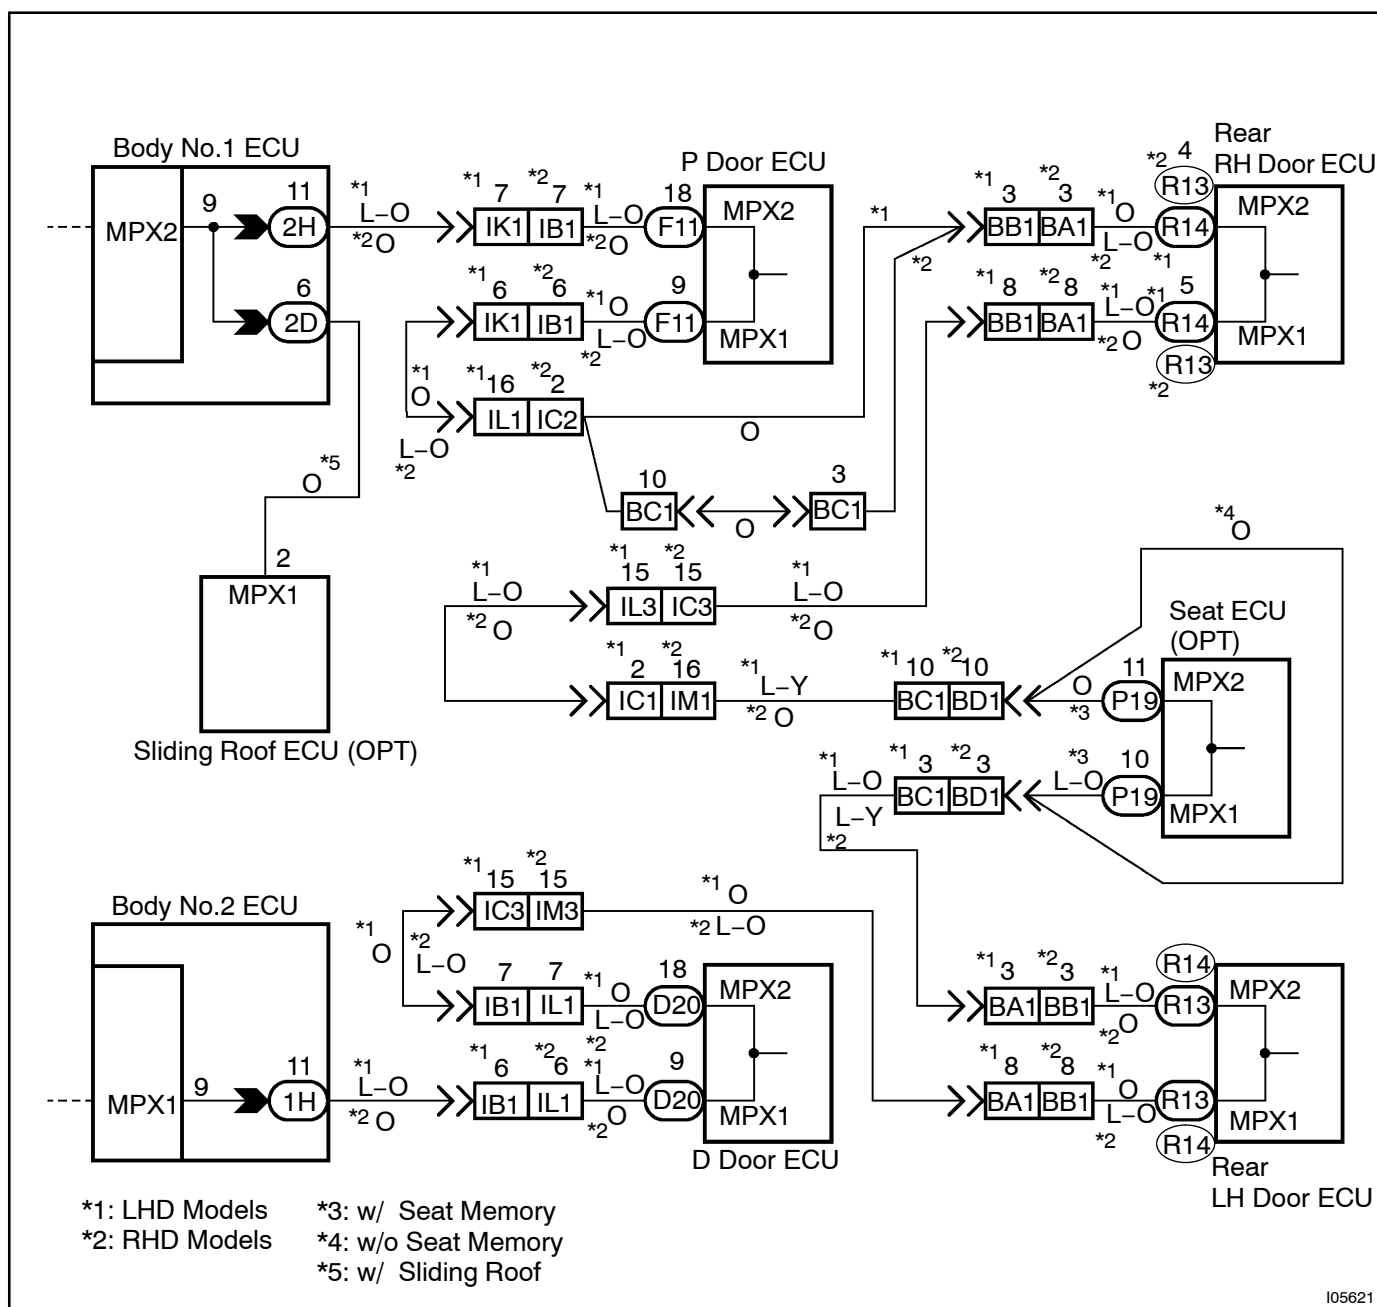
I05621

This DTC is output when communication stops between driver door ECU and body No.1 ECU.

WIRING DIAGRAM

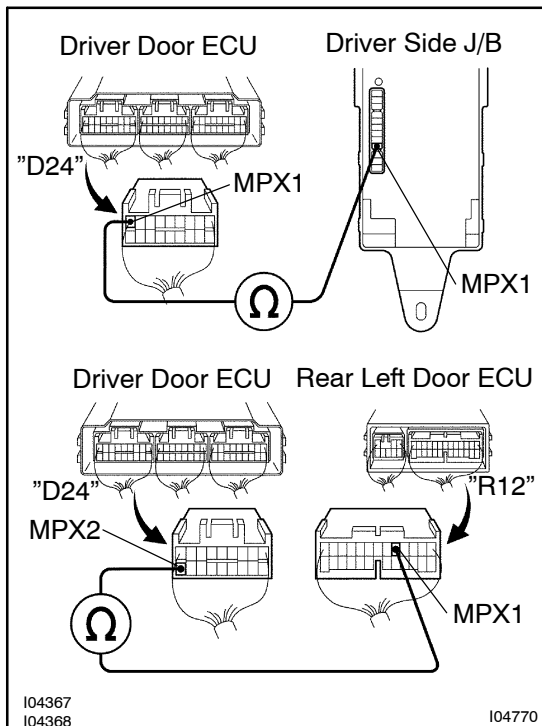
Disconnect connector of body No.2 ECU, "D24" of driver door ECU and "D12" of rear left ECU.

- Check continuity between terminals MPX1 of body No.2 ECU and MPX1 of driver door ECU.
- Check continuity between terminals MPX2 of driver door ECU and MPX1 of rear left door ECU.

There is a continuity in wireharness of both (a) and (b). or either (a) or (b).

If there is OPEN in wireharness of either (a) or (b), please repair it.

Repair or replace wireharness.
