DTC	B0135/73	Short in P/T Squib (LH) Circuit
-----	----------	---------------------------------

CIRCUIT DESCRIPTION

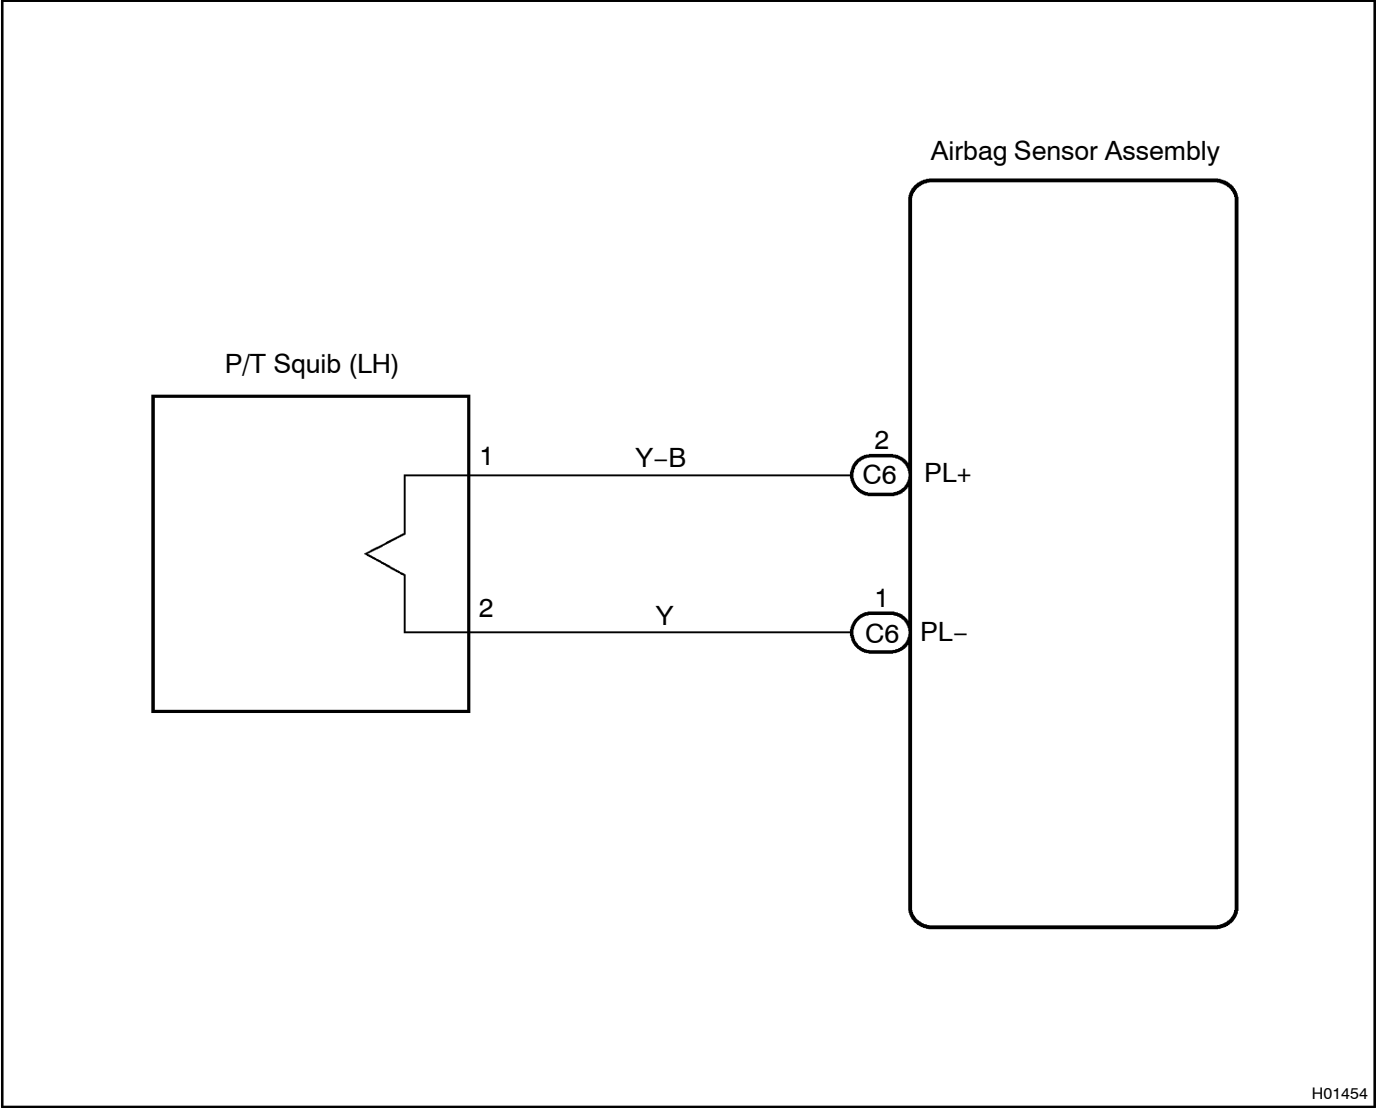
WIRING DIAGRAM

The P/T squib (LH) circuit consists of the airbag sensor assembly and seat belt pretensioner (LH). It causes the SRS to deploy when the SRS deployment conditions are satisfied. For details of the function of each component, see OPERATION on [page RS-2](#). DTC B0135/73 is recorded when a short is detected in the P/T squib (LH) circuit.

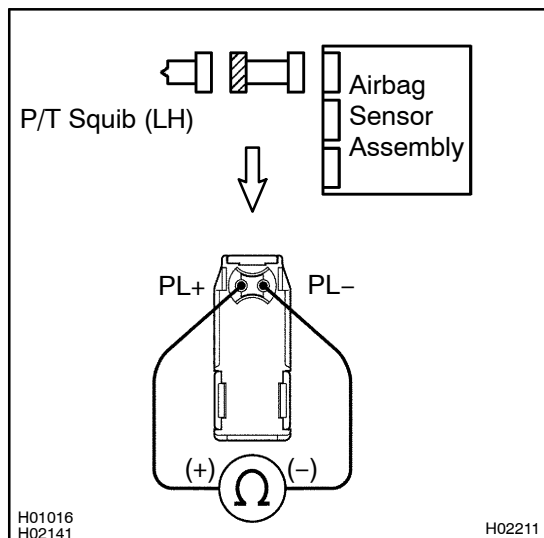
2 Check P/T squib (LH) circuit.

Release the airbag activation prevention mechanism of the connector (on the airbag sensor assembly side) between the airbag sensor assembly and the seat belt pretensioner (LH) ([See page DI-369](#)).

For the connector (on the seat belt pretensioner side) between the seat belt pretensioner (LH) and the airbag sensor assembly, measure the resistance between PL+ and PL-.

Resistance: 1 MΩ or Higher

Repair or replace harness or connector between seat belt pretensioner (LH) and airbag sensor assembly.

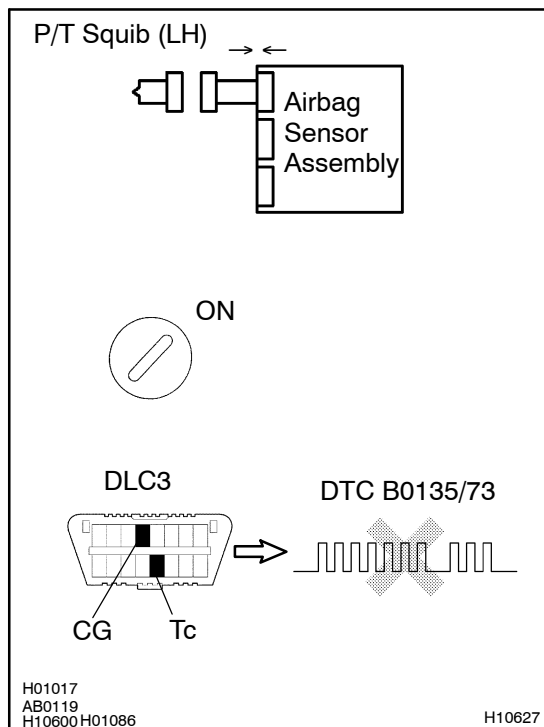
3 Check airbag sensor assembly.

- Connect the connector to the airbag sensor assembly.
- Connect negative (-) terminal cable to the battery, and wait at least for 2 seconds.

- Turn the ignition switch to ON and wait at least for 20 seconds.
- Clear the DTC stored in memory (See page DI-369).
- Turn the ignition switch to LOCK, and wait at least for 20 seconds.
- Turn the ignition switch to ON, and wait at least for 20 seconds.
- Check the DTC (See page DI-369).

DTC B0135/73 is not output.

Replace airbag sensor assembly.

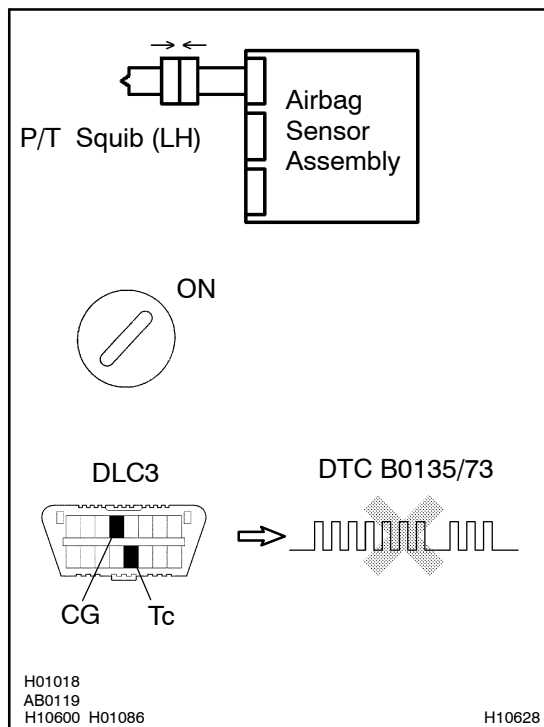
4 Check P/T squib (LH).

- Turn the ignition switch to LOCK.
- Disconnect negative (-) terminal cable from the battery, and wait at least for 90 seconds.
- Connect the seat belt pretensioner (LH) connector.
- Connect negative (-) terminal cable to the battery, and wait at least for 2 seconds.

- Turn the ignition switch to LOCK, and wait at least for 20 seconds.
- Turn the ignition switch to ON, and wait at least for 20 seconds.
- Clear the DTC stored in memory (See page DI-369).
- Turn the ignition switch to LOCK, and wait at least for 20 seconds.
- Turn the ignition switch to ON, and wait at least for 20 seconds.
- Check the DTC (See page DI-369).

DTC B0135/73 is not output.

Replace seat belt pretensioner (LH).
