DTC	B0137/61	Short in LH and RH P/T Squib Circuit (to Ground)
-----	----------	--

CIRCUIT DESCRIPTION

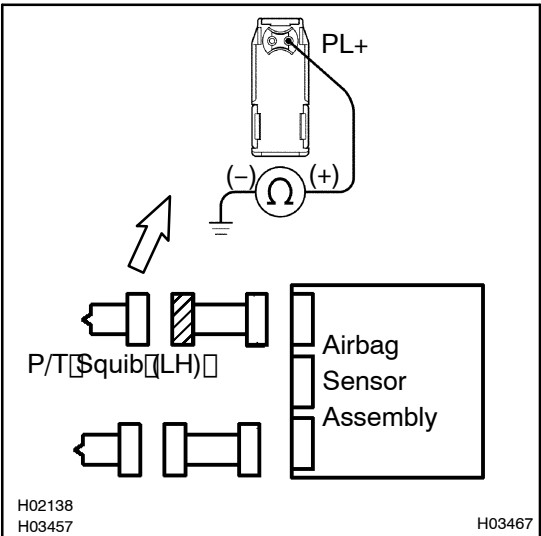
2	Check P/T squib (LH) circuit.
---	-------------------------------

CHECK:
For the connector (on the airbag sensor assembly side) between the seat belt pretensioner and airbag sensor assembly, measure the resistance between PL+ and body ground.

OK:
Resistance: 1 MΩ or Higher

NG
Repair or replace harness or connector between the seat belt pretensioner (LH) and airbag sensor assembly.

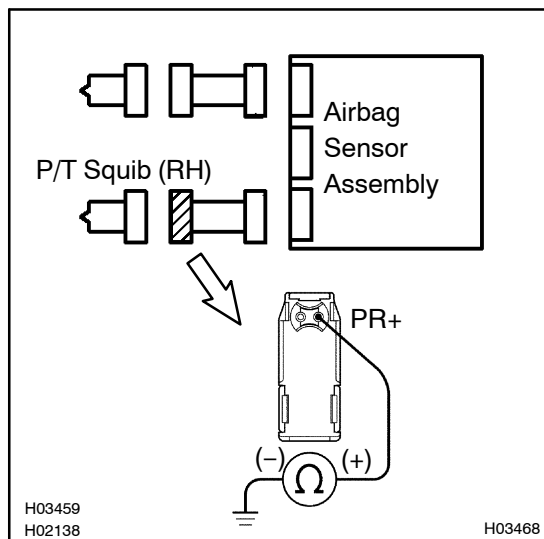
3 Check P/T squib (RH) circuit.

**CHECK:**

For the connector (on the airbag sensor assembly side) between the seat belt pretensioner and airbag sensor assembly, measure the resistance between PR+ and body ground.

OK:

Resistance: 1 MΩ or Higher

NG

Repair or replace harness or connector between the seat belt pretensioner (RH) and airbag sensor assembly.

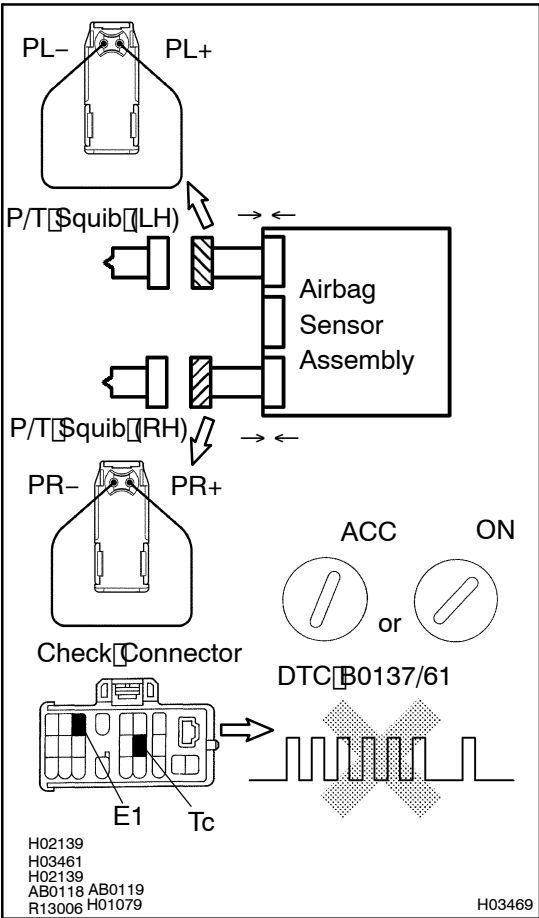
4 Check airbag sensor assembly.

PREPARATION:

- Connect the connectors to the airbag sensor assembly.
- Using a service wire, connect PL+ and PL- of the connector (on the seat belt pretensioner side) between the seat belt pretensioner (LH) and airbag sensor assembly.
- Using a service wire, connect PR+ and PR- of the connector (on the seat belt pretensioner side) between the seat belt pretensioner (RH) and airbag sensor assembly.
- Connect negative (-) terminal cable to the battery, and wait at least for 2 seconds.

CHECK:

- Turn ignition switch to ACC or ON and wait at least for 20 seconds.
- Clear DTC stored in memory. (See step 5 on [page DI-386](#))
- Turn ignition switch to LOCK, and wait at least for 20 seconds.
- Turn ignition switch to ACC or ON, and wait at least for 20 seconds.
- Check DTC. (See [page DI-386](#))

OK:

DTC B0137/61 is not output.

NG

Replace airbag sensor assembly.

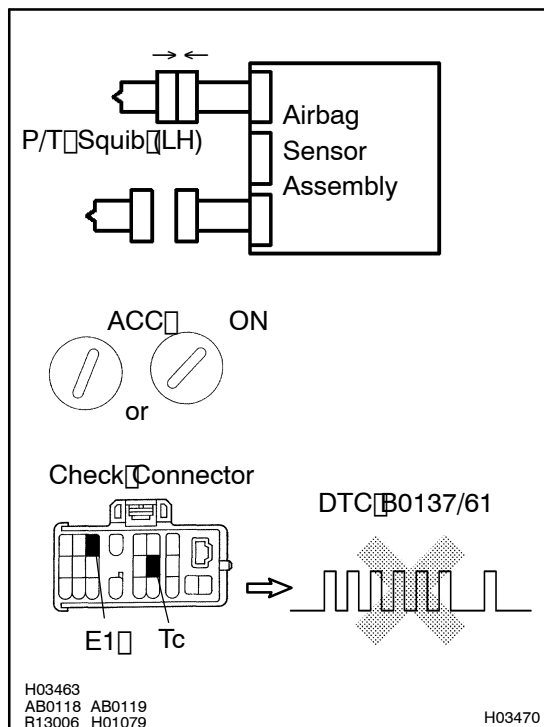
5 Check P/T Squib (LH).

PREPARATION:

- Turn ignition switch to LOCK.
- Disconnect negative (-) terminal cable from the battery, and wait at least for 90 seconds.
- Connect the seat belt pretensioner (LH) connector.
- Connect negative (-) terminal cable to the battery, and wait at least for 2 seconds.

CHECK:

- Turn ignition switch to ACC or ON, and wait at least for 20 seconds.
- Clear DTC stored in memory.
(See step 5 on [page DI-386](#))
- Turn ignition switch to LOCK, and wait at least for 20 seconds.
- Turn ignition switch to ACC or ON, and wait at least for 20 seconds.
- Check DTC. ([See page DI-386](#))

OK:

DTC B0137/61 is not output.

NG

Replace seat belt pretensioner (LH).

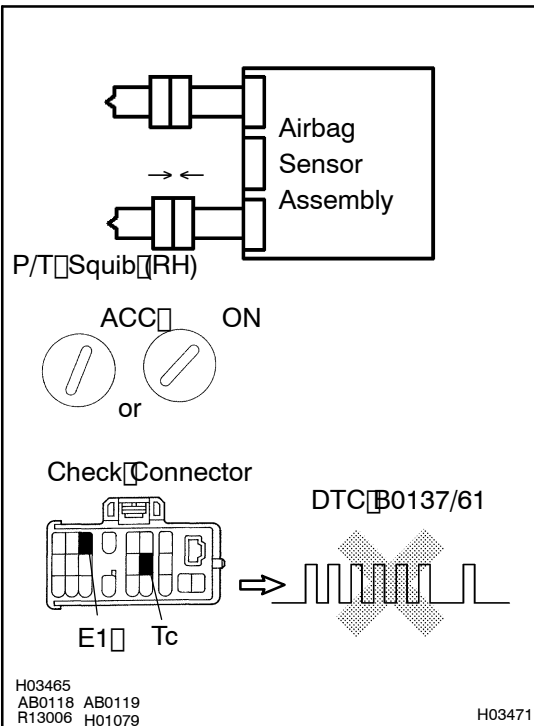
6 Check P/T Squib (LH).

PREPARATION:

- Turn ignition switch to LOCK.
- Disconnect negative (-) terminal cable from the battery, and wait at least for 90 seconds.
- Connect the seat belt pretensioner (RH) connector.
- Connect negative (-) terminal cable to the battery, and wait at least for 2 seconds.

CHECK:

- Turn ignition switch to ACC or ON, and wait at least for 20 seconds.
- Clear DTC stored in memory.
(See step 5 on [page DI-386](#))
- Turn ignition switch to LOCK, and wait at least for 20 seconds.
- Turn ignition switch to ACC or ON, and wait at least for 20 seconds.
- Check DTC. ([See page DI-386](#))

OK:

DTC B0137/61 is not output.

NG

Replace seat belt pretensioner (RH).
