## Horn circuit

## CIRCUIT DESCRIPTION

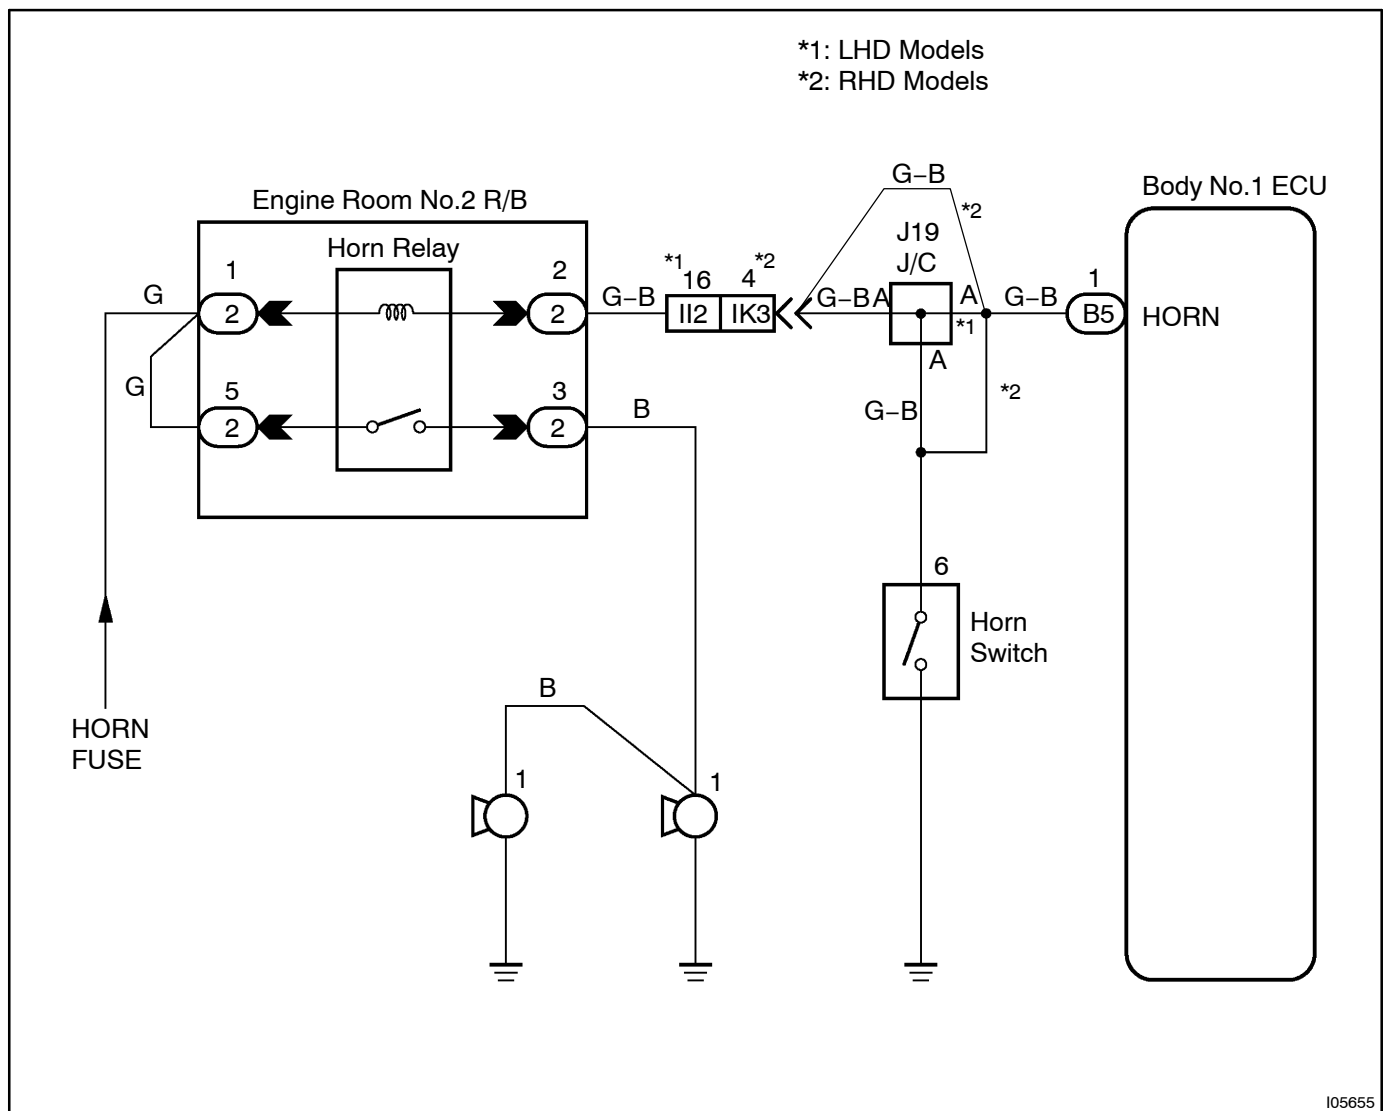
## WIRING DIAGRAM

The horn is connected to the body No.1 ECU and activated by the body No.1 ECU during warning of the theft deterrent system.

Check wireharness and connector between horn relay and body ECU, battery and horn relay.
