DTC	B0137/71	Short in P/T Squib (LH) Circuit (to Ground)
------------	-----------------	--

CIRCUIT DESCRIPTION

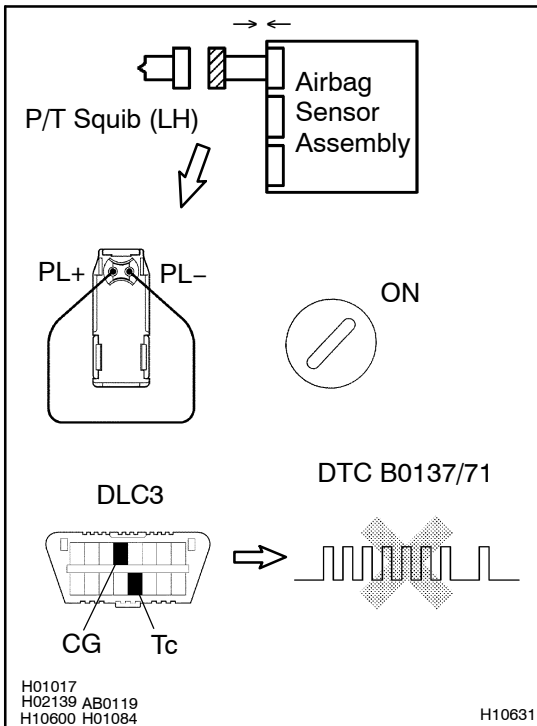
3 Check airbag sensor assembly.

- Connect the connector to the airbag sensor assembly.
- Using a service wire, connect PL+ and PL- of the connector (on the seat belt pretensioner side) between the seat belt pretensioner (LH) and the airbag sensor assembly.
- Connect negative (-) terminal cable to the battery, and wait at least for 2 seconds.

- Turn the ignition switch to ON and wait at least for 20 seconds.
- Clear the DTC stored in memory (See step 5 on [page DI-369](#)).
- Turn the ignition switch to LOCK, and wait at least for 20 seconds.
- Turn the ignition switch to ON, and wait at least for 20 seconds.
- Check the DTC (See [page DI-369](#)).

DTC B0137/71 is not output.

Replace airbag sensor assembly.

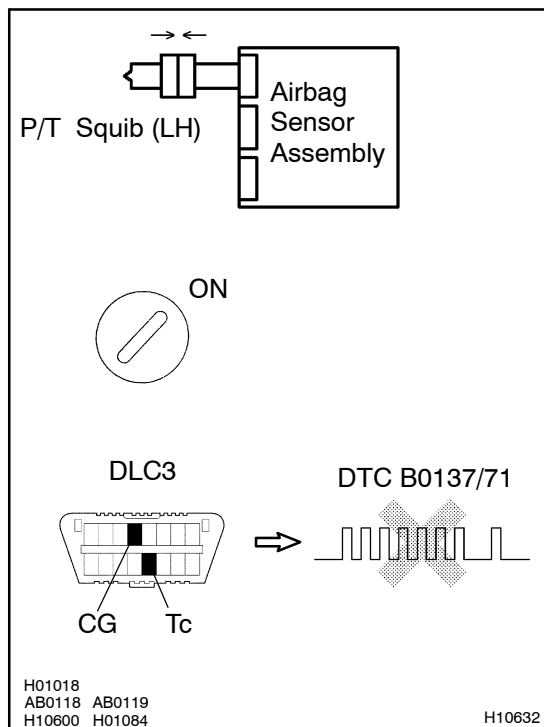
4 Check P/T squib (LH).

- Turn the ignition switch to LOCK.
- Disconnect negative (-) terminal cable from the battery, and wait at least for 90 seconds.
- Connect the seat belt pretensioner (LH) connector.
- Connect negative (-) terminal cable to the battery, and wait at least for 2 seconds.

- Turn the ignition switch to ON, and wait at least for 20 seconds.
- Clear the DTC stored in memory (See step 5 on [page DI-369](#)).
- Turn the ignition switch to LOCK, and wait at least for 20 seconds.
- Turn the ignition switch to ON, and wait at least for 20 seconds.
- Check the DTC (See [page DI-369](#)).

DTC B0137/71 is not output.

Replace seat belt pretensioner (LH).
