Hazard switch circuit

CIRCUIT DESCRIPTION

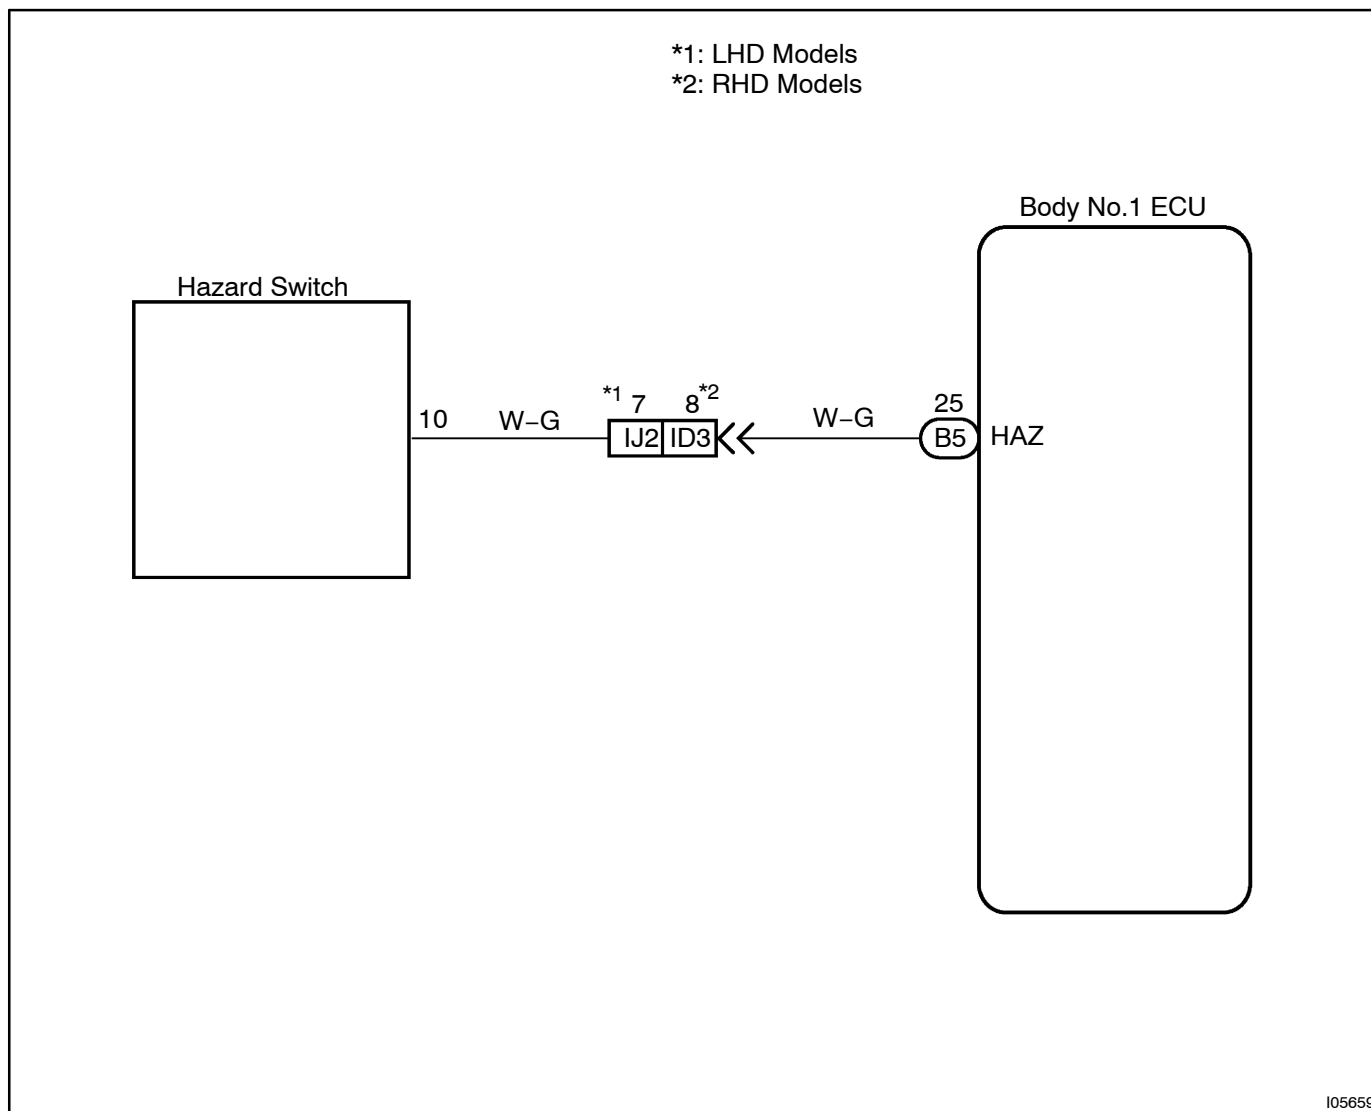
WIRING DIAGRAM

Body No.1 ECU activates the flasher relay during warning of the theft deterrent system and flashes the hazard.
