Fig. 129 FEBA: 5x5 ROD BUNDLE, TEST SERIES 2, TEST-No. 229

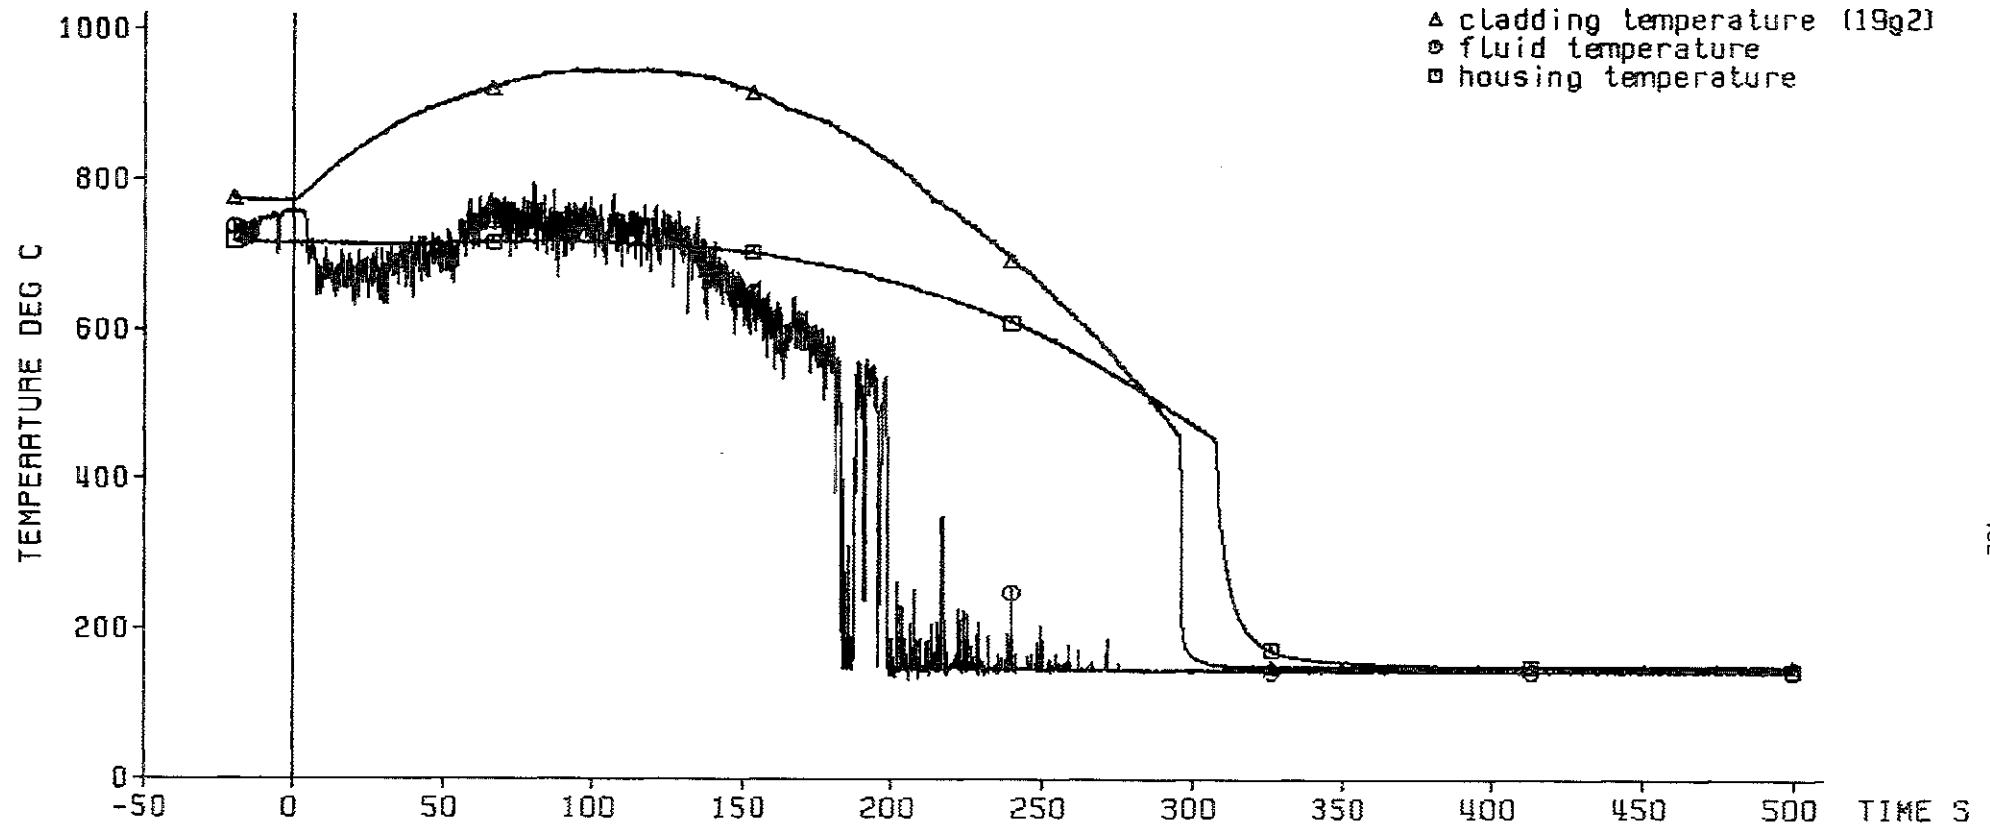
axial level: 1725 mm

decay heat
flooding rate (cold)
system pressure
feedwater temperature

120% RNS standard
3.82 cm/s
4.15 bar
40 deg C
