Fig. 175 FEBA: 5x5 ROD BUNDLE, TEST SERIES 2, TEST-No. 228

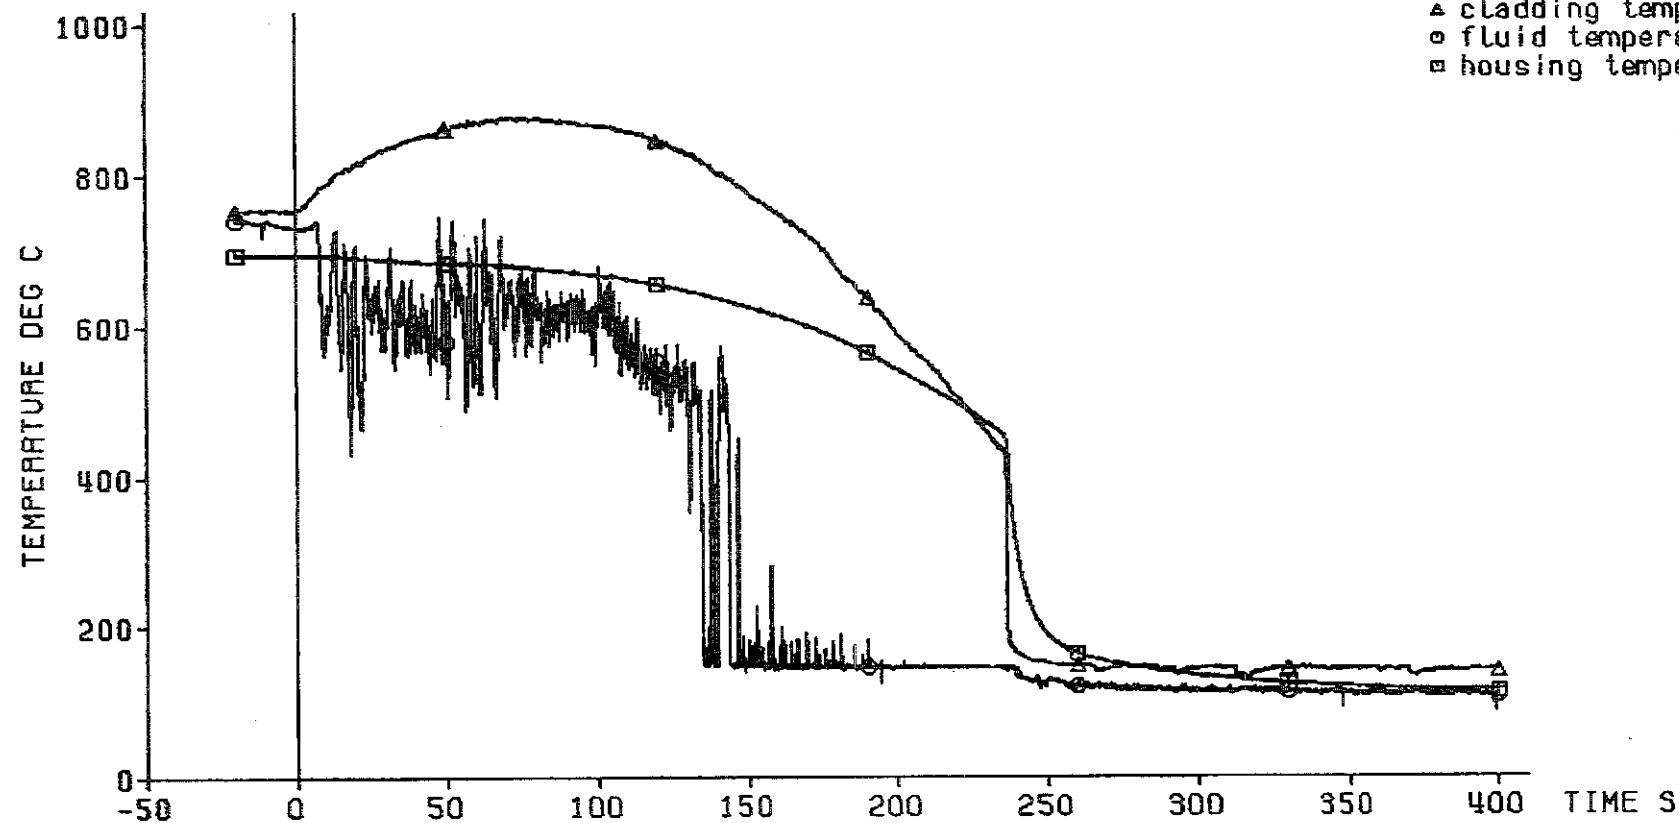
axial level: 1625 mm

decay heat
flooding rate (cold)
system pressure
feedwater temperature

120% RNS standard
5.72 cm/s
4.11 bar
40 deg C
