Fig.127 FEBRA: 5x5 ROD BUNDLE, TEST SERIES 2, TEST-No. 229

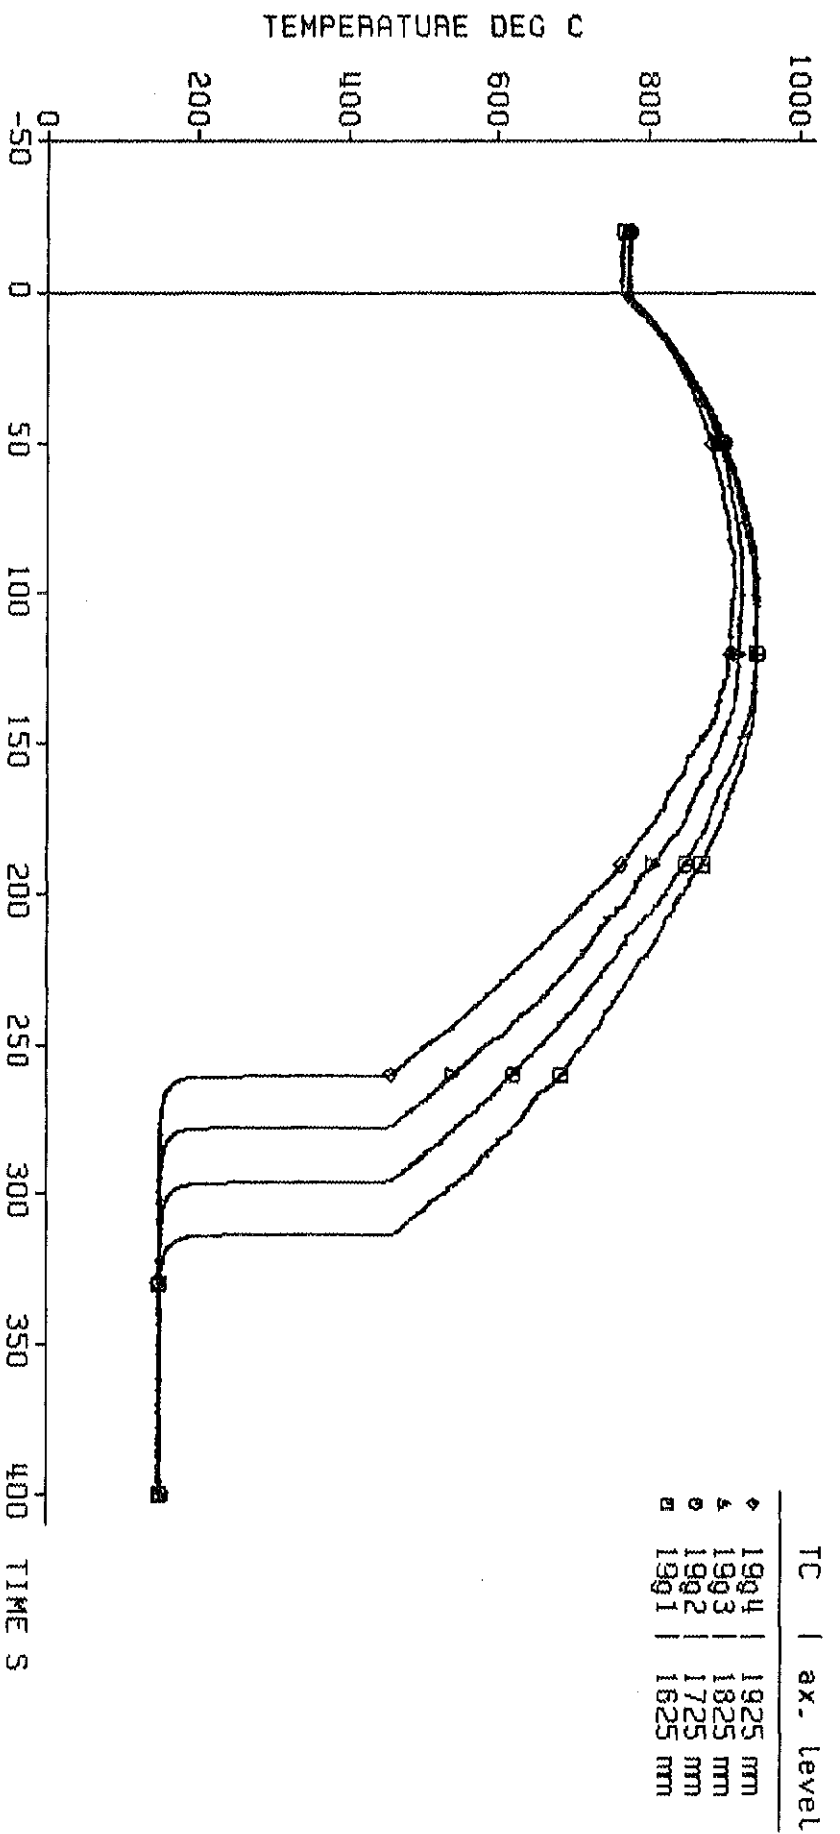
cladding temperature

decay heat  
flooding rate (cold)  
system pressure  
feedwater temperature

120% ANS standard  
3.82 cm/s  
4.15 bar  
40 deg C
