Fig. 189 FEBA: 5x5 ROD BUNDLE, TEST SERIES 2, TEST-No. 230

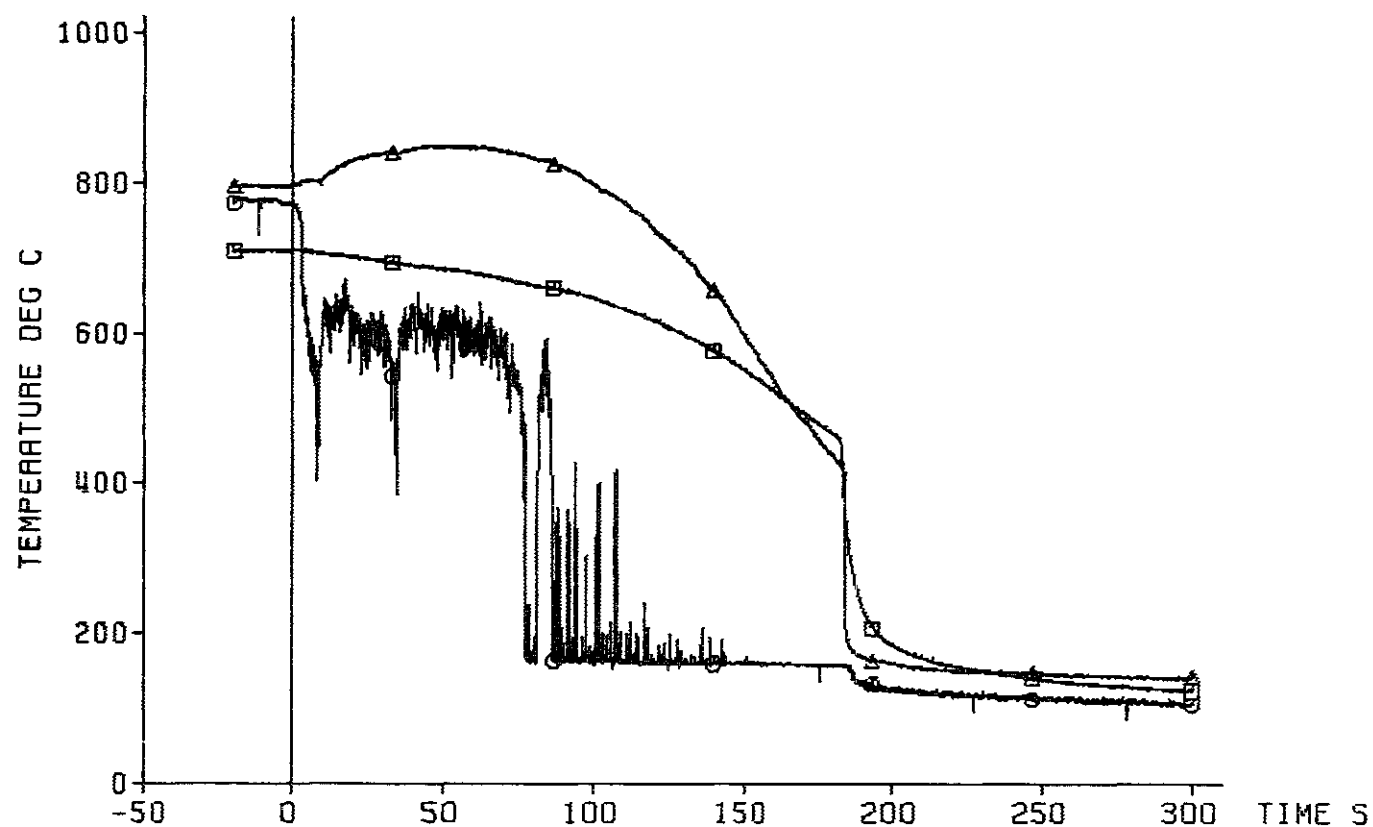
axial level: 1725 mm

decay heat 120% ANS standard
flooding rate (cold) 5.77 cm/s
system pressure 6.15 bar
feedwater temperature 40 deg C
