Fig.142 FEBA: 5x5 ROD BUNDLE, TEST SERIES 2, TEST-No. 231

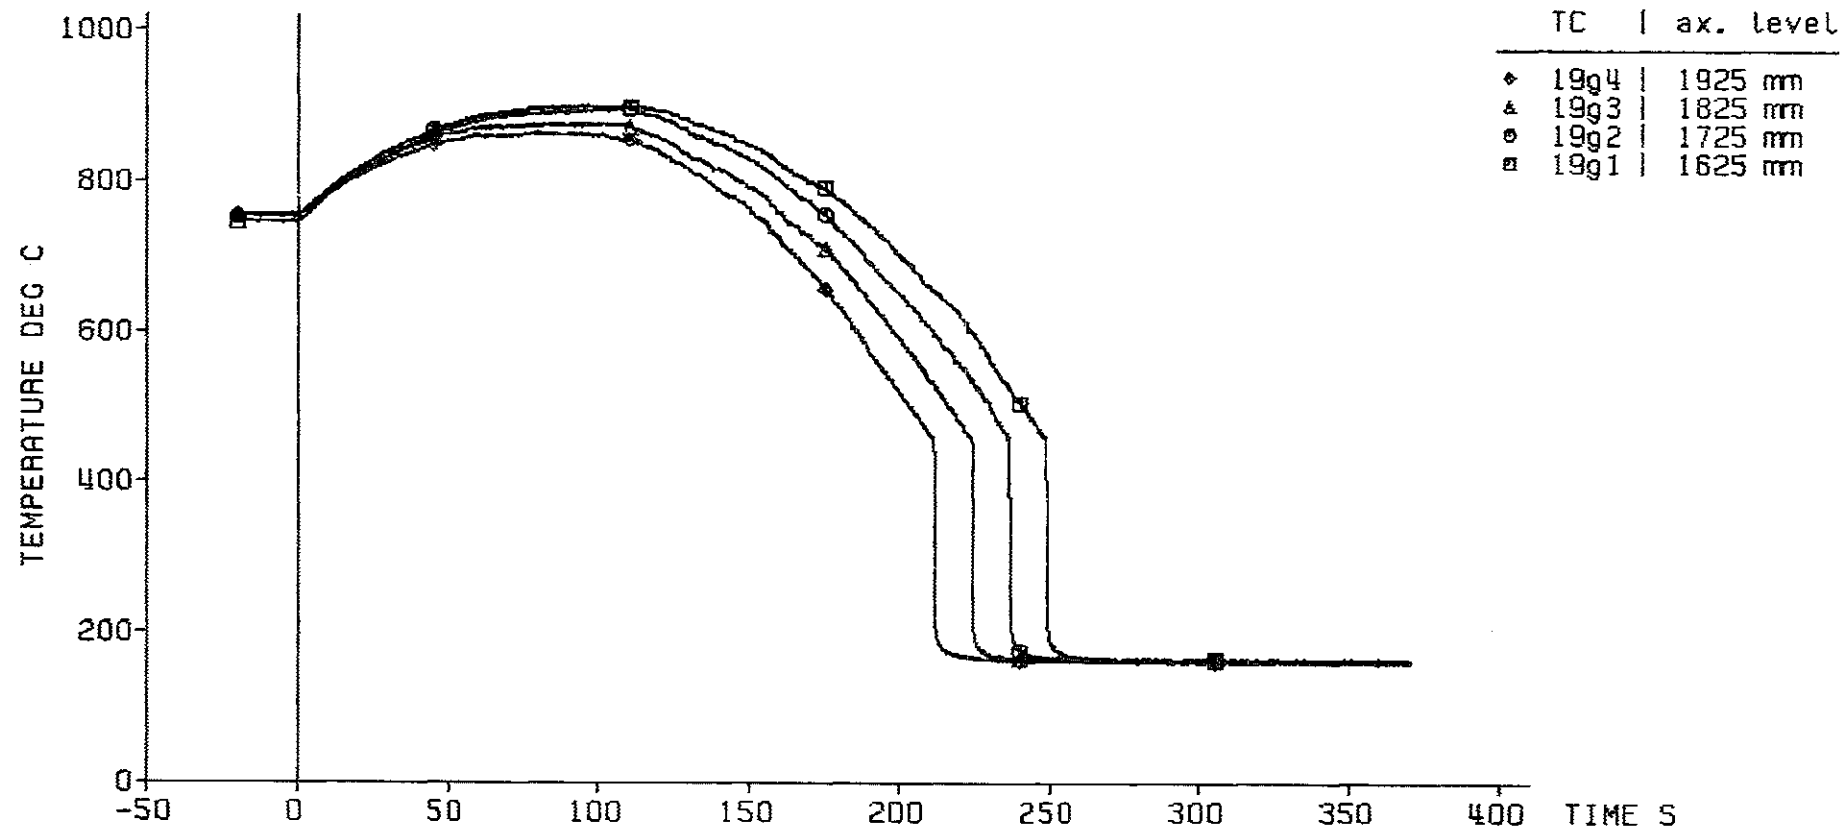
cladding temperature

decay heat 120% RNS standard
 flooding rate (cold) 3.80 cm/s
 system pressure 6.19 bar
 feedwater temperature 40 deg C
