Fig. 183 FEBA: 5x5 ROD BUNDLE, TEST SERIES 2, TEST-No. 230

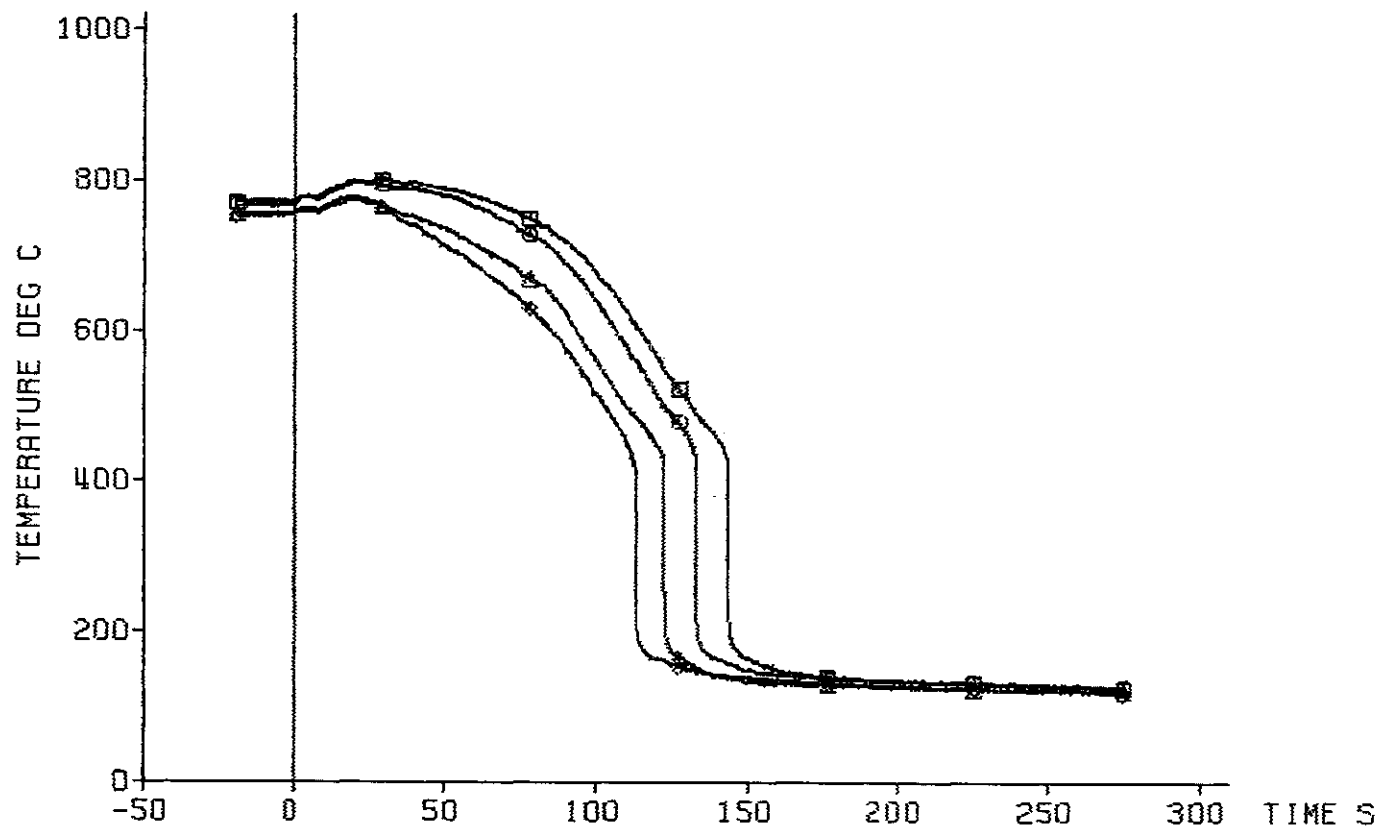
cladding temperature

decay heat
 flooding rate (cold)
 system pressure
 feedwater temperature

120% RMS standard
 5.77 cm/s
 6.15 bar
 40 deg C
