Fig. 178 FEBA: 5x5 ROD BUNDLE
TEST SERIES 2, TEST-No. 228

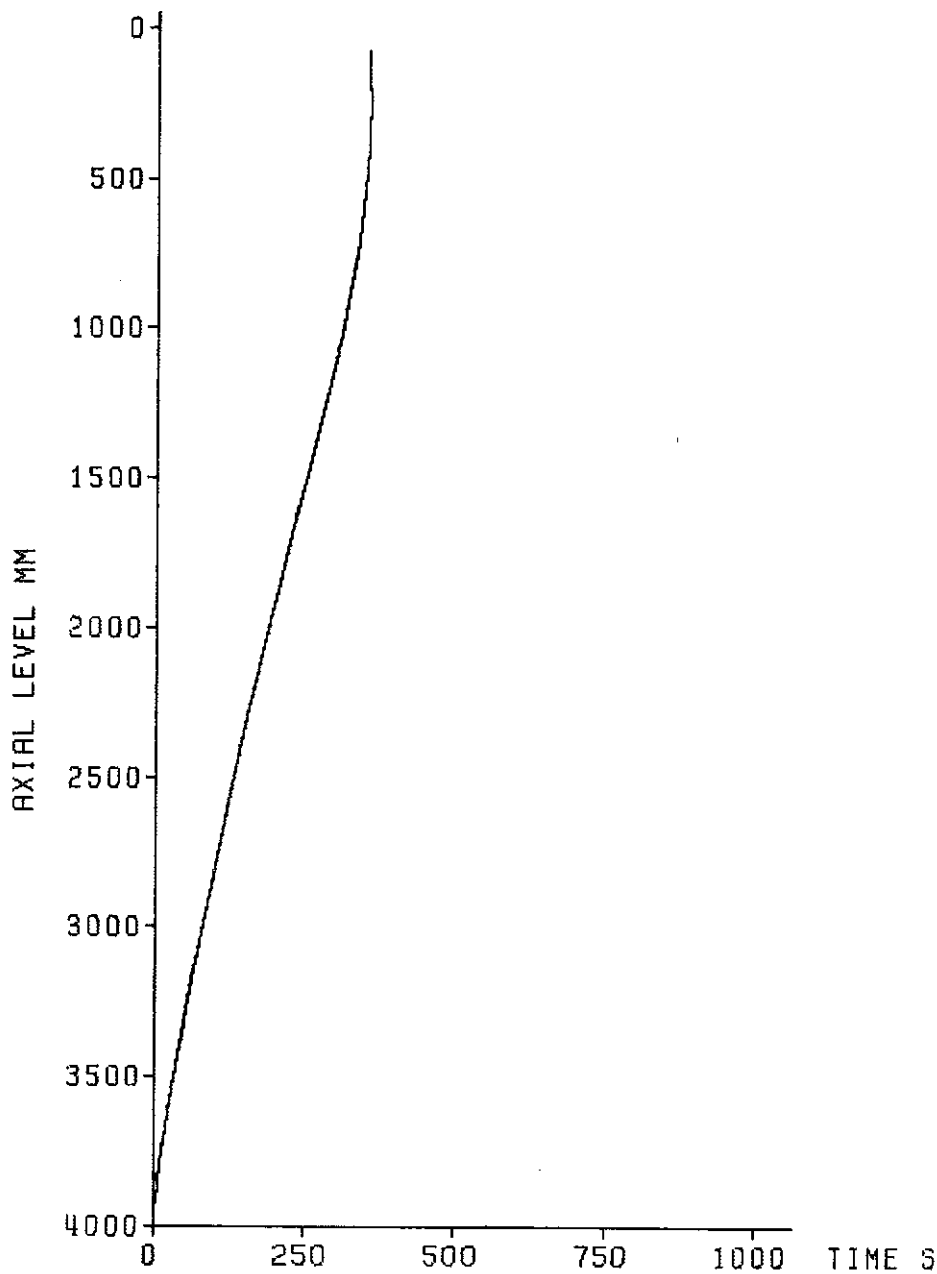
axial position of the quench front

decay heat	120% RNS standard
flooding rate (cold)	5.72 cm/s
system pressure	4.11 bar
feedwater temperature	40 deg C
