Fig. 148 FEBA: 5x5 ROD BUNDLE  
TEST SERIES 2, TEST-No. 231

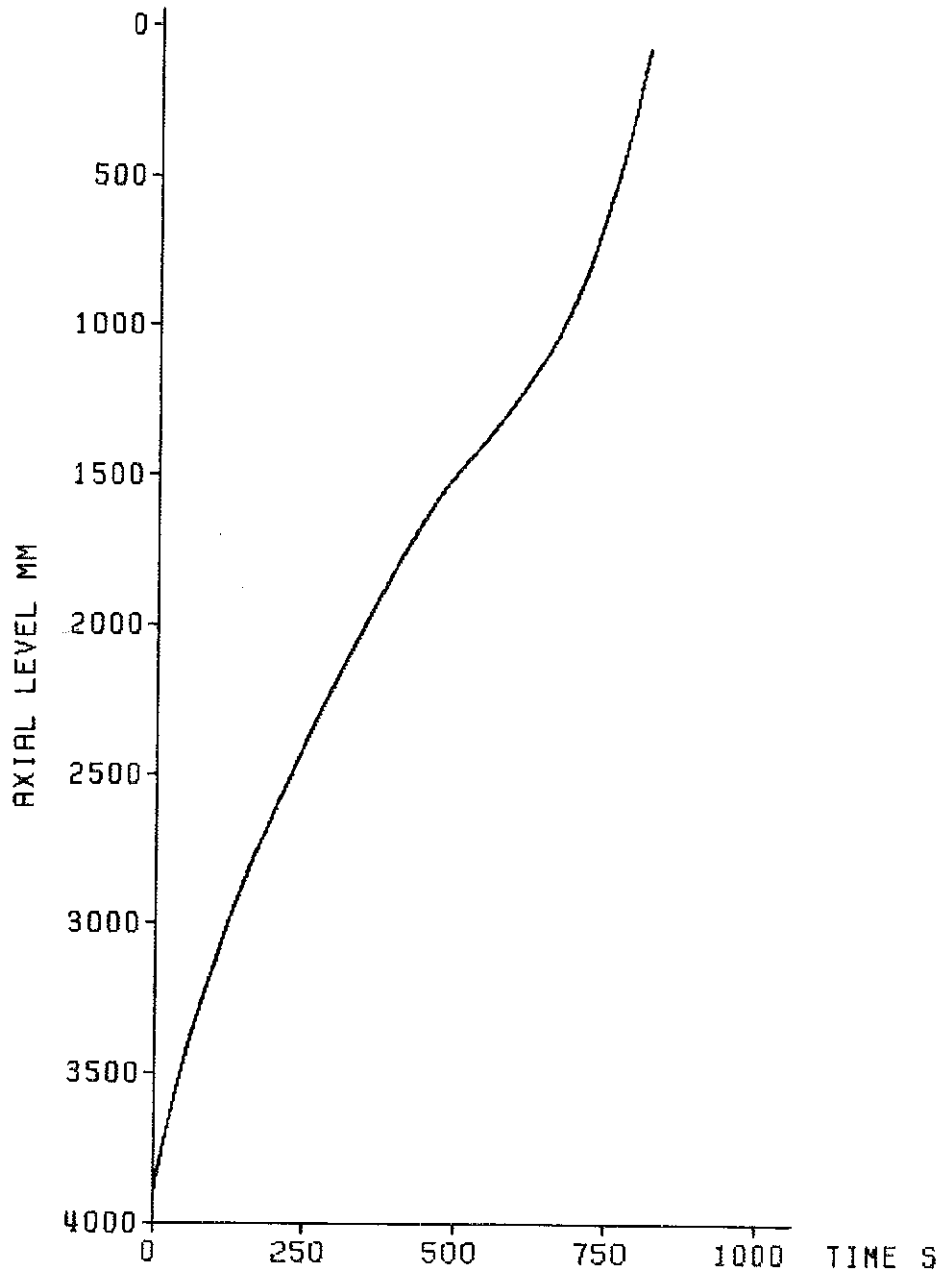
axial position of the quench front

decay heat	120% RNS standard
flooding rate (cold)	3.80 cm/s
system pressure	6.19 bar
feedwater temperature	40 deg C
