Fig. 110 FEBA: 5x5 ROD BUNDLE, TEST SERIES 2, TEST-No. 234

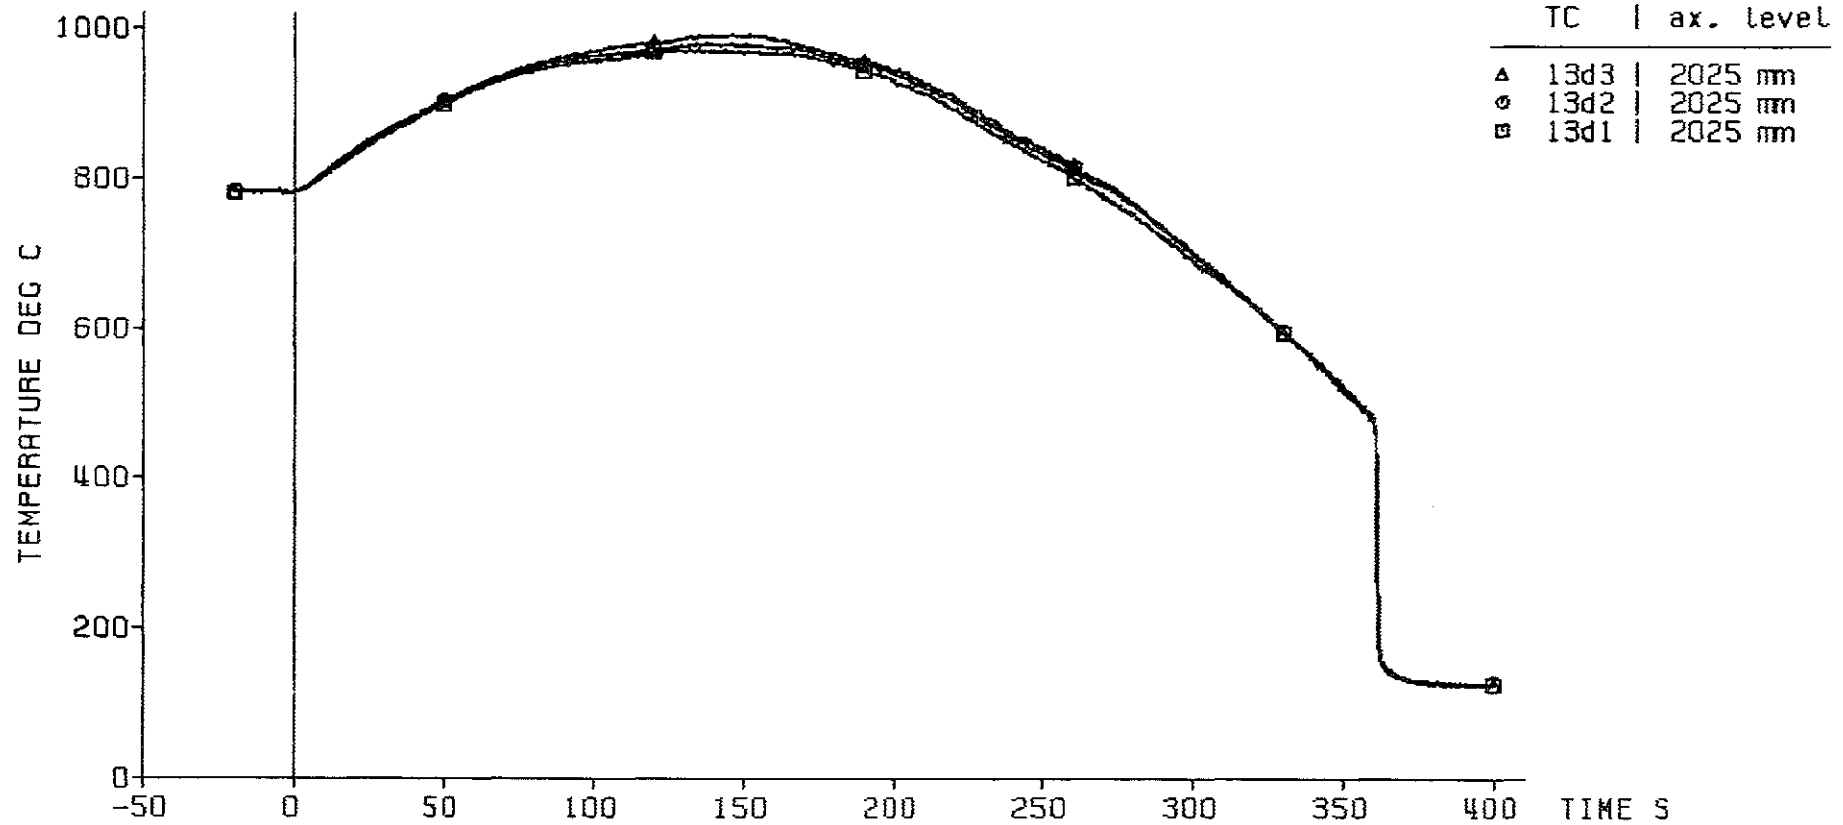
cladding temperature

decay heat 120% ANS standard
 flooding rate (cold) 3.80 cm/s
 system pressure 2.02 bar
 feedwater temperature 40 deg C
