Fig. 159 FEBA: 5x5 ROD BUNDLE, TEST SERIES 2, TEST-No. 233

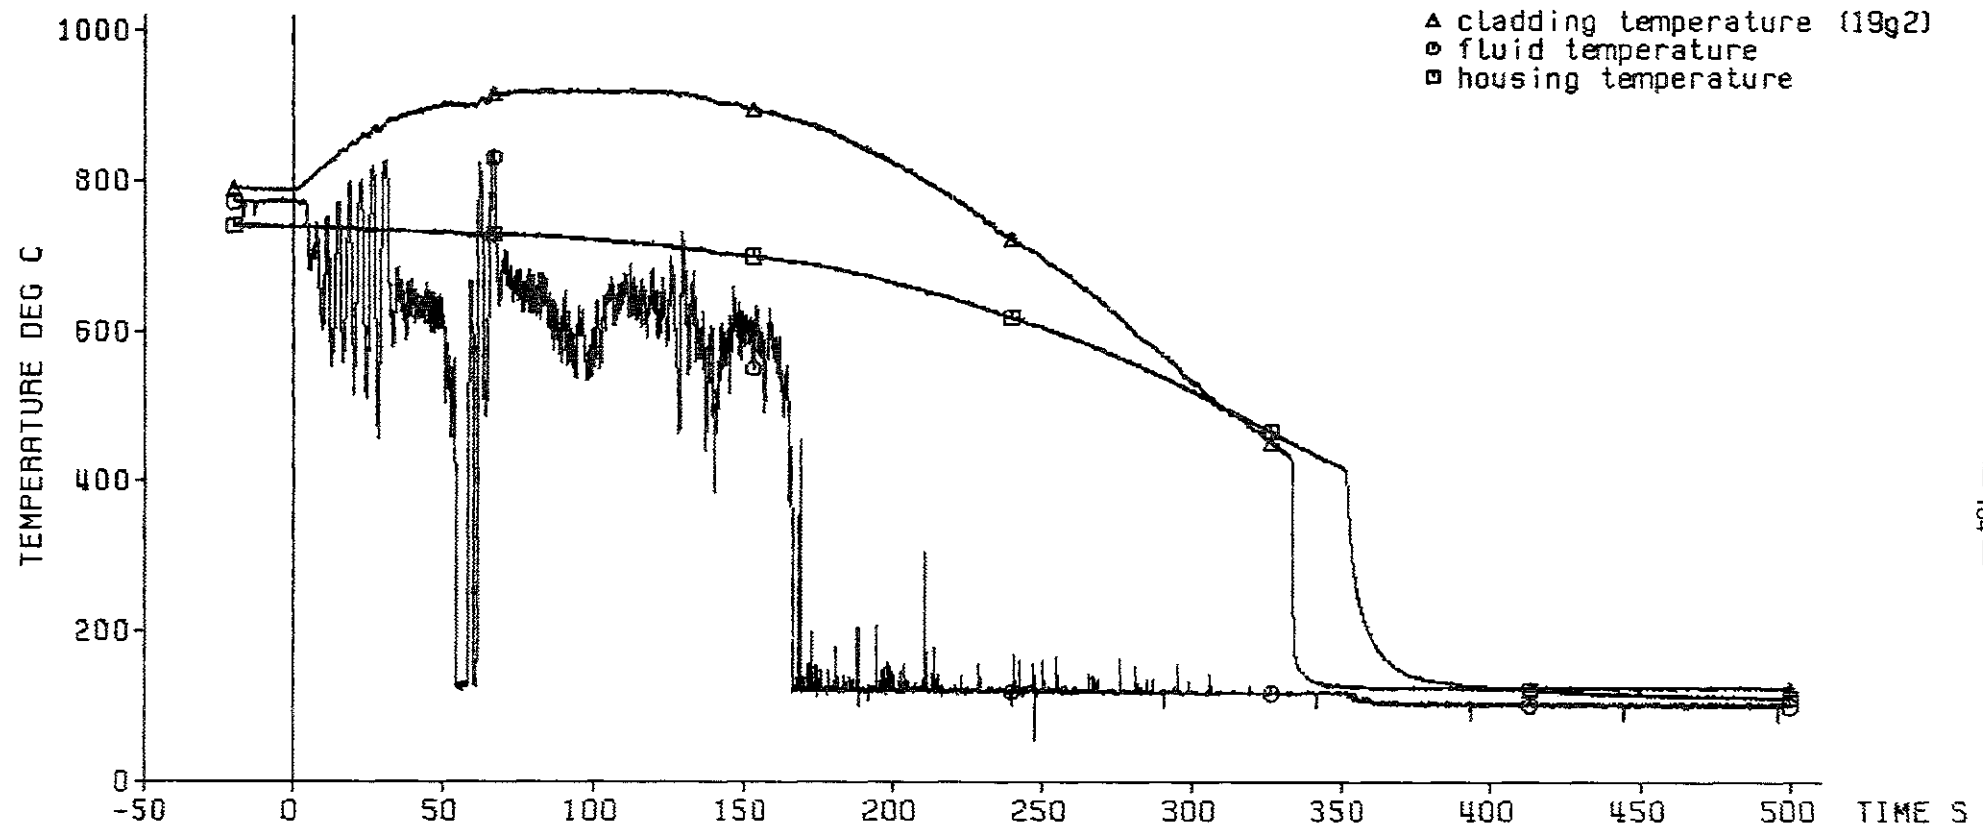
axial level: 1725 mm

decay heat 120% ANS standard
flooding rate (cold) 5.82 cm/s
system pressure 1.99 bar
feedwater temperature 40 deg C
