Fig. 145 FEBA: 5x5 ROD BUNDLE, TEST SERIES 2, TEST-No. 231

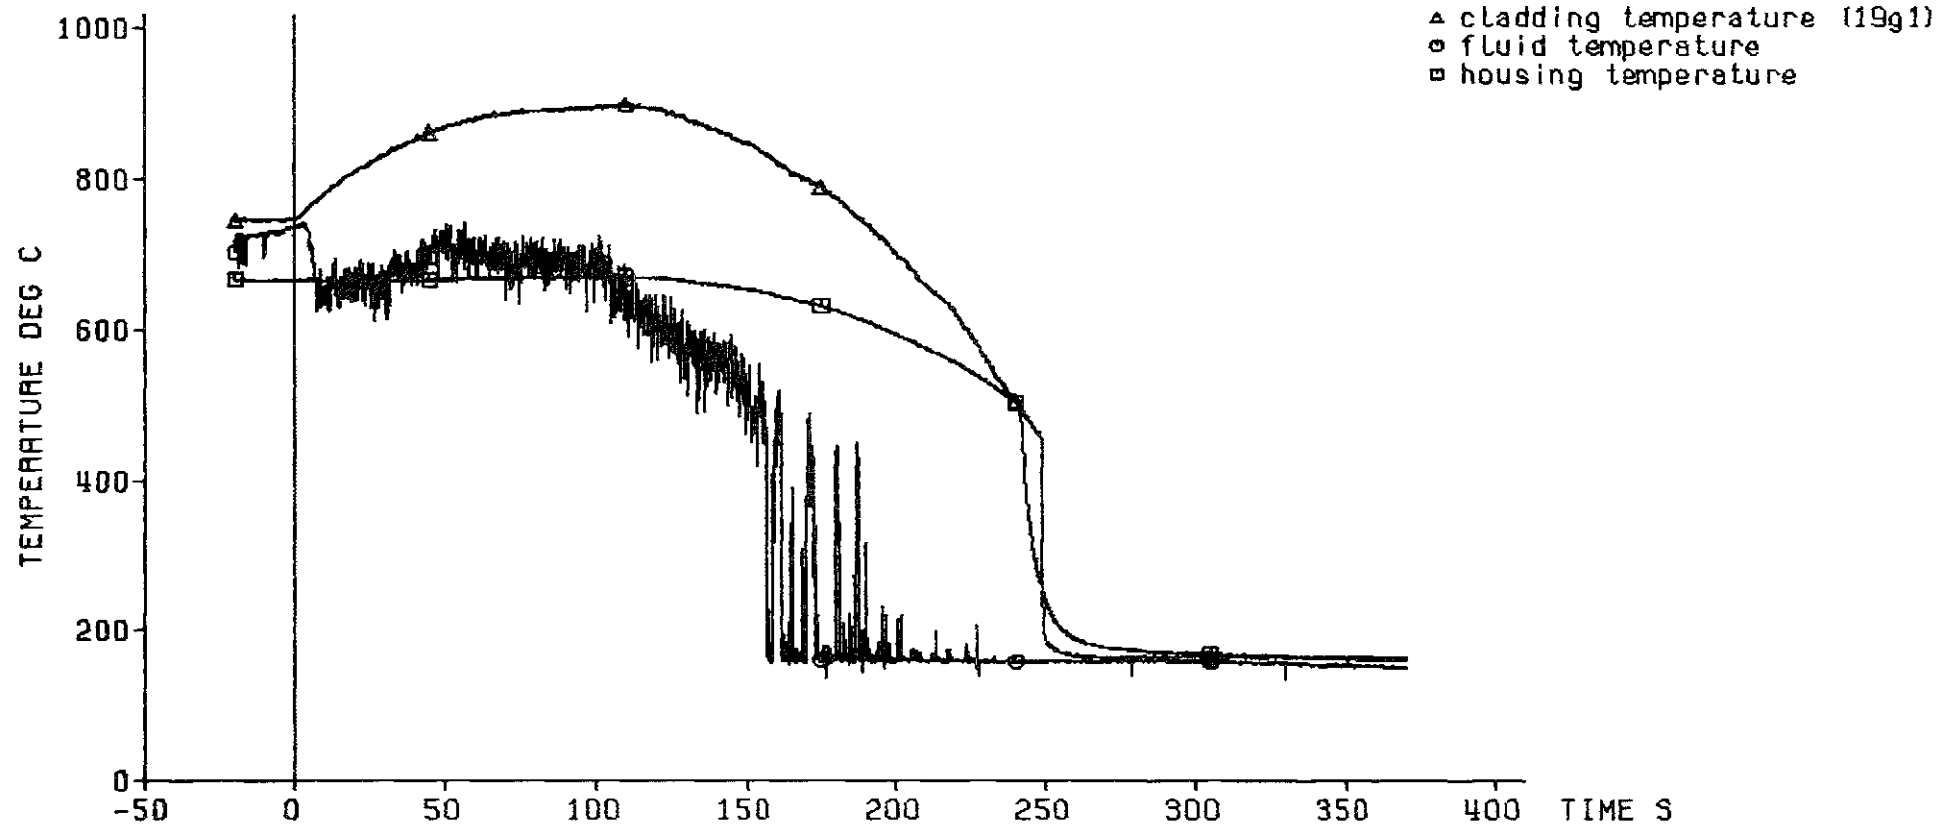
axial level: 1625 mm

decay heat  
flooding rate (cold)  
system pressure  
feedwater temperature

120% RNS standard  
3.80 cm/s  
6.19 bar  
40 deg C
