Fig. 165 FEBRA: 5x5 ROD BUNDLE, TEST SERIES 2, TEST-NO. 228

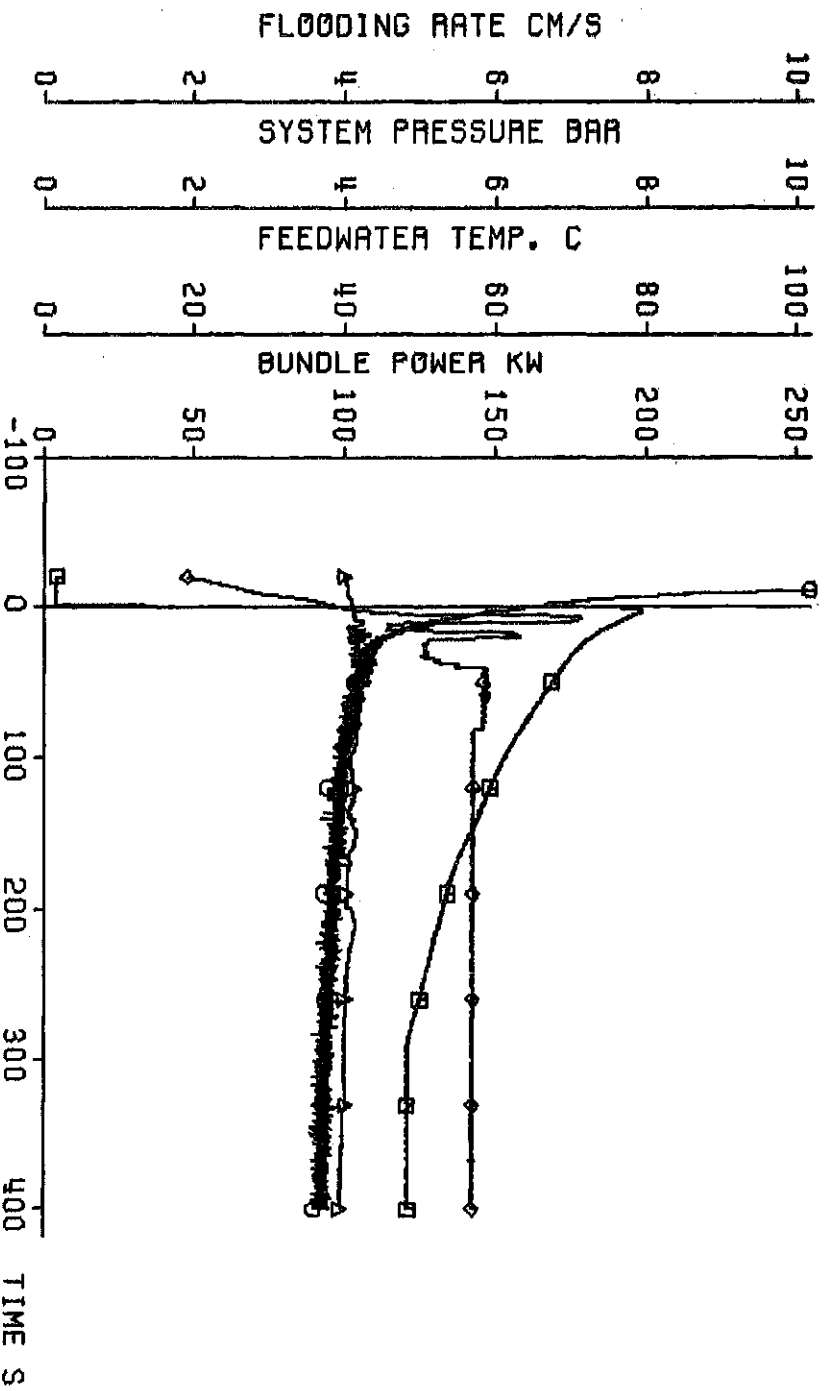
test parameters:

- ◊ flooding rate
- △ system pressure
- feedwater temperature
- bundle power

decay heat
flooding rate (cold)
system pressure
feedwater temperature

120% ANS standard
5.72 cm/s
4.11 bar
40 deg C
