Fig. 130 FEBA: 5x5 ROD BUNDLE, TEST SERIES 2, TEST-No. 229

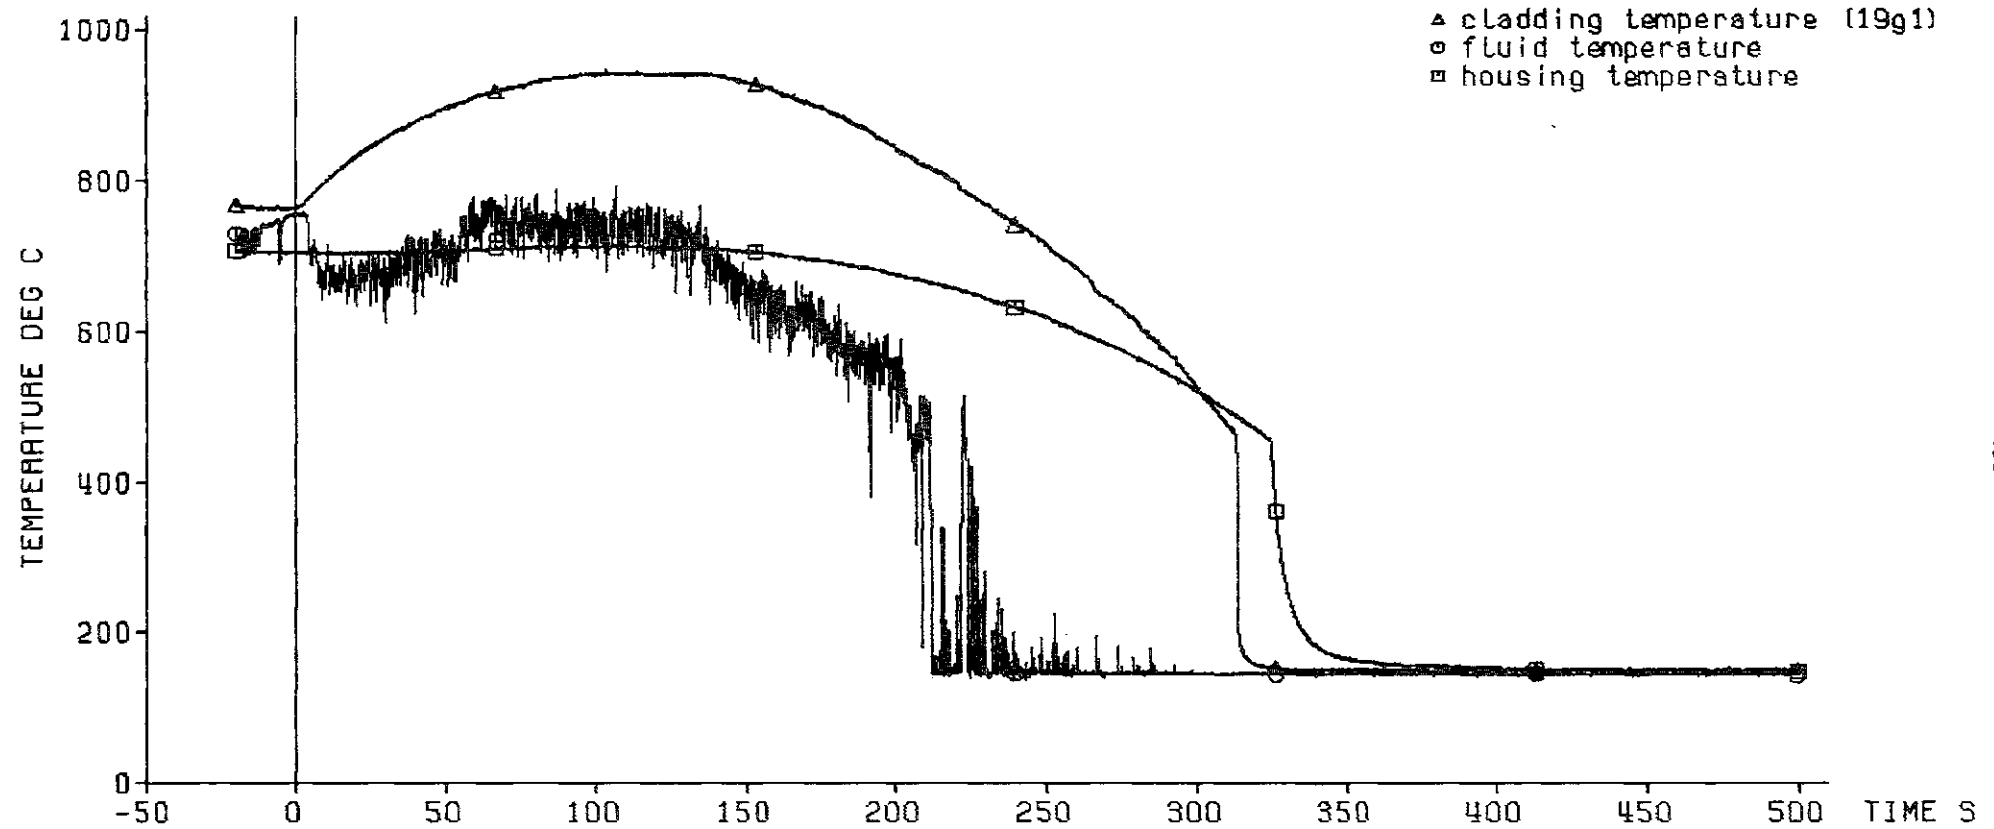
axial level: 1625 mm

decay heat 120% ANS standard  
flooding rate (cold) 3.82 cm/s  
system pressure 4.15 bar  
feedwater temperature 40 deg C
