Fig. 144 FEBA: 5x5 ROD BUNDLE, TEST SERIES 2, TEST-No. 231

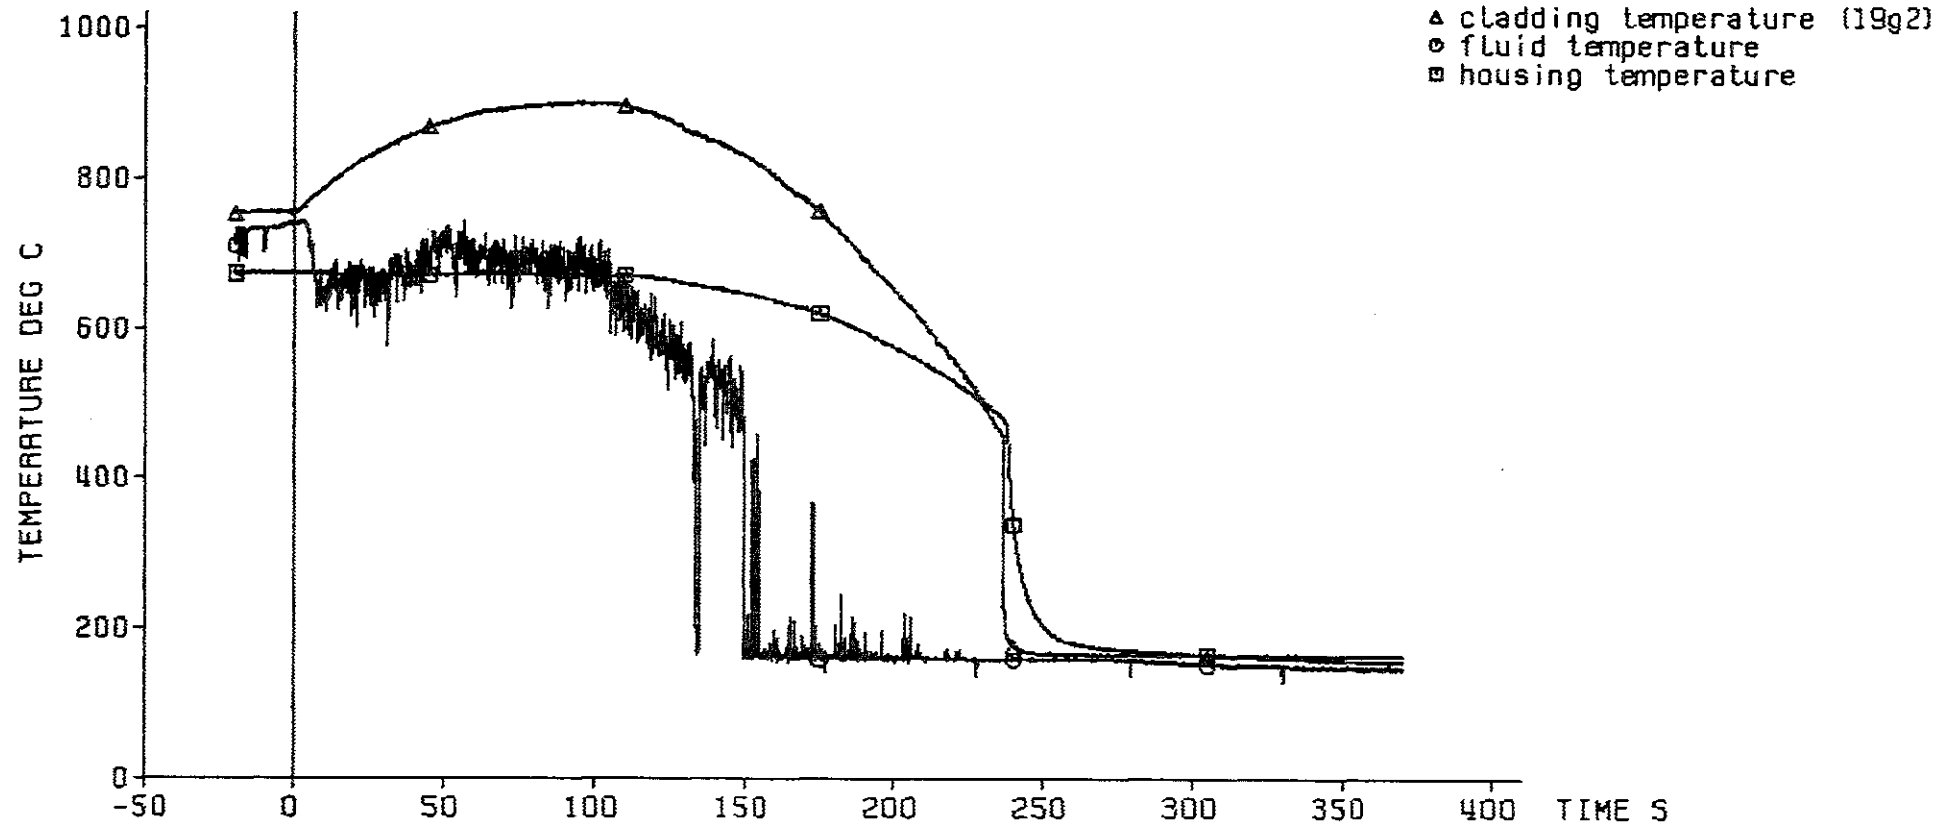
axial level: 1725 mm

decay heat 120% RNS standard
flooding rate (cold) 3.80 cm/s
system pressure 6.19 bar
feedwater temperature 40 deg C
