Fig.172 FEBA: 5x5 ROD BUNDLE, TEST SERIES 2, TEST-No. 228

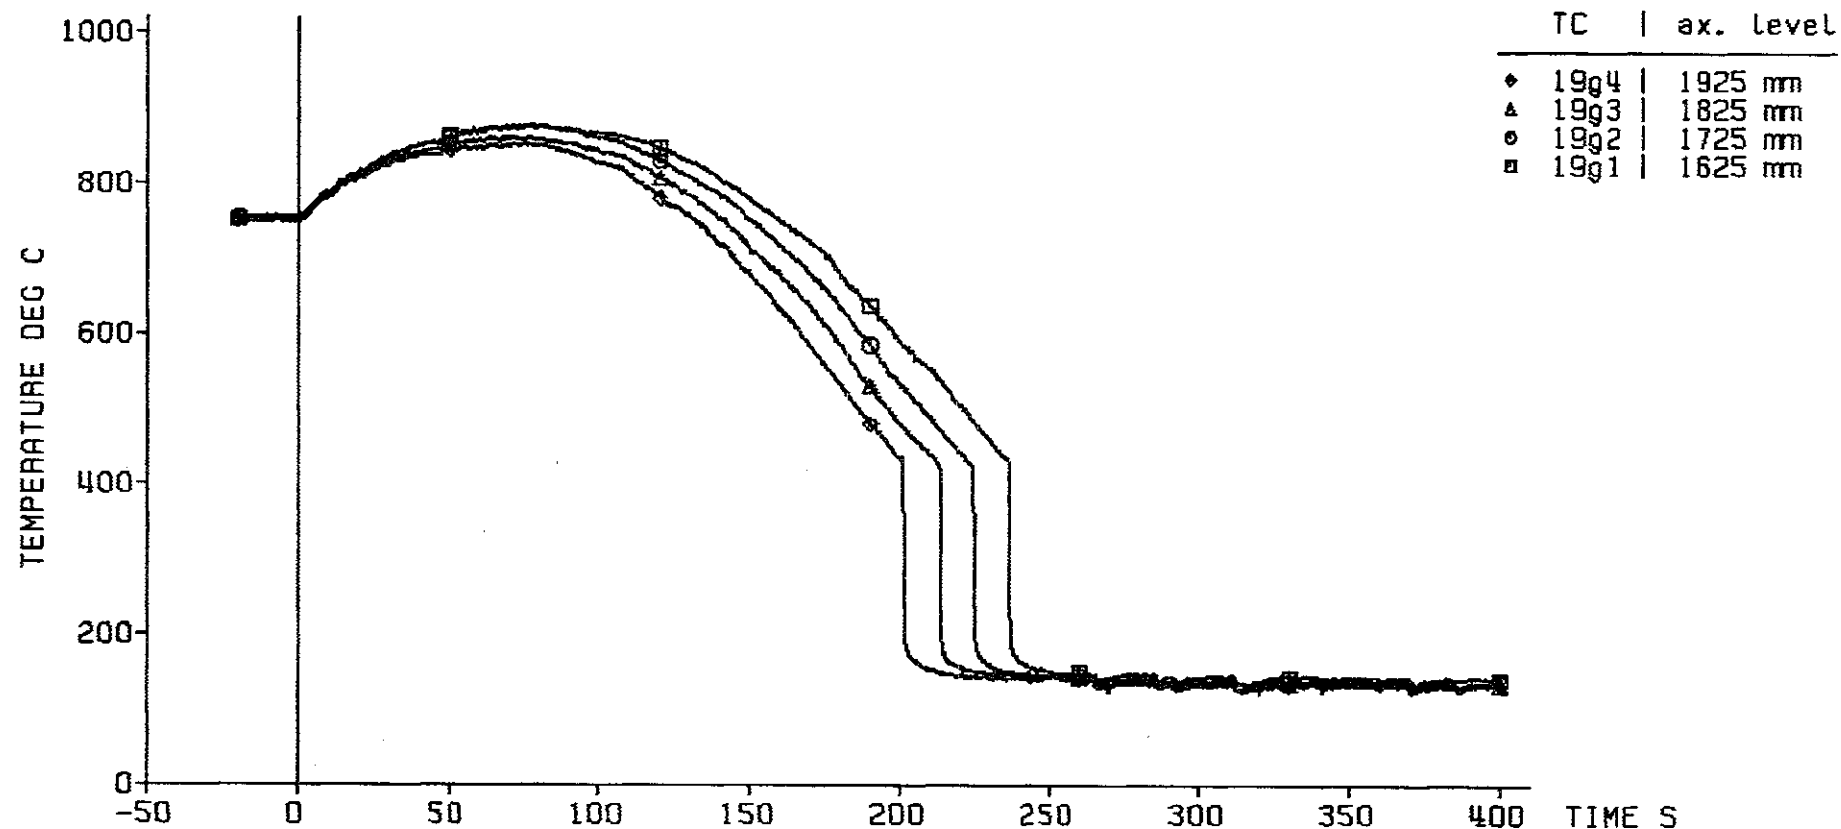
cladding temperature

decay heat 120% ANS standard  
 flooding rate (cold) 5.72 cm/s  
 system pressure 4.11 bar  
 feedwater temperature 40 deg C
